Profile/Photo Observation Report

Street:	Capitol	Flow Control:	Not Controlled
City:	Hobart, IN	Year Renewed:	
Location:	Light Highway	Tape/Media #:	
Purpose:	Maintenance Related	Dia/Height:	12"
Use:	Sanitary	Material:	PVC
Drain Area:	NA	Lining:	Cured in Place
Category:	NA		
Comment:	silt at 12'.

Location Details:		Direction of Survey:	Upstream
US MH:	M-807-009	DS MH:	M-807-012
		Total Length Surveyed (ft):	13.2

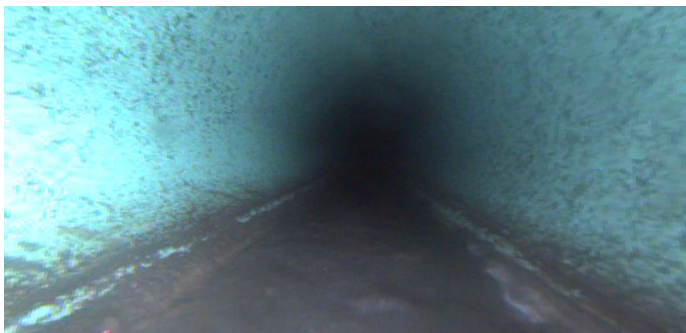
Code: **AMH**
Description: **Manhole**

Distance (ft): **.0**
Structural Grade: **0**
O&M Grade: **0**
Clock Start/From:
Clock To:
1st Value:
2nd Value:
Value Percent:
Continuous Index:
Within 8" of Joint: **NO**
Remarks: **M-807-012**

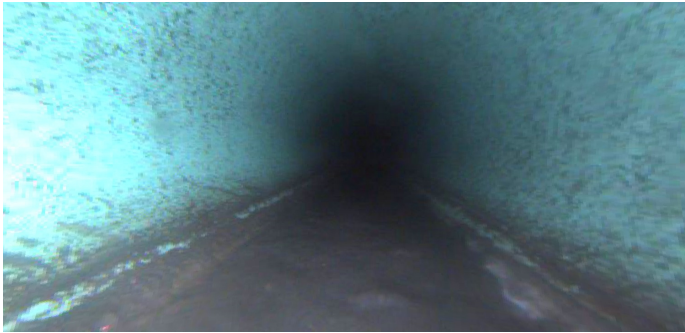
Code:	MWL
Description:	Water Level

Distance (ft):	.0
Structural Grade:	0
O&M Grade:	0
Clock Start/From:	
Clock To:	
1st Value:	
2nd Value:	
Value Percent:	5.000
Continuous Index:	
Within 8" of Joint:	NO
Remarks:
