Profile/Photo Observation Report

Date:	04/16/2018	Weather:		Coding:	PACP 6.0
Pipe Length (ft):	233.0	Owner:	NA	Pre Clean:	Not Known
P.O.#:		Surveyor:	Selasie Honu	PSR:	P-807-012-009
Customer:		Clean Date:	01/01/1900	Shape:	C

Street:	S HOBART RD	Flow Control:	Not Controlled
City:	Hobart, IN	Year Renewed:	
Location:	Light Highway	Tape/Media #:	
Purpose:	Maintenance Related	Dia/Height:	12"
Use:	Sanitary	Material:	PVC
Drain Area:	NA	Lining:	Cured in Place
Category:	NA		
Comment:	Reverse setup. tracks sinking in sediment at 7'.		
Location Details:		Direction of Survey:	Downstream
US MH:	M-807-009	DS MH:	M-807-012
		Total Length Surveyed (ft):	8.2

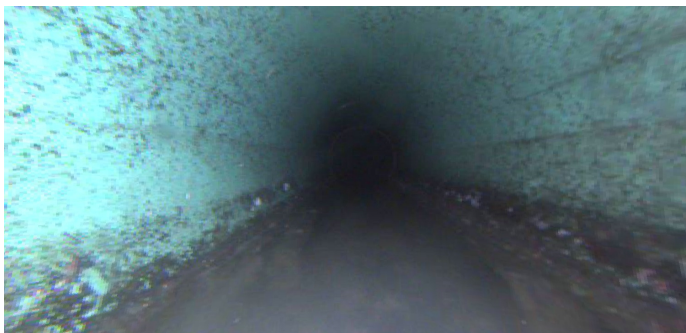
Code: **AMH**
Description: **Manhole**

Distance (ft): **.0**
Structural Grade: **0**
O&M Grade: **0**
Clock Start/From:
Clock To:
1st Value:
2nd Value:
Value Percent:
Continuous Index:
Within 8" of Joint: **NO**
Remarks: **M-807-009**

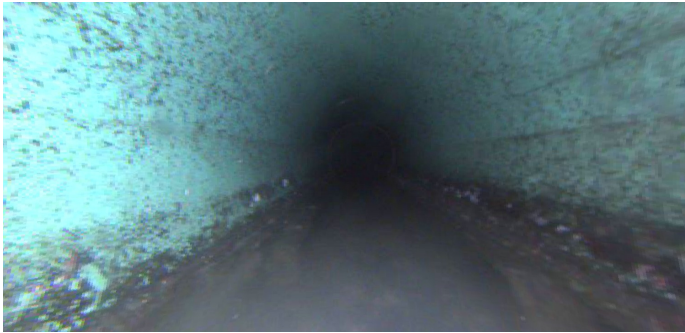
Code:	MWL
Description:	Water Level

Distance (ft):	.0
Structural Grade:	0
O&M Grade:	0
Clock Start/From:	
Clock To:	
1st Value:	
2nd Value:	
Value Percent:	5.000
Continuous Index:	
Within 8" of Joint:	NO
Remarks:
