Profile/Photo Observation Report

Date:	04/16/2018	Weather:		Coding:	PACP 6.0
Pipe Length (ft):	233.0	Owner:	NA	Pre Clean:	Not Known
P.O.#:		Surveyor:	Selasie Honu	PSR:	P-807-012-009
Customer:		Clean Date:	01/01/1900	Shape:	C

Street:	Capitol	Flow Control:	Not Controlled
City:	Hobart, IN	Year Renewed:	
Location:	Light Highway	Tape/Media #:	
Purpose:	Maintenance Related	Dia/Height:	12"
Use:	Sanitary	Material:	PVC
Drain Area:	NA	Lining:	Cured in Place
Category:	NA		
Comment:	Reverse setup. tracks sinking in sediment at 7'.		
Location Details:		Direction of Survey:	Downstream
US MH:	M-807-009	DS MH:	M-807-012
		Total Length Surveyed (ft):	8.2

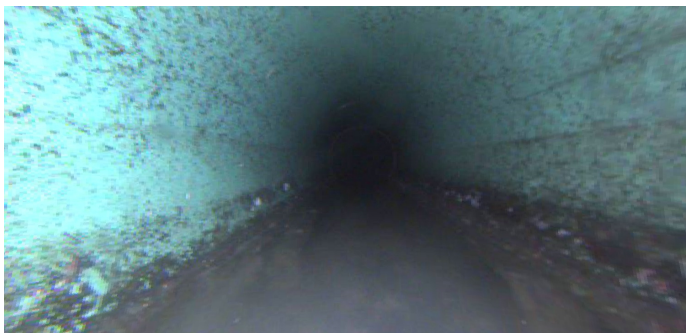
Code: **AMH**
Description: **Manhole**

Distance (ft): **.0**
Structural Grade: **0**
O&M Grade: **0**
Clock Start/From:
Clock To:
1st Value:
2nd Value:
Value Percent:
Continuous Index:
Within 8" of Joint: **NO**
Remarks: **M-807-009**

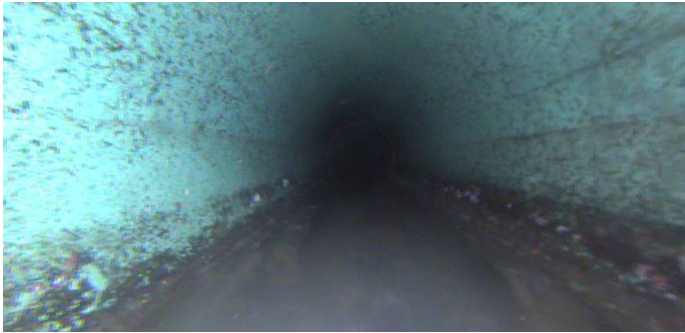
Code:	MWL
Description:	Water Level

Distance (ft):	.0
Structural Grade:	0
O&M Grade:	0
Clock Start/From:	
Clock To:	
1st Value:	
2nd Value:	
Value Percent:	5.000
Continuous Index:	
Within 8" of Joint:	NO
Remarks:
