## Profile/Photo Observation Report

Street:	<b>S HOBART RD</b>	Flow Control:	<b>Not Controlled</b>
City:	<b>Hobart, IN</b>	Year Renewed:	
Location:	<b>Light Highway</b>	Tape/Media #:	
Purpose:	<b>Maintenance Related</b>	Dia/Height:	<b>10"</b>
Use:	<b>Sanitary</b>	Material:	<b>PVC</b>
Drain Area:	<b>NA</b>	Lining:	<b>Cured in Place</b>
Category:	<b>NA</b>		
Comment:	<b>silt at 22'. flow incorrect.</b>

Location Details:		Direction of Survey:	<b>Upstream</b>
US MH:	<b>M-807-010</b>	DS MH:	<b>M-807-009</b>
		Total Length Surveyed (ft):	<b>24.0</b>

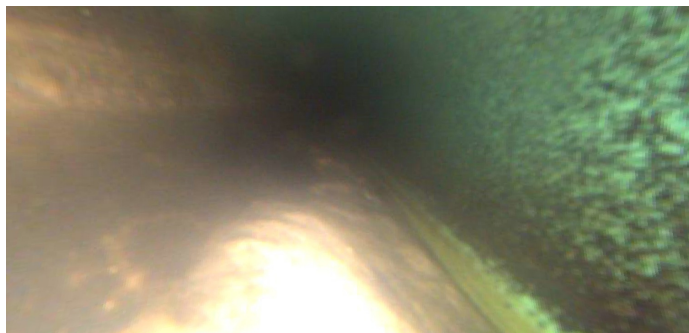
Code: **AMH**  
Description: **Manhole**

Distance (ft): **.0**  
Structural Grade: **0**  
O&M Grade: **0**  
Clock Start/From:  
Clock To:  
1st Value:  
2nd Value:  
Value Percent:  
Continuous Index:  
Within 8" of Joint: **NO**  
Remarks: **M-807-009**

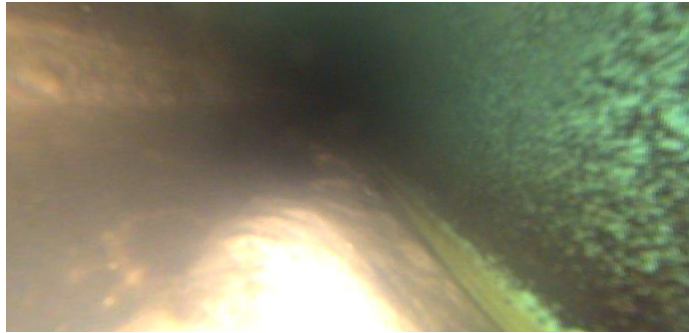
Code: **MWL**  
Description: **Water Level**

Distance (ft): **.0**  
Structural Grade: **0**  
O&M Grade: **0**  
Clock Start/From:  
Clock To:  
1st Value:  
2nd Value:  
Value Percent: **5.000**  
Continuous Index:  
Within 8" of Joint: **NO**  
Remarks:

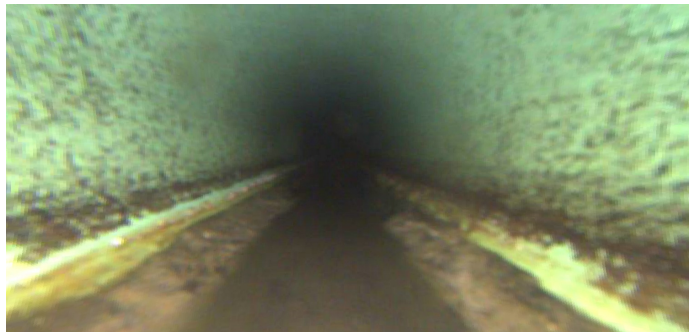
Code: **MSA**  
Description: **Abandoned Survey**

Distance (ft): **24.0**  
Structural Grade: **0**  
O&M Grade: **0**  
Clock Start/From:  
Clock To:  
1st Value:  
2nd Value:  
Value Percent:  
Continuous Index:  
Within 8" of Joint: **NO**  
Remarks: **camera stopped**
