Profile/Photo Observation Report

| Street: | Capitol | Flow Control: | Not Controlled |
| City: | Hobart, IN | Year Renewed: | |

| US MH: | M-807-010 | DS MH: | M-807-009 |

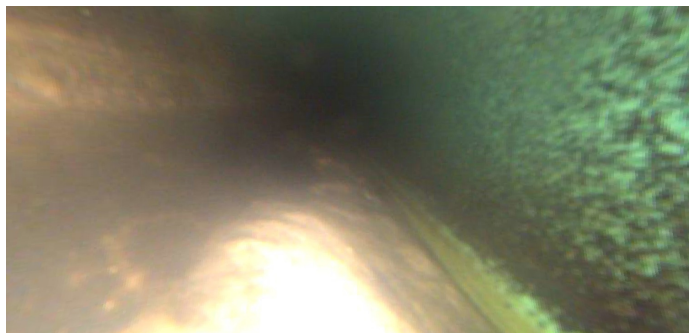
Code: **AMH**
Description: **Manhole**

Distance (ft): **.0**
Structural Grade: **0**
O&M Grade: **0**
Clock Start/From:
Clock To:
1st Value:
2nd Value:
Value Percent:
Continuous Index:
Within 8" of Joint: **NO**
Remarks: **M-807-009**

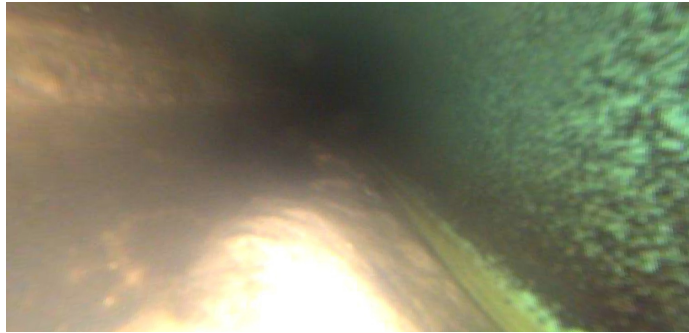
Code: **MWL**
Description: **Water Level**

Distance (ft): **.0**
Structural Grade: **0**
O&M Grade: **0**
Clock Start/From:
Clock To:
1st Value:
2nd Value:
Value Percent: **5.000**
Continuous Index:
Within 8" of Joint: **NO**
Remarks:

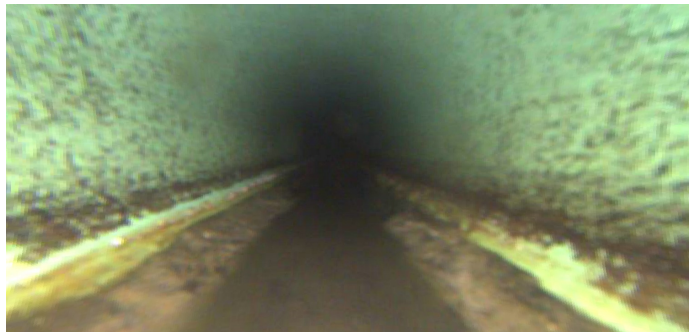
| Comment: | silt at 22'. flow incorrect. | | |

Code: **MSA**
Description: **Abandoned Survey**

Distance (ft): **24.0**
Structural Grade: **0**
O&M Grade: **0**
Clock Start/From:
Clock To:
1st Value:
2nd Value:
Value Percent:
Continuous Index:
Within 8" of Joint: **NO**
Remarks: **camera stopped**
