Profile/Photo Observation Report

Street:	S HOBART RD	Flow Control:	Not Controlled
City:	Hobart, IN	Year Renewed:	
Location:	Yard	Tape/Media #:	
Purpose:	Maintenance Related	Dia/Height:	12"
Use:	Sanitary	Material:	PVC
Drain Area:	NA	Lining:	Cured in Place
Category:	NA		
Comment:	Reverse setup. flow incorrect.

Location Details:		Direction of Survey:	Downstream
US MH:	M-807-010	DS MH:	M-807-009
		Total Length Surveyed (ft):	45.8

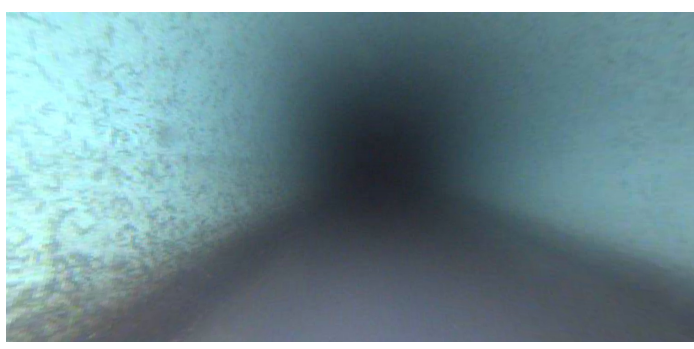
Code: **AMH**
Description: **Manhole**

Distance (ft): **.0**
Structural Grade: **0**
O&M Grade: **0**
Clock Start/From:
Clock To:
1st Value:
2nd Value:
Value Percent:
Continuous Index:
Within 8" of Joint: **NO**
Remarks: **M-807-010**

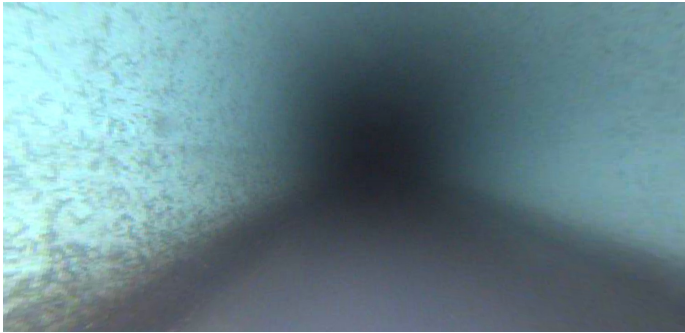
Code:	MWL
Description:	Water Level

Distance (ft):	.0
Structural Grade:	0
O&M Grade:	0
Clock Start/From:	
Clock To:	
1st Value:	
2nd Value:	
Value Percent:	5.000
Continuous Index:	
Within 8" of Joint:	NO
Remarks:

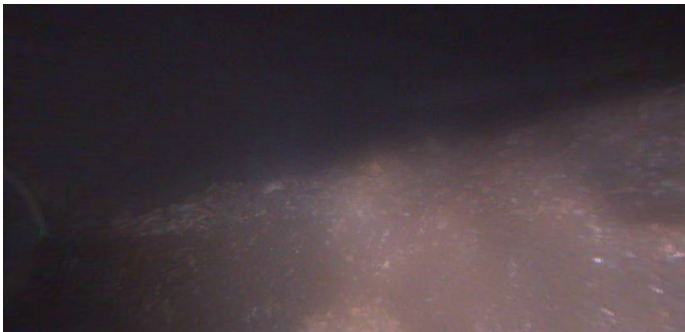
Code:	AMH
Description:	Manhole

Distance (ft):	45.8
Structural Grade:	0
O&M Grade:	0
Clock Start/From:	
Clock To:	
1st Value:	
2nd Value:	
Value Percent:	
Continuous Index:	
Within 8" of Joint:	NO
Remarks:	M-807-009
