Profile/Photo Observation Report

Date:	04/16/2018	Weather:		Coding:	PACP 6.0
Pipe Length (ft):	50.6	Owner:	NA	Pre Clean:	Not Known
P.O.#:		Surveyor:	Selasie Honu	PSR:	P-807-009-010
Customer:		Clean Date:	01/01/1900	Shape:	C

Location Details:		Direction of Survey:	Downstream
US MH:	M-807-010	DS MH:	M-807-009
		Total Length Surveyed (ft):	45.8

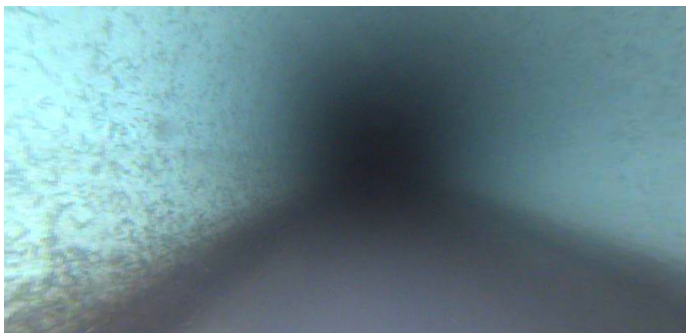
Code: **AMH**
Description: **Manhole**

Distance (ft): **.0**
Structural Grade: **0**
O&M Grade: **0**
Clock Start/From:
Clock To:
1st Value:
2nd Value:
Value Percent:
Continuous Index:
Within 8" of Joint: **NO**
Remarks: **M-807-010**

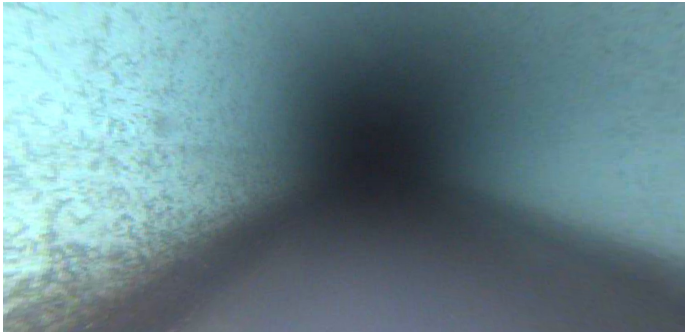
Code:	MWL
Description:	Water Level

Distance (ft):	.0
Structural Grade:	0
O&M Grade:	0
Clock Start/From:	
Clock To:	
1st Value:	
2nd Value:	
Value Percent:	5.000
Continuous Index:	
Within 8" of Joint:	NO
Remarks:

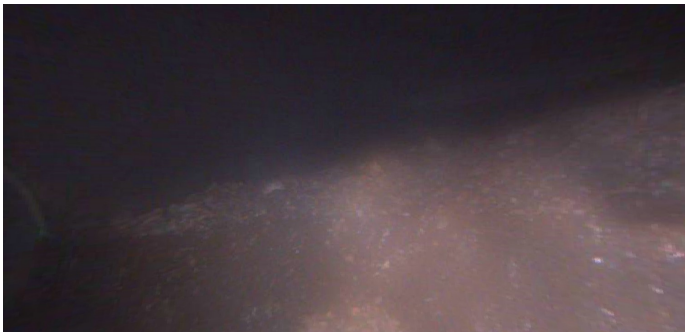
Code:	AMH
Description:	Manhole

Distance (ft):	45.8
Structural Grade:	0
O&M Grade:	0
Clock Start/From:	
Clock To:	
1st Value:	
2nd Value:	
Value Percent:	
Continuous Index:	
Within 8" of Joint:	NO
Remarks:	M-807-009
