Profile/Photo Observation Report

Street:	OFF E 10TH ST	Flow Control:	Not Controlled
City:	Hobart, IN	Year Renewed:	
Location:	Yard	Tape/Media #:	
Purpose:	Maintenance Related	Dia/Height:	12"
Use:	Sanitary	Material:	PVC
Drain Area:	NA	Lining:	Cured in Place
Category:	NA		
Comment:	blk silt at 57'.

Location Details:		Direction of Survey:	Upstream
US MH:	M-807-011	DS MH:	M-807-010
		Total Length Surveyed (ft):	58.3

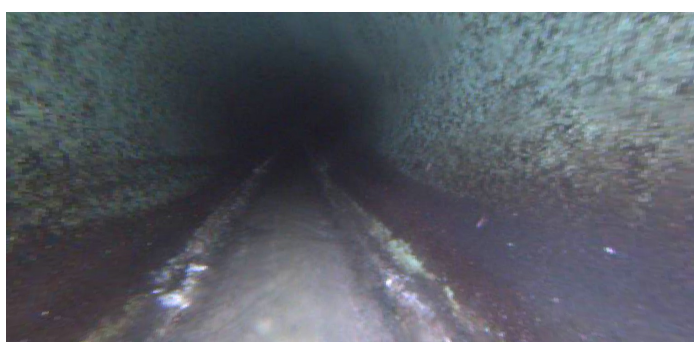
Code: **AMH**
Description: **Manhole**

Distance (ft): **.0**
Structural Grade: **0**
O&M Grade: **0**
Clock Start/From:
Clock To:
1st Value:
2nd Value:
Value Percent:
Continuous Index:
Within 8" of Joint: **NO**
Remarks: **M-807-010**

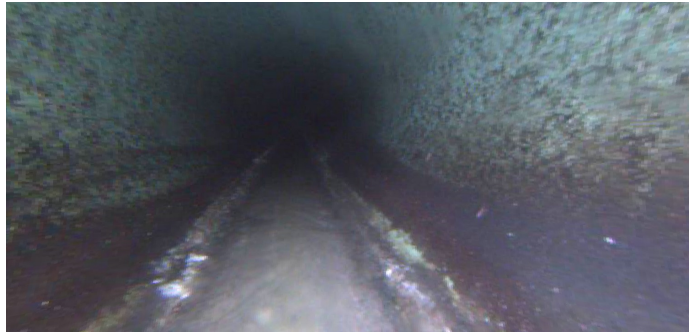
Code:	MWL
Description:	Water Level
Distance (ft):	.0
Structural Grade:	0
O&M Grade:	0
Clock Start/From:	
Clock To:	
1st Value:	
2nd Value:	
Value Percent:	5.000
Continuous Index:	
Within 8" of Joint:	NO
Remarks:

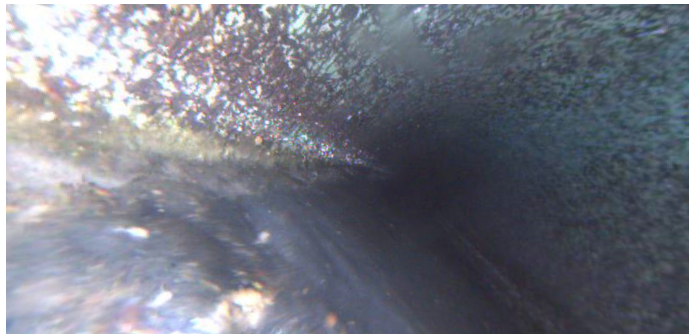
Code:	MWL
Description:	Water Level
Distance (ft):	58.3
Structural Grade:	0
O&M Grade:	0
Clock Start/From:	
Clock To:	
1st Value:	
2nd Value:	
Value Percent:	40.000
Continuous Index:	
Within 8" of Joint:	NO
Remarks:

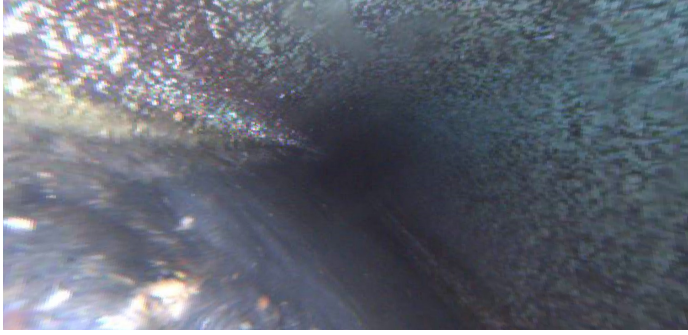
Code:	MSA
Description:	Abandoned Survey
Distance (ft):	58.3
Structural Grade:	0
O&M Grade:	0
Clock Start/From:	
Clock To:	
1st Value:	
2nd Value:	
Value Percent:	
Continuous Index:	
Within 8" of Joint:	NO
Remarks:	camera stopped
