## Profile/Photo Observation Report

| Street: | <b>Capitol</b> | Flow Control: | <b>Not Controlled</b> |
| City: | <b>Hobart, IN</b> | Year Renewed: | |

| US MH: | <b>M-807-011</b> | DS MH: | <b>M-807-010</b> |

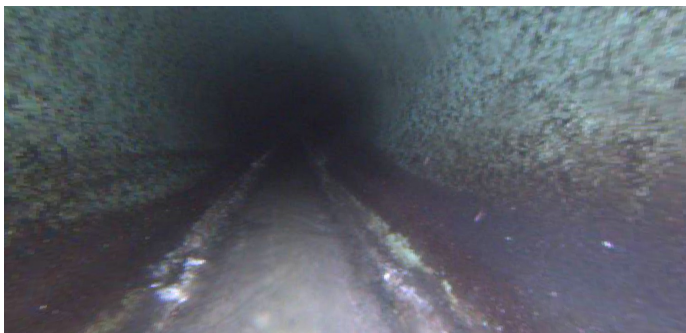
Code: **AMH**  
Description: **Manhole**

Distance (ft): **.0**  
Structural Grade: **0**  
O&M Grade: **0**  
Clock Start/From:  
Clock To:  
1st Value:  
2nd Value:  
Value Percent:  
Continuous Index:  
Within 8" of Joint: **NO**  
Remarks: **M-807-010**

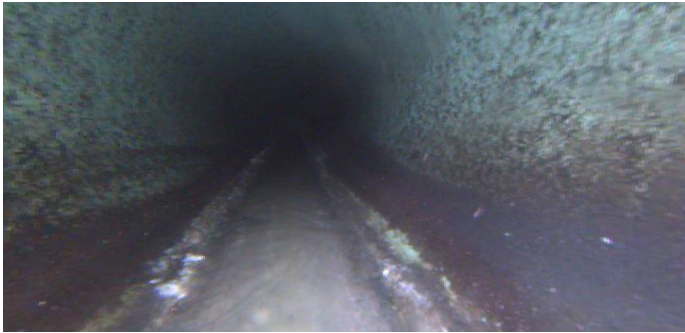
| Description: | <b>Water Level</b> |

| Distance (ft): | <b>.0</b> |
| Value Percent: | <b>5.000</b> |

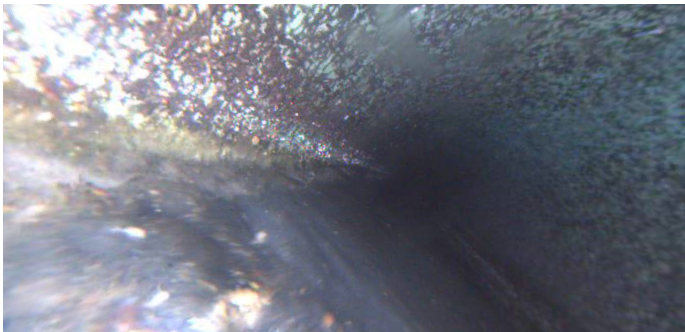
| Comment: | <b>blk silt at 57'.</b> | | |

| Description: | <b>Water Level</b> |

| Distance (ft): | <b>58.3</b> |
| Value Percent: | <b>40.000</b> |

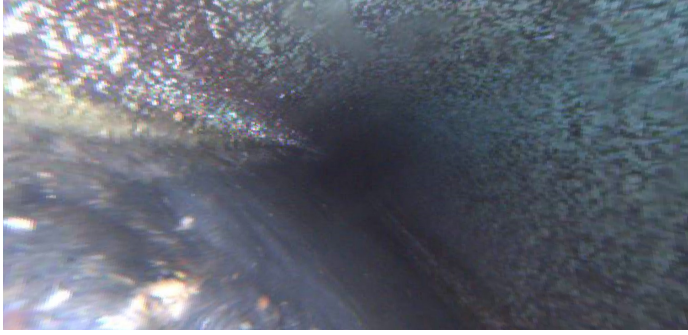
| Description: | <b>Abandoned Survey</b> |
| Distance (ft): | <b>58.3</b> |
| Remarks: | <b>camera stopped</b> |
