## Profile/Photo Observation Report

Street:	<b>S HOBART RD</b>	Flow Control:	<b>Not Controlled</b>
City:	<b>Hobart, IN</b>	Year Renewed:	
Location:	<b>Light Highway</b>	Tape/Media #:	
Purpose:	<b>Maintenance Related</b>	Dia/Height:	<b>12"</b>
Use:	<b>Sanitary</b>	Material:	<b>PVC</b>
Drain Area:	<b>NA</b>	Lining:	<b>Cured in Place</b>
Category:	<b>NA</b>		
Comment:	<b>Reverse setup. user set max at 100'.</b>

Location Details:		Direction of Survey:	<b>Downstream</b>
US MH:	<b>M-807-012</b>	DS MH:	<b>M-907-004</b>
		Total Length Surveyed (ft):	<b>101.6</b>

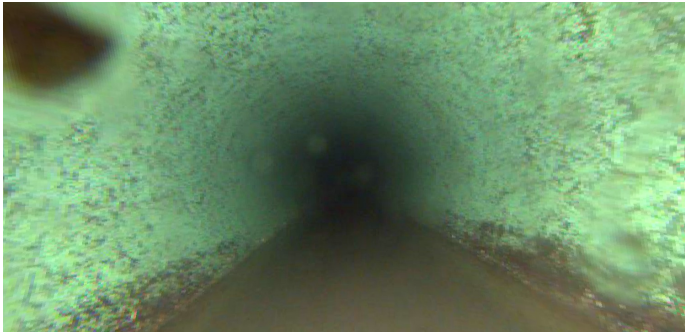
Code:	<b>MWL</b>
Description:	<b>Water Level</b>

Distance (ft):	<b>.0</b>
Structural Grade:	<b>0</b>
O&M Grade:	<b>0</b>
Clock Start/From:	
Clock To:	
1st Value:	
2nd Value:	
Value Percent:	<b>5.000</b>
Continuous Index:	
Within 8" of Joint:	<b>NO</b>
Remarks:

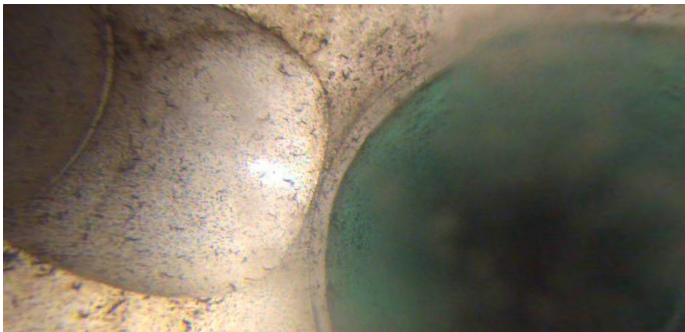
Code:	<b>TF</b>
Description:	<b>Tap Factory</b>

Distance (ft):	<b>89.2</b>
Structural Grade:	<b>0</b>
O&M Grade:	<b>0</b>
Clock Start/From:	<b>3</b>
Clock To:	
1st Value:	<b>4.000</b>
2nd Value:	
Value Percent:	
Continuous Index:	
Within 8" of Joint:	
Remarks:

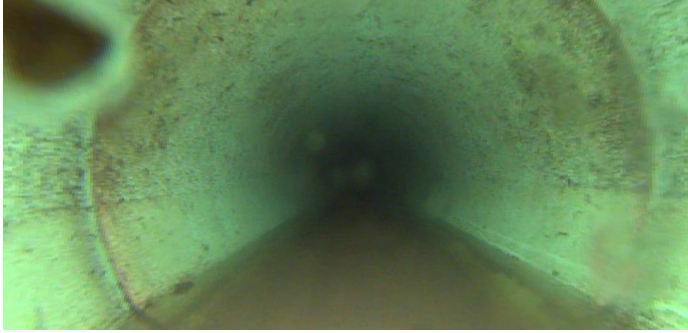
Code:	<b>MSA</b>
Description:	<b>Abandoned Survey</b>
Distance (ft):	<b>101.6</b>
Structural Grade:	<b>0</b>
O&M Grade:	<b>0</b>
Clock Start/From:	
Clock To:	
1st Value:	
2nd Value:	
Value Percent:	
Continuous Index:	
Within 8" of Joint:	<b>NO</b>
Remarks:	<b>camera stopped</b>
