Profile/Photo Observation Report

Date:	04/15/2018	Weather:		Coding:	PACP 6.0
Pipe Length (ft):	188.8	Owner:	NA	Pre Clean:	Not Known
P.O.#:		Surveyor:	Selasie Honu	PSR:	P-907-004-012
Customer:		Clean Date:	01/01/1900	Shape:	C

Street:	Capitol	Flow Control:	Not Controlled
City:	Hobart, IN	Year Renewed:	
Location:	Light Highway	Tape/Media #:	
Purpose:	Maintenance Related	Dia/Height:	12"
Use:	Sanitary	Material:	PVC
Drain Area:	NA	Lining:	Cured in Place
Category:	NA		
Comment:	Reverse setup. user set max at 100'.

Location Details:	Direction of Survey:	Downstream
US MH: M-807-012	DS MH: M-907-004	Total Length Surveyed (ft): 101.6

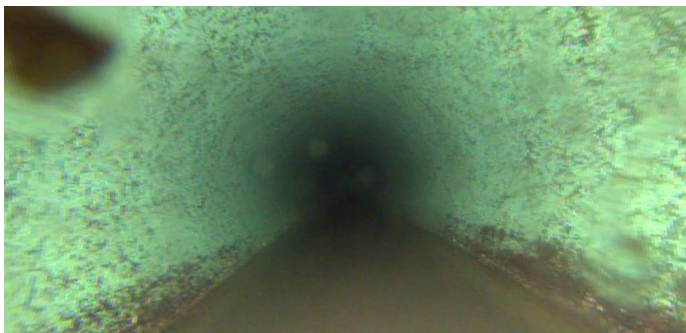
Code: **AMH**
Description: **Manhole**

Distance (ft): **.0**
Structural Grade: **0**
O&M Grade: **0**
Clock Start/From:
Clock To:
1st Value:
2nd Value:
Value Percent:
Continuous Index:
Within 8" of Joint: **NO**
Remarks: **M-807-012**

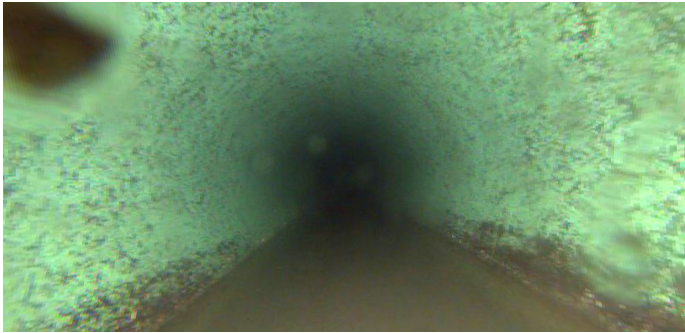
Code:	MWL
Description:	Water Level

Distance (ft):	.0
Structural Grade:	0
O&M Grade:	0
Clock Start/From:	
Clock To:	
1st Value:	
2nd Value:	
Value Percent:	5.000
Continuous Index:	
Within 8" of Joint:	NO
Remarks:

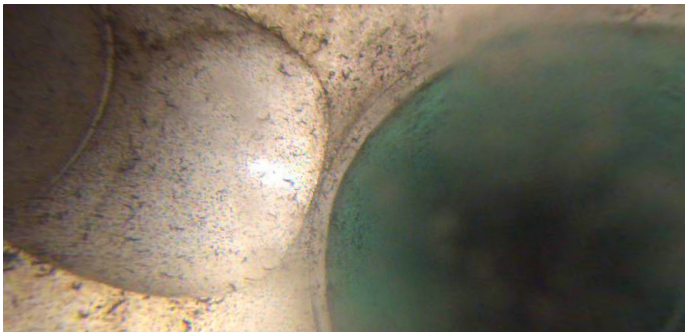
Code:	TF
Description:	Tap Factory

Distance (ft):	89.2
Structural Grade:	0
O&M Grade:	0
Clock Start/From:	3
Clock To:	
1st Value:	4.000
2nd Value:	
Value Percent:	
Continuous Index:	
Within 8" of Joint:	
Remarks:

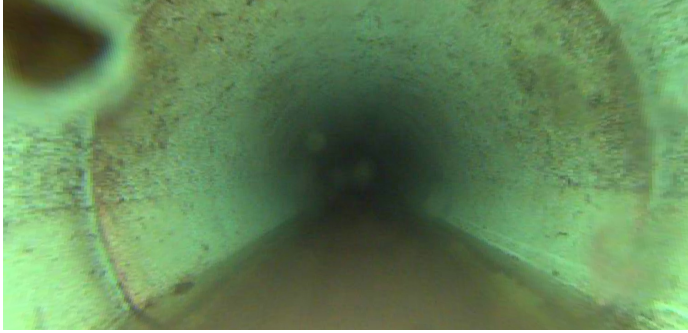
Code:	MSA
Description:	Abandoned Survey
Distance (ft):	101.6
Structural Grade:	0
O&M Grade:	0
Clock Start/From:	
Clock To:	
1st Value:	
2nd Value:	
Value Percent:	
Continuous Index:	
Within 8" of Joint:	NO
Remarks:	camera stopped
