Profile/Photo Observation Report

Date:	03/30/2018	Weather:		Coding:	PACP 6.0
Pipe Length (ft):	330.7	Owner:	NA	Pre Clean:	Not Known
P.O.#:		Surveyor:	Jen Costello	PSR:	P-807-013-014
Customer:		Clean Date:	01/01/1900	Shape:	C

Street:	E 14TH ST & S ILLINOIS ST	Flow Control:	Not Controlled
City:	Hobart, IN	Year Renewed:	
Location:	Light Highway	Tape/Media #:	
Purpose:	Maintenance Related	Dia/Height:	8"
Use:	Sanitary	Material:	PVC
Drain Area:	NA	Lining:	Cured in Place
Category:	NA		
Comment:

Location Details:		Direction of Survey:	Upstream
US MH:	M-807-013	DS MH:	M-807-014
		Total Length Surveyed (ft):	355.5

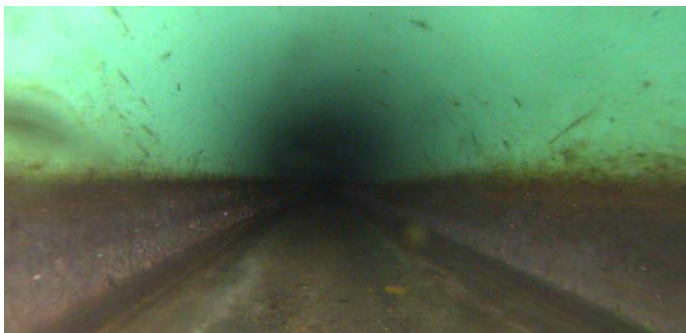
Code: **AMH**
Description: **Manhole**

Distance (ft): **.0**
Structural Grade: **0**
O&M Grade: **0**
Clock Start/From:
Clock To:
1st Value:
2nd Value:
Value Percent:
Continuous Index:
Within 8" of Joint: **NO**
Remarks: **M-807-014**

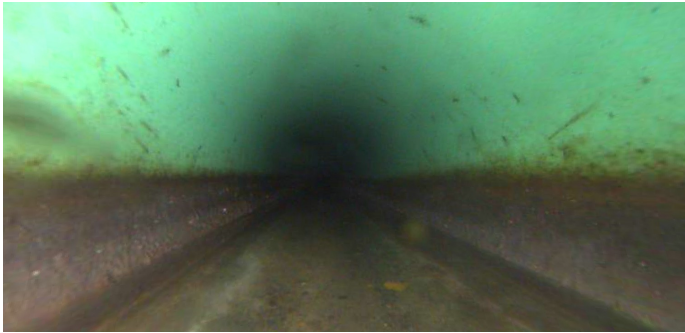
Code:	MWL
Description:	Water Level

Distance (ft):	.0
Structural Grade:	0
O&M Grade:	0
Clock Start/From:	
Clock To:	
1st Value:	
2nd Value:	
Value Percent:	10.000
Continuous Index:	
Within 8" of Joint:	NO
Remarks:

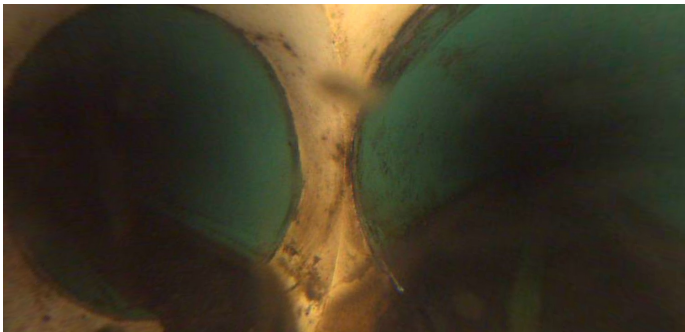
Code:	TFA
Description:	Tap Factory Active

Distance (ft):	234.0
Structural Grade:	0
O&M Grade:	0
Clock Start/From:	9
Clock To:	
1st Value:	4.000
2nd Value:	
Value Percent:	
Continuous Index:	
Within 8" of Joint:	
Remarks:

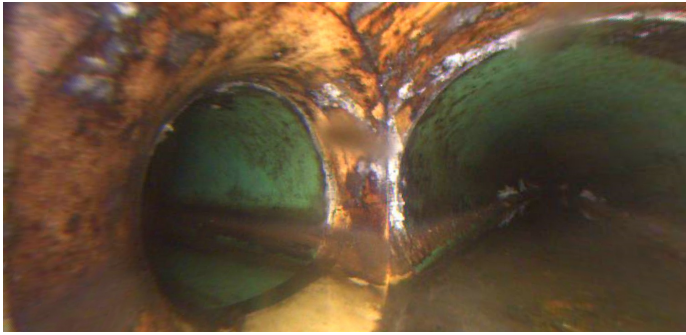
Code: **TFA**
Description: **Tap Factory Active**

Distance (ft): **276.5**
Structural Grade: **0**
O&M Grade: **0**
Clock Start/From: **9**
Clock To:
1st Value: **4.000**
2nd Value:
Value Percent:
Continuous Index:
Within 8" of Joint:
Remarks:

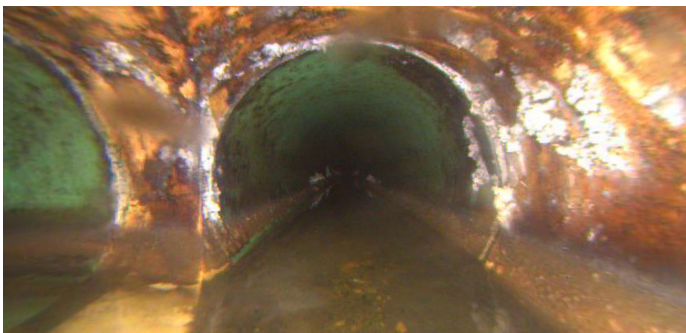
Code: **DAGS**
Description: **Deposits Attached Grease**

Distance (ft): **276.5**
Structural Grade: **0**
O&M Grade: **2**
Clock Start/From: **8**
Clock To: **4**
1st Value:
2nd Value:
Value Percent: **5.000**
Continuous Index: **S01**
Within 8" of Joint: **NO**
Remarks:

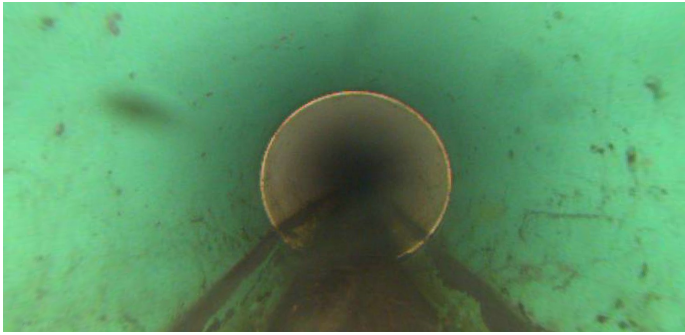
Code: **DAGS**
Description: **Deposits Attached Grease**

Distance (ft): **304.2**
Structural Grade: **0**
O&M Grade: **2**
Clock Start/From: **8**
Clock To: **4**
1st Value:
2nd Value:
Value Percent: **5.000**
Continuous Index: **F01**
Within 8" of Joint: **NO**
Remarks:

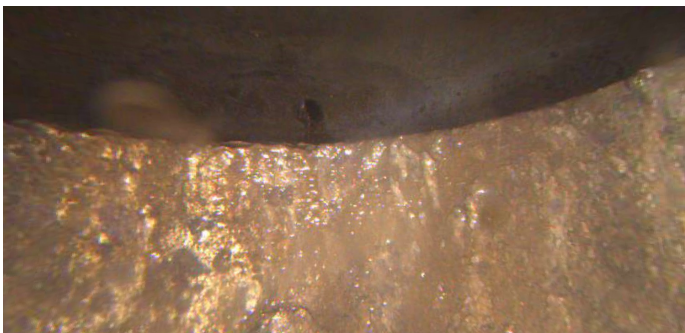
Code: **AMH**
Description: **Manhole**

Distance (ft): **355.5**
Structural Grade: **0**
O&M Grade: **0**
Clock Start/From:
Clock To:
1st Value:
2nd Value:
Value Percent:
Continuous Index:
Within 8" of Joint: **NO**
Remarks: **M-807-013**
