## Profile/Photo Observation Report

Street:	<b>Illinois</b>	Flow Control:	<b>Not Controlled</b>
City:	<b>Hobart, IN</b>	Year Renewed:	
Location:	<b>Light Highway</b>	Tape/Media #:	
Purpose:	<b>Maintenance Related</b>	Dia/Height:	<b>8"</b>
Use:	<b>Sanitary</b>	Material:	<b>PVC</b>
Drain Area:	<b>NA</b>	Lining:	<b>Cured in Place</b>
Category:	<b>NA</b>		
Comment:

Location Details:		Direction of Survey:	<b>Upstream</b>
US MH:	<b>M-807-013</b>	DS MH:	<b>M-807-014</b>
		Total Length Surveyed (ft):	<b>355.5</b>

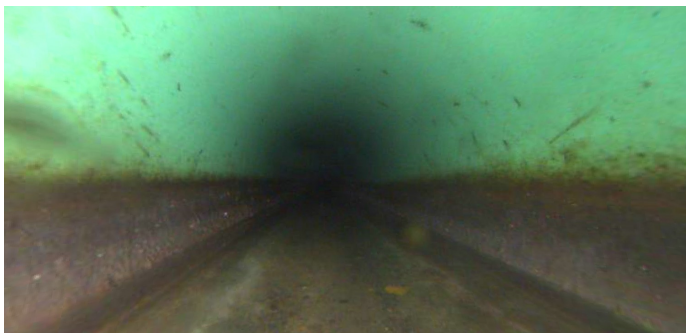
Code: **AMH**  
Description: **Manhole**

Distance (ft): **.0**  
Structural Grade: **0**  
O&M Grade: **0**  
Clock Start/From:  
Clock To:  
1st Value:  
2nd Value:  
Value Percent:  
Continuous Index:  
Within 8" of Joint: **NO**  
Remarks: **M-807-014**

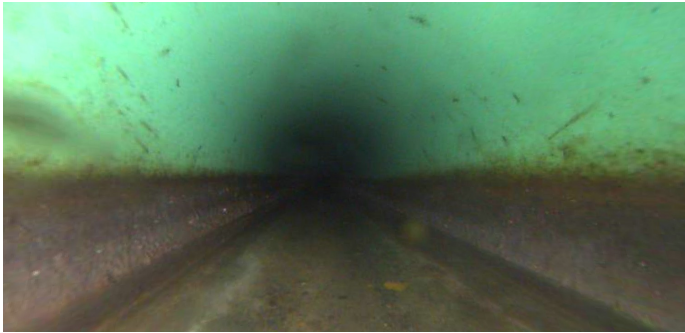
Code:	<b>MWL</b>
Description:	<b>Water Level</b>

Distance (ft):	<b>.0</b>
Structural Grade:	<b>0</b>
O&M Grade:	<b>0</b>
Clock Start/From:	
Clock To:	
1st Value:	
2nd Value:	
Value Percent:	<b>10.000</b>
Continuous Index:	
Within 8" of Joint:	<b>NO</b>
Remarks:

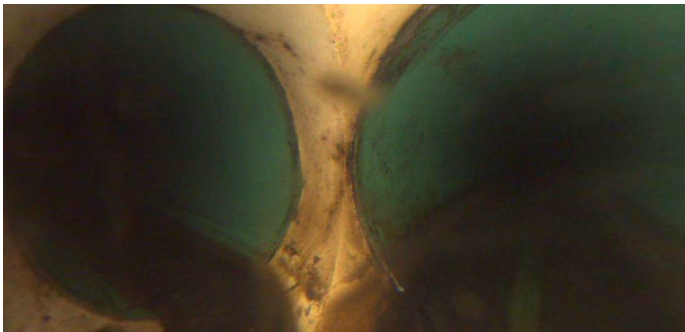
Code:	<b>TFA</b>
Description:	<b>Tap Factory Active</b>

Distance (ft):	<b>234.0</b>
Structural Grade:	<b>0</b>
O&M Grade:	<b>0</b>
Clock Start/From:	<b>9</b>
Clock To:	
1st Value:	<b>4.000</b>
2nd Value:	
Value Percent:	
Continuous Index:	
Within 8" of Joint:	
Remarks:

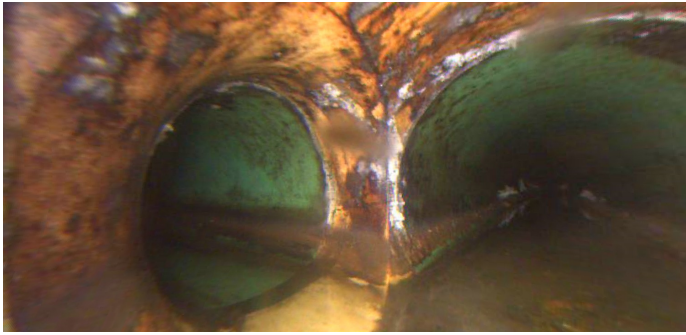
Code: **TFA**  
Description: **Tap Factory Active**

Distance (ft): **276.5**  
Structural Grade: **0**  
O&M Grade: **0**  
Clock Start/From: **9**  
Clock To:  
1st Value: **4.000**  
2nd Value:  
Value Percent:  
Continuous Index:  
Within 8" of Joint:  
Remarks:

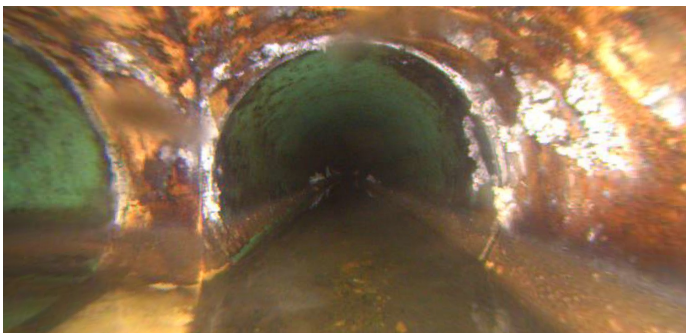
Code: **DAGS**  
Description: **Deposits Attached Grease**

Distance (ft): **276.5**  
Structural Grade: **0**  
O&M Grade: **2**  
Clock Start/From: **8**  
Clock To: **4**  
1st Value:  
2nd Value:  
Value Percent: **5.000**  
Continuous Index: **S01**  
Within 8" of Joint: **NO**  
Remarks:

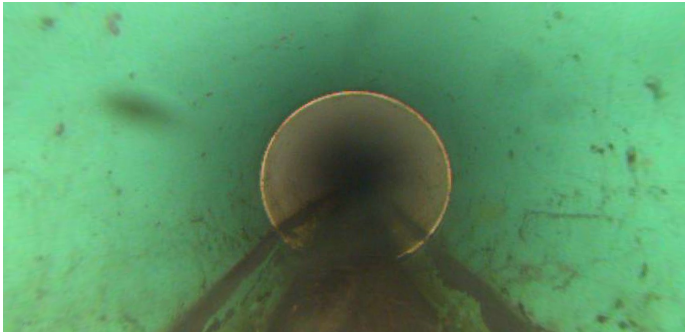
Code: **DAGS**  
Description: **Deposits Attached Grease**

Distance (ft): **304.2**  
Structural Grade: **0**  
O&M Grade: **2**  
Clock Start/From: **8**  
Clock To: **4**  
1st Value:  
2nd Value:  
Value Percent: **5.000**  
Continuous Index: **F01**  
Within 8" of Joint: **NO**  
Remarks:

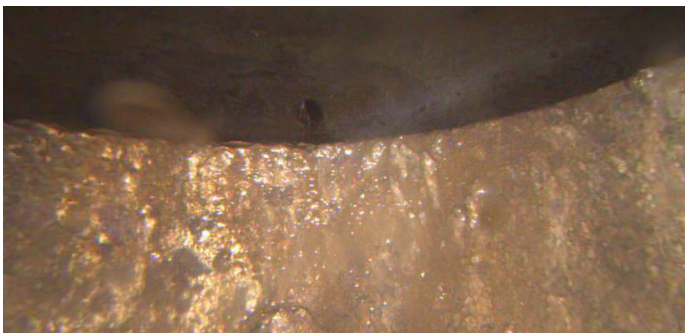
Code: **AMH**  
Description: **Manhole**

Distance (ft): **355.5**  
Structural Grade: **0**  
O&M Grade: **0**  
Clock Start/From:  
Clock To:  
1st Value:  
2nd Value:  
Value Percent:  
Continuous Index:  
Within 8" of Joint: **NO**  
Remarks: **M-807-013**
