Profile/Photo Observation Report

Date:	04/02/2018	Weather:		Coding:	PACP 6.0
Pipe Length (ft):	400.8	Owner:	NA	Pre Clean:	Not Known
P.O.#:		Surveyor:	Jen Costello	PSR:	P-808-002-001
Customer:		Clean Date:	01/01/1900	Shape:	C

Street:	CAPITOL DR	Flow Control:	Not Controlled
City:	Hobart, IN	Year Renewed:	
Location:	Sidewalk	Tape/Media #:	
Purpose:	Maintenance Related	Dia/Height:	12"
Use:	Sanitary	Material:	PVC
Drain Area:	NA	Lining:	Cured in Place
Category:	NA		
Comment:	Flow direction wrong. Debris at 270'.		
Location Details:		Direction of Survey:	Downstream
US MH:	M-808-001	DS MH:	M-808-002
		Total Length Surveyed (ft):	270.4

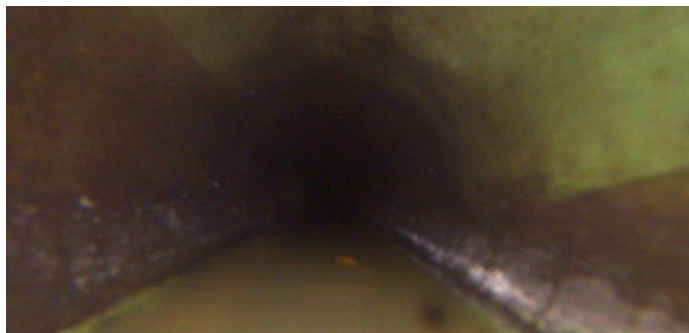
Code: **AMH**
Description: **Manhole**

Distance (ft): **.0**
Structural Grade: **0**
O&M Grade: **0**
Clock Start/From:
Clock To:
1st Value:
2nd Value:
Value Percent:
Continuous Index:
Within 8" of Joint: **NO**
Remarks: **M-808-001**

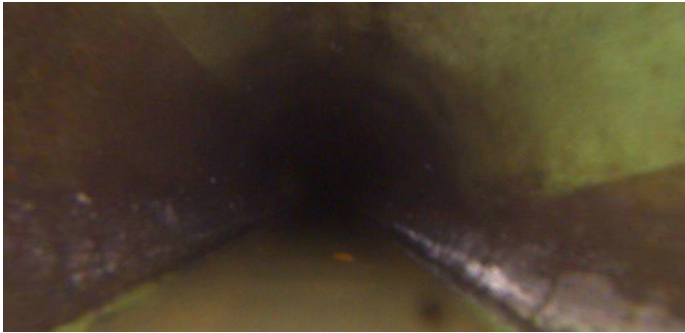
Code:	MWL
Description:	Water Level

Distance (ft):	.0
Structural Grade:	0
O&M Grade:	0
Clock Start/From:	
Clock To:	
1st Value:	
2nd Value:	
Value Percent:	10.000
Continuous Index:	
Within 8" of Joint:	NO
Remarks:

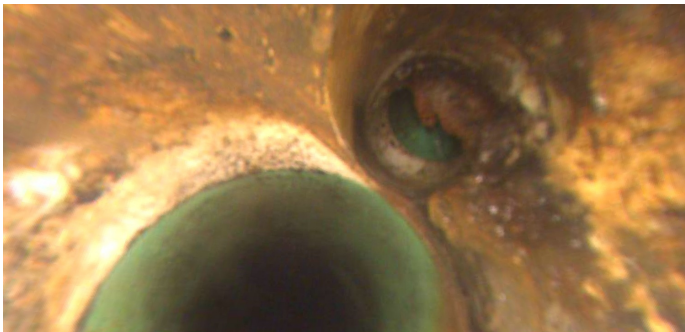
Code:	TF
Description:	Tap Factory

Distance (ft):	19.0
Structural Grade:	0
O&M Grade:	0
Clock Start/From:	2
Clock To:	
1st Value:	4.000
2nd Value:	
Value Percent:	
Continuous Index:	
Within 8" of Joint:	
Remarks:

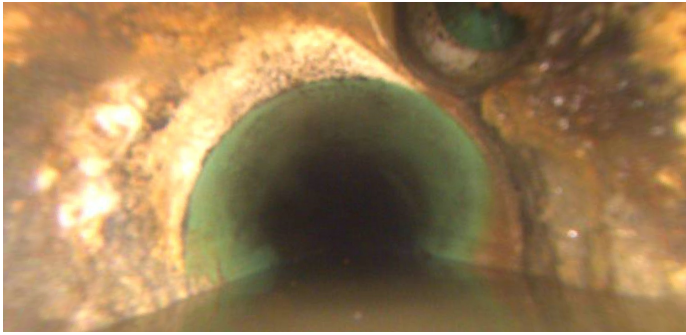
Code: **DAGS**
Description: **Deposits Attached Grease**

Distance (ft): **19.0**
Structural Grade: **0**
O&M Grade: **2**
Clock Start/From: **8**
Clock To: **4**
1st Value:
2nd Value:
Value Percent: **5.000**
Continuous Index:
Within 8" of Joint: **NO**
Remarks:

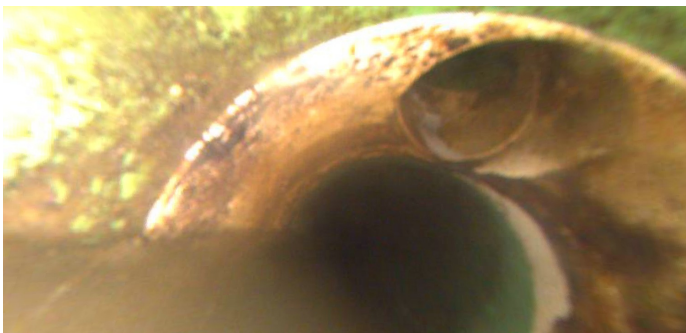
Code: **TF**
Description: **Tap Factory**

Distance (ft): **32.5**
Structural Grade: **0**
O&M Grade: **0**
Clock Start/From: **12**
Clock To:
1st Value: **4.000**
2nd Value:
Value Percent:
Continuous Index:
Within 8" of Joint:
Remarks:

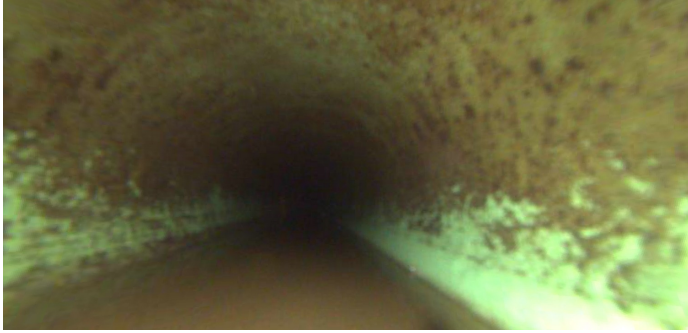
Code:	MSA
Description:	Abandoned Survey
Distance (ft):	62.5
Structural Grade:	0
O&M Grade:	0
Clock Start/From:	
Clock To:	
1st Value:	
2nd Value:	
Value Percent:	
Continuous Index:	
Within 8" of Joint:	NO
Remarks:	DEBRIS UNDER WATER PAYOUT CONTINUES TO INCREASE
