Profile/Photo Observation Report

Street:	Capitol	Flow Control:	Not Controlled
City:	Hobart, IN	Year Renewed:	
Location:	Sidewalk	Tape/Media #:	
Purpose:	Maintenance Related	Dia/Height:	12"
Use:	Sanitary	Material:	PVC
Drain Area:	NA	Lining:	Cured in Place
Category:	NA		
Comment:	Flow direction wrong. Debris at 270'.		
Location Details:		Direction of Survey:	Downstream
US MH:	M-808-001	DS MH:	M-808-002
		Total Length Surveyed (ft):	270.4

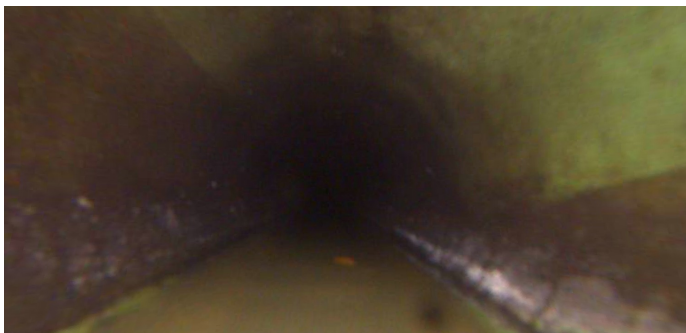
Code: **AMH**
Description: **Manhole**

Distance (ft): **.0**
Structural Grade: **0**
O&M Grade: **0**
Clock Start/From:
Clock To:
1st Value:
2nd Value:
Value Percent:
Continuous Index:
Within 8" of Joint: **NO**
Remarks: **M-808-001**

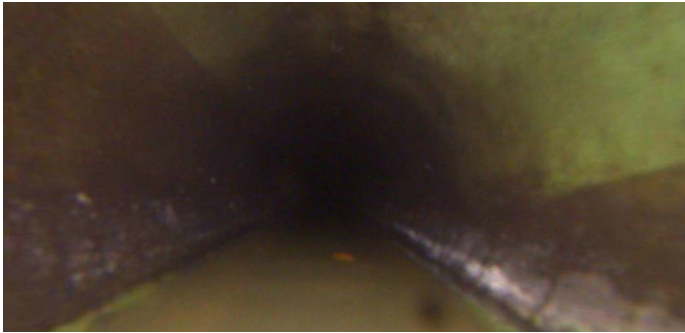
Code:	MWL
Description:	Water Level

Distance (ft):	.0
Structural Grade:	0
O&M Grade:	0
Clock Start/From:	
Clock To:	
1st Value:	
2nd Value:	
Value Percent:	10.000
Continuous Index:	
Within 8" of Joint:	NO
Remarks:

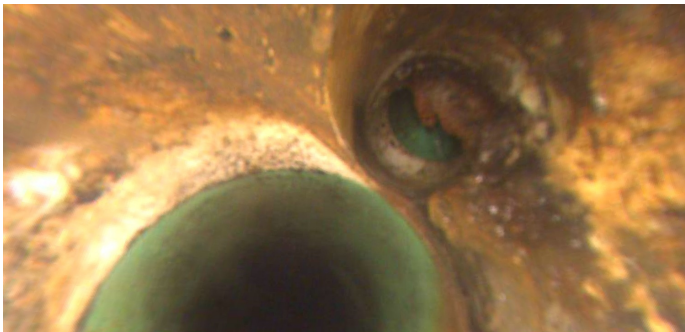
Code:	TF
Description:	Tap Factory

Distance (ft):	19.0
Structural Grade:	0
O&M Grade:	0
Clock Start/From:	2
Clock To:	
1st Value:	4.000
2nd Value:	
Value Percent:	
Continuous Index:	
Within 8" of Joint:	
Remarks:

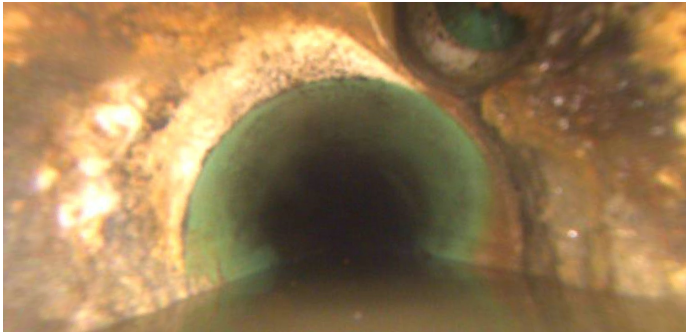
Code: **DAGS**
Description: **Deposits Attached Grease**

Distance (ft): **19.0**
Structural Grade: **0**
O&M Grade: **2**
Clock Start/From: **8**
Clock To: **4**
1st Value:
2nd Value:
Value Percent: **5.000**
Continuous Index:
Within 8" of Joint: **NO**
Remarks:

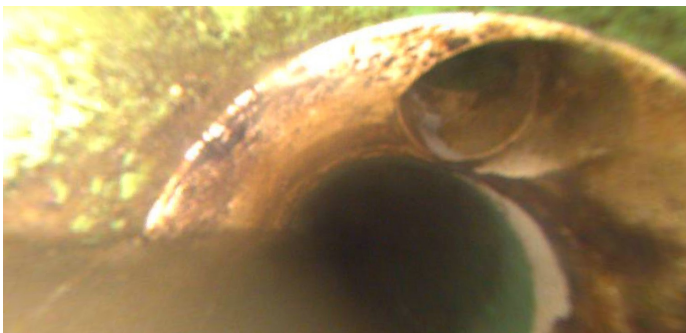
Code: **TF**
Description: **Tap Factory**

Distance (ft): **32.5**
Structural Grade: **0**
O&M Grade: **0**
Clock Start/From: **12**
Clock To:
1st Value: **4.000**
2nd Value:
Value Percent:
Continuous Index:
Within 8" of Joint:
Remarks:

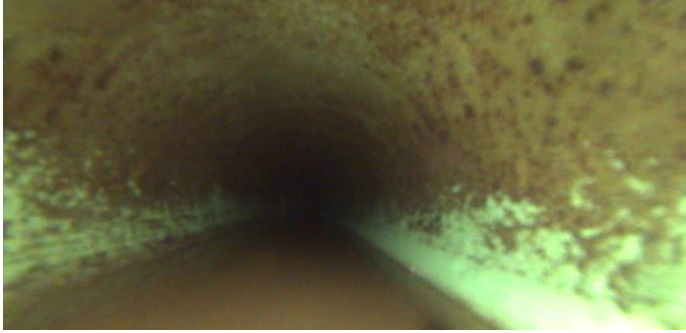
Code:	MSA
Description:	Abandoned Survey
Distance (ft):	62.5
Structural Grade:	0
O&M Grade:	0
Clock Start/From:	
Clock To:	
1st Value:	
2nd Value:	
Value Percent:	
Continuous Index:	
Within 8" of Joint:	NO
Remarks:	DEBRIS UNDER WATER PAYOUT CONTINUES TO INCREASE
