## Profile/Photo Observation Report

Street:	<b>CAPITOL DR</b>	Flow Control:	<b>Not Controlled</b>
City:	<b>Hobart, IN</b>	Year Renewed:	
Location:	<b>Sidewalk</b>	Tape/Media #:	
Purpose:	<b>Maintenance Related</b>	Dia/Height:	<b>8"</b>
Use:	<b>Sanitary</b>	Material:	<b>PVC</b>
Drain Area:	<b>NA</b>	Lining:	<b>Cured in Place</b>
Category:	<b>NA</b>		
Comment:	<b>Flow direction wrong. Reverse setup.</b>		
Location Details:		Direction of Survey:	<b>Upstream</b>
US MH:	<b>M-808-001</b>	DS MH:	<b>M-808-002</b>
		Total Length Surveyed (ft):	<b>128.6</b>

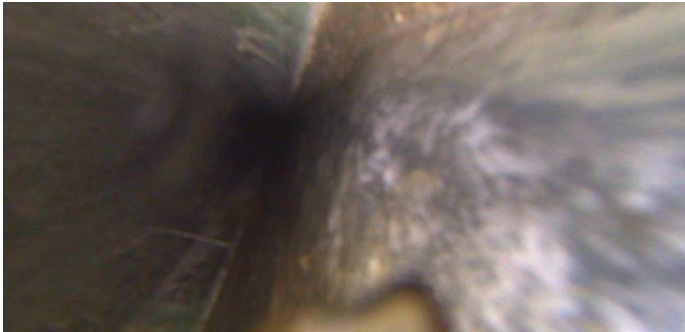
Code:	<b>MWL</b>
Description:	<b>Water Level</b>

Distance (ft):	<b>.0</b>
Structural Grade:	<b>0</b>
O&M Grade:	<b>0</b>
Clock Start/From:	
Clock To:	
1st Value:	
2nd Value:	
Value Percent:	<b>30.000</b>
Continuous Index:	
Within 8" of Joint:	<b>NO</b>
Remarks:

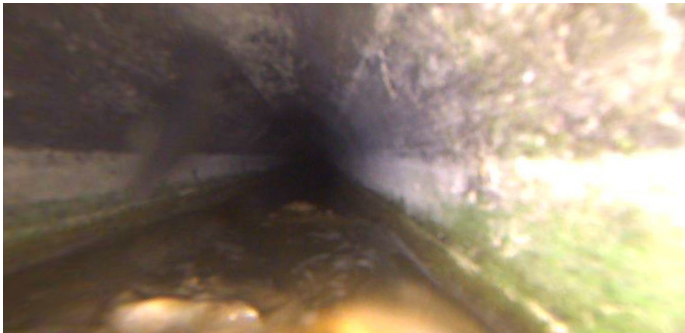
Code:	<b>DAGS</b>
Description:	<b>Deposits Attached Grease</b>

Distance (ft):	<b>4.2</b>
Structural Grade:	<b>0</b>
O&M Grade:	<b>2</b>
Clock Start/From:	<b>8</b>
Clock To:	<b>4</b>
1st Value:	
2nd Value:	
Value Percent:	<b>5.000</b>
Continuous Index:	<b>S01</b>
Within 8" of Joint:	<b>NO</b>
Remarks:

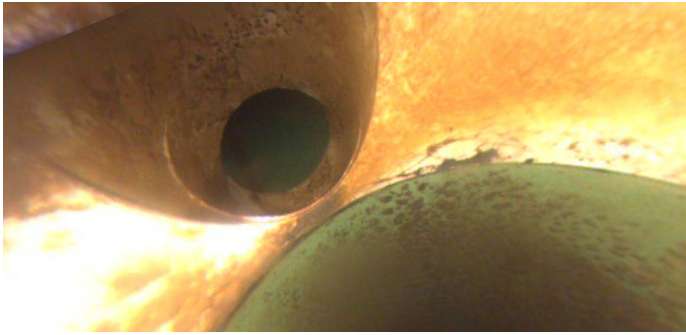
Code: **TF**  
Description: **Tap Factory**

Distance (ft): **48.0**  
Structural Grade: **0**  
O&M Grade: **0**  
Clock Start/From: **1**  
Clock To:  
1st Value: **4.000**  
2nd Value:  
Value Percent:  
Continuous Index:  
Within 8" of Joint:  
Remarks:

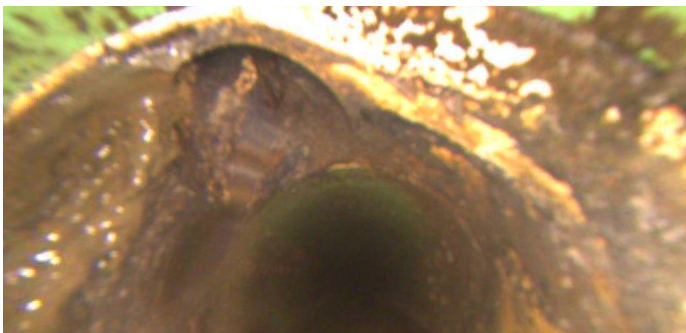
Code: **DAGS**  
Description: **Deposits Attached Grease**

Distance (ft): **49.3**  
Structural Grade: **0**  
O&M Grade: **2**  
Clock Start/From: **8**  
Clock To: **4**  
1st Value:  
2nd Value:  
Value Percent: **10.000**  
Continuous Index:  
Within 8" of Joint: **NO**  
Remarks:

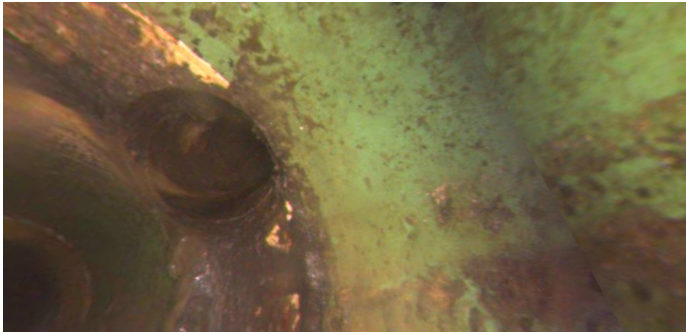
Code: **TF**  
Description: **Tap Factory**

Distance (ft): **50.8**  
Structural Grade: **0**  
O&M Grade: **0**  
Clock Start/From: **10**  
Clock To:  
1st Value: **4.000**  
2nd Value:  
Value Percent:  
Continuous Index:  
Within 8" of Joint:  
Remarks:

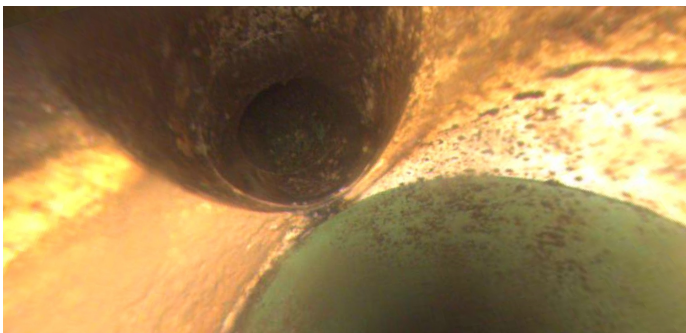
Code: **TF**  
Description: **Tap Factory**

Distance (ft): **112.1**  
Structural Grade: **0**  
O&M Grade: **0**  
Clock Start/From: **1**  
Clock To:  
1st Value: **4.000**  
2nd Value:  
Value Percent:  
Continuous Index:  
Within 8" of Joint:  
Remarks:

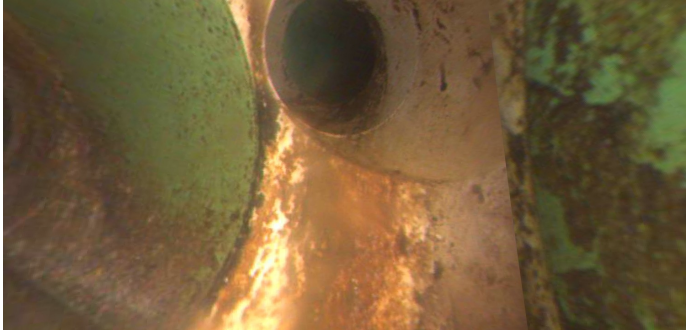
Code: **TF**  
Description: **Tap Factory**

Distance (ft): **114.0**  
Structural Grade: **0**  
O&M Grade: **0**  
Clock Start/From: **10**  
Clock To:  
1st Value: **4.000**  
2nd Value:  
Value Percent:  
Continuous Index:  
Within 8" of Joint:  
Remarks:

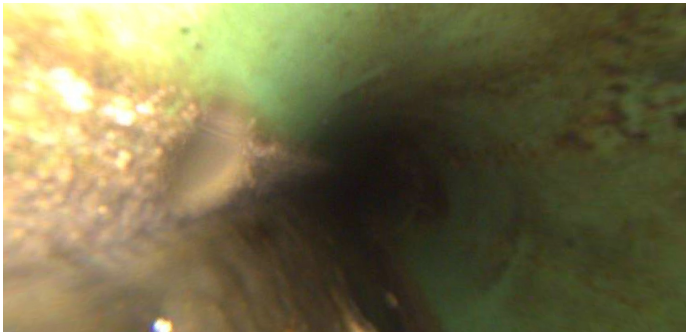
Code: **MSA**  
Description: **Abandoned Survey**

Distance (ft): **128.6**  
Structural Grade: **0**  
O&M Grade: **0**  
Clock Start/From:  
Clock To:  
1st Value:  
2nd Value:  
Value Percent:  
Continuous Index:  
Within 8" of Joint: **NO**  
Remarks: **OVERTURNED**

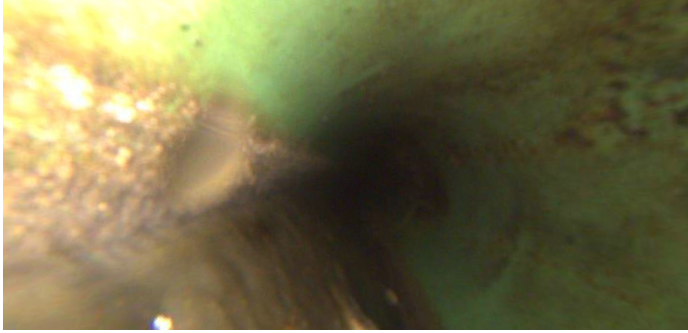
Code:	<b>DAGS</b>
Description:	<b>Deposits Attached Grease</b>
Distance (ft):	<b>128.6</b>
Structural Grade:	<b>0</b>
O&M Grade:	<b>2</b>
Clock Start/From:	<b>8</b>
Clock To:	<b>4</b>
1st Value:	
2nd Value:	
Value Percent:	<b>5.000</b>
Continuous Index:	<b>F01</b>
Within 8" of Joint:	<b>NO</b>
Remarks:
