Profile/Photo Observation Report

Street:	Capitol	Flow Control:	Not Controlled
City:	Hobart, IN	Year Renewed:	
Location:	Sidewalk	Tape/Media #:	
Purpose:	Maintenance Related	Dia/Height:	8"
Use:	Sanitary	Material:	PVC
Drain Area:	NA	Lining:	Cured in Place
Category:	NA		
Comment:	Flow direction wrong. Reverse setup.		
Location Details:		Direction of Survey:	Upstream
US MH:	M-808-001	DS MH:	M-808-002
		Total Length Surveyed (ft):	128.6

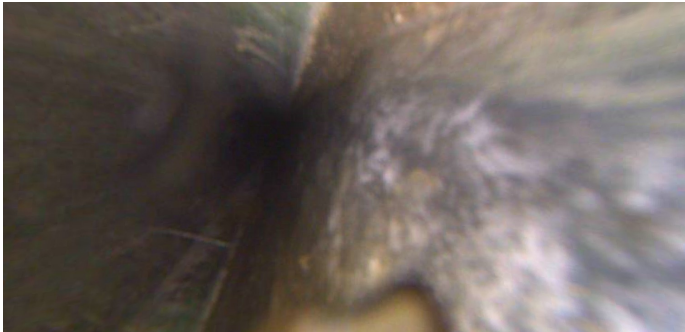
Code:	MWL
Description:	Water Level

Distance (ft):	.0
Structural Grade:	0
O&M Grade:	0
Clock Start/From:	
Clock To:	
1st Value:	
2nd Value:	
Value Percent:	30.000
Continuous Index:	
Within 8" of Joint:	NO
Remarks:

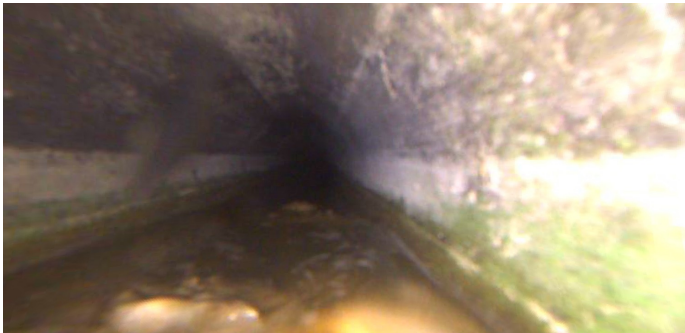
Code:	DAGS
Description:	Deposits Attached Grease

Distance (ft):	4.2
Structural Grade:	0
O&M Grade:	2
Clock Start/From:	8
Clock To:	4
1st Value:	
2nd Value:	
Value Percent:	5.000
Continuous Index:	S01
Within 8" of Joint:	NO
Remarks:

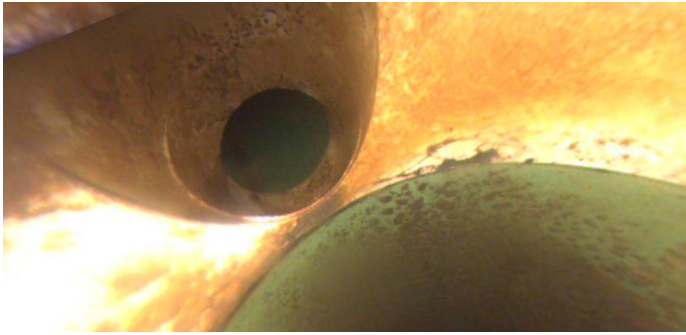
Code: **TF**
Description: **Tap Factory**

Distance (ft): **48.0**
Structural Grade: **0**
O&M Grade: **0**
Clock Start/From: **1**
Clock To:
1st Value: **4.000**
2nd Value:
Value Percent:
Continuous Index:
Within 8" of Joint:
Remarks:

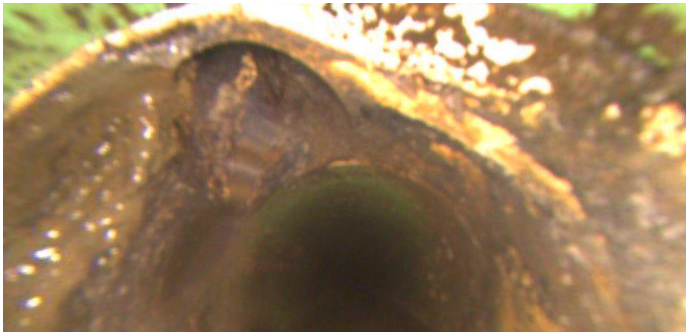
Code: **DAGS**
Description: **Deposits Attached Grease**

Distance (ft): **49.3**
Structural Grade: **0**
O&M Grade: **2**
Clock Start/From: **8**
Clock To: **4**
1st Value:
2nd Value:
Value Percent: **10.000**
Continuous Index:
Within 8" of Joint: **NO**
Remarks:

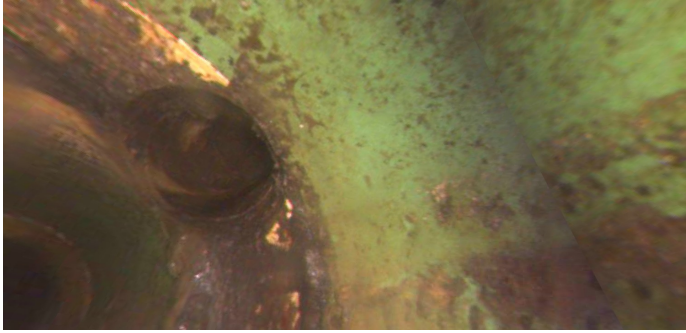
Code: **TF**
Description: **Tap Factory**

Distance (ft): **50.8**
Structural Grade: **0**
O&M Grade: **0**
Clock Start/From: **10**
Clock To:
1st Value: **4.000**
2nd Value:
Value Percent:
Continuous Index:
Within 8" of Joint:
Remarks:

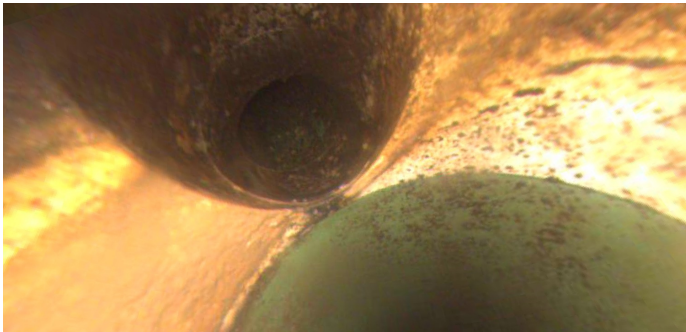
Code: **TF**
Description: **Tap Factory**

Distance (ft): **112.1**
Structural Grade: **0**
O&M Grade: **0**
Clock Start/From: **1**
Clock To:
1st Value: **4.000**
2nd Value:
Value Percent:
Continuous Index:
Within 8" of Joint:
Remarks:

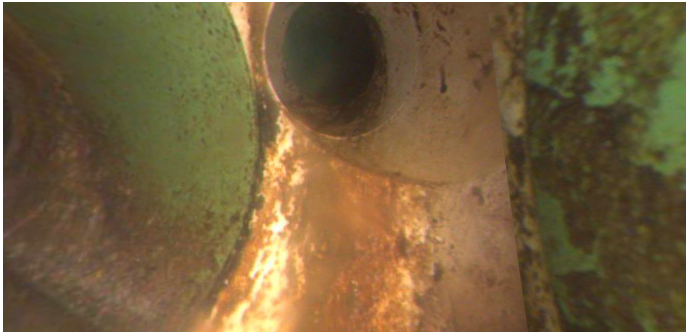
Code: **TF**
Description: **Tap Factory**

Distance (ft): **114.0**
Structural Grade: **0**
O&M Grade: **0**
Clock Start/From: **10**
Clock To:
1st Value: **4.000**
2nd Value:
Value Percent:
Continuous Index:
Within 8" of Joint:
Remarks:

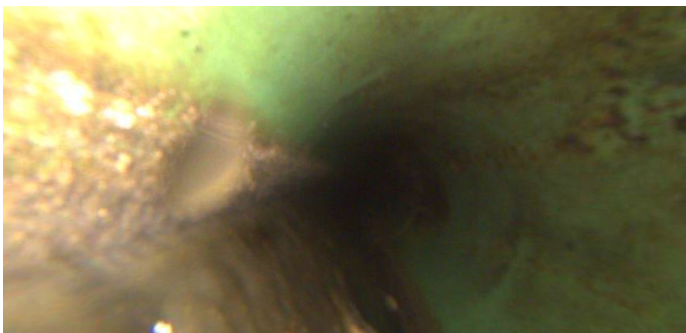
Code: **MSA**
Description: **Abandoned Survey**

Distance (ft): **128.6**
Structural Grade: **0**
O&M Grade: **0**
Clock Start/From:
Clock To:
1st Value:
2nd Value:
Value Percent:
Continuous Index:
Within 8" of Joint: **NO**
Remarks: **OVERTURNED**

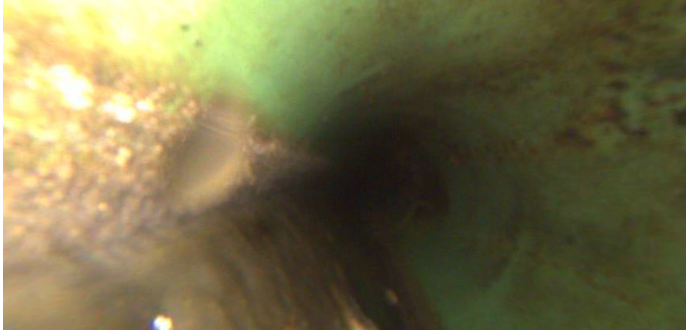
Code:	DAGS
Description:	Deposits Attached Grease
Distance (ft):	128.6
Structural Grade:	0
O&M Grade:	2
Clock Start/From:	8
Clock To:	4
1st Value:	
2nd Value:	
Value Percent:	5.000
Continuous Index:	F01
Within 8" of Joint:	NO
Remarks:
