## Profile/Photo Observation Report

Street:	<b>CAPITOL DR</b>	Flow Control:	<b>Not Controlled</b>
City:	<b>Hobart, IN</b>	Year Renewed:	
Location:	<b>Sidewalk</b>	Tape/Media #:	
Purpose:	<b>Maintenance Related</b>	Dia/Height:	<b>12"</b>
Use:	<b>Sanitary</b>	Material:	<b>PVC</b>
Drain Area:	<b>NA</b>	Lining:	<b>Cured in Place</b>
Category:	<b>NA</b>		
Comment:	<b>Flow direction wrong.</b>

Location Details:		Direction of Survey:	<b>Upstream</b>
US MH:	<b>M-808-002</b>	DS MH:	<b>M-808-003</b>
		Total Length Surveyed (ft):	<b>103.7</b>

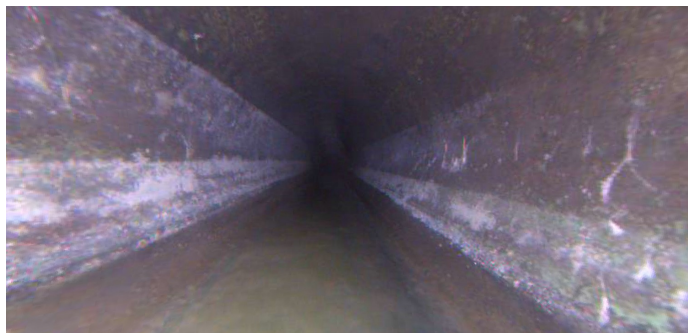
Code: **AMH**  
 Description: **Manhole**  
 Distance (ft): **.0**  
 Structural Grade: **0**  
 O&M Grade: **0**  
 Clock Start/From:  
 Clock To:  
 1st Value:  
 2nd Value:  
 Value Percent:  
 Continuous Index:  
 Within 8" of Joint: **NO**  
 Remarks: **M-808-003**

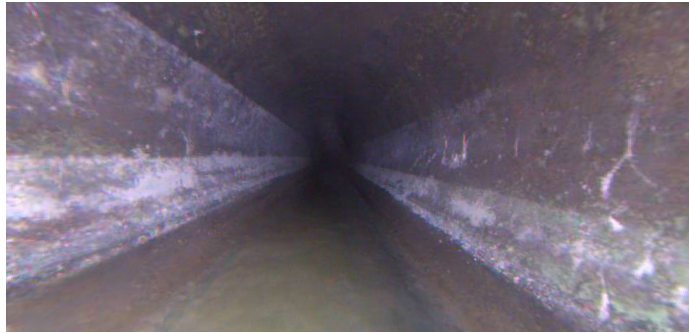
Code:	<b>MWL</b>
Description:	<b>Water Level</b>
Distance (ft):	<b>.0</b>
Structural Grade:	<b>0</b>
O&M Grade:	<b>0</b>
Clock Start/From:	
Clock To:	
1st Value:	
2nd Value:	
Value Percent:	<b>10.000</b>
Continuous Index:	
Within 8" of Joint:	<b>NO</b>
Remarks:

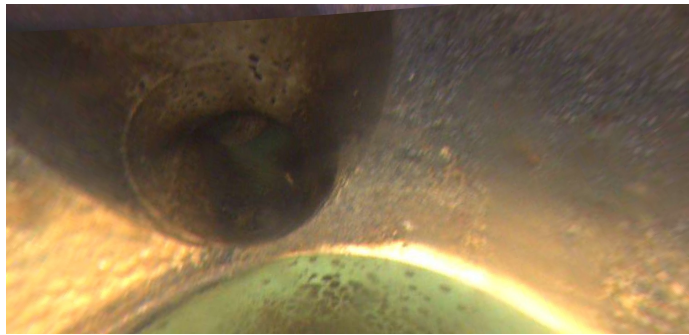
Code:	<b>TF</b>
Description:	<b>Tap Factory</b>
Distance (ft):	<b>42.8</b>
Structural Grade:	<b>0</b>
O&M Grade:	<b>0</b>
Clock Start/From:	<b>1</b>
Clock To:	
1st Value:	<b>4.000</b>
2nd Value:	
Value Percent:	
Continuous Index:	
Within 8" of Joint:	
Remarks:

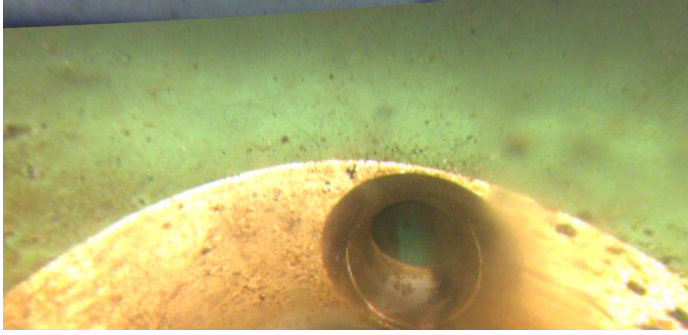
Code: **TF**  
Description: **Tap Factory**

Distance (ft): **45.3**  
Structural Grade: **0**  
O&M Grade: **0**  
Clock Start/From: **11**  
Clock To:  
1st Value: **4.000**  
2nd Value:  
Value Percent:  
Continuous Index:  
Within 8" of Joint:  
Remarks:

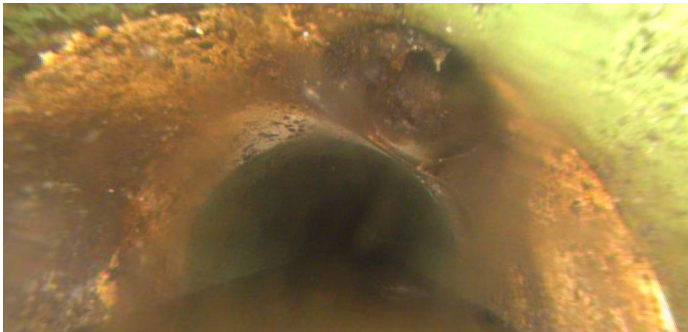
Code: **TF**  
Description: **Tap Factory**

Distance (ft): **98.7**  
Structural Grade: **0**  
O&M Grade: **0**  
Clock Start/From: **11**  
Clock To:  
1st Value: **4.000**  
2nd Value:  
Value Percent:  
Continuous Index:  
Within 8" of Joint:  
Remarks:

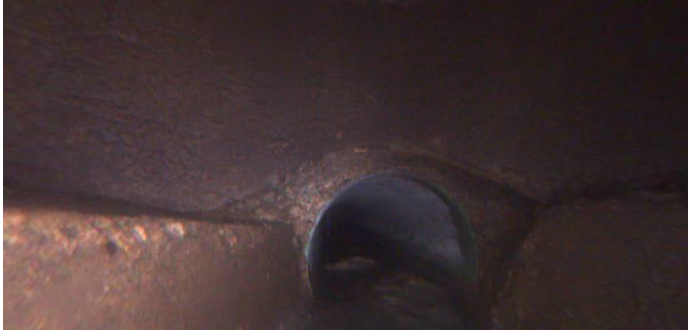
Code:	<b>AMH</b>
Description:	<b>Manhole</b>
Distance (ft):	<b>103.7</b>
Structural Grade:	<b>0</b>
O&M Grade:	<b>0</b>
Clock Start/From:	
Clock To:	
1st Value:	
2nd Value:	
Value Percent:	
Continuous Index:	
Within 8" of Joint:	<b>NO</b>
Remarks:	<b>M-808-002</b>
