Profile/Ph	noto Observatio	n Report			RedZo
Date:	04/07/2018	Weather:		Coding:	PACP 6.0
Pipe Length (ft	t): 106.2	Owner:	NA	Pre Clean:	Not Known
P.O.#:		Surveyor:	Jen Costello	PSR:	P-808-004-003
Customer:		Clean Date:	01/01/1900	Shape:	С
Street:	Capitol		Flow Control:	Not Controlled	
City:	Hobart, IN		Year Renewed:		
Location:	Sidewalk		Tape/Media #:		
Purpose:	Maintenance Re	lated	Dia/Height:	12"	
Use:	Sanitary		Material:	PVC	
Drain Area:	NA		Lining:	Cured in Place	
Category:	NA				
Comment:	Flow direction w	rong.			
Location Detai	ils:		Direction of Surv	vey: Downstream	
US MH:	M-808-003	DS MH:	M-808-004	Total Length Surveyed (ft)	: 104.7
D&M Index:	0.00	O&M Quick:	000	00 O&M Rating:	0.00
Structural Index	. 0.00	Structural Q	uick: 000		0.00
Overall Index:	0.00	Overall Quic			0.00

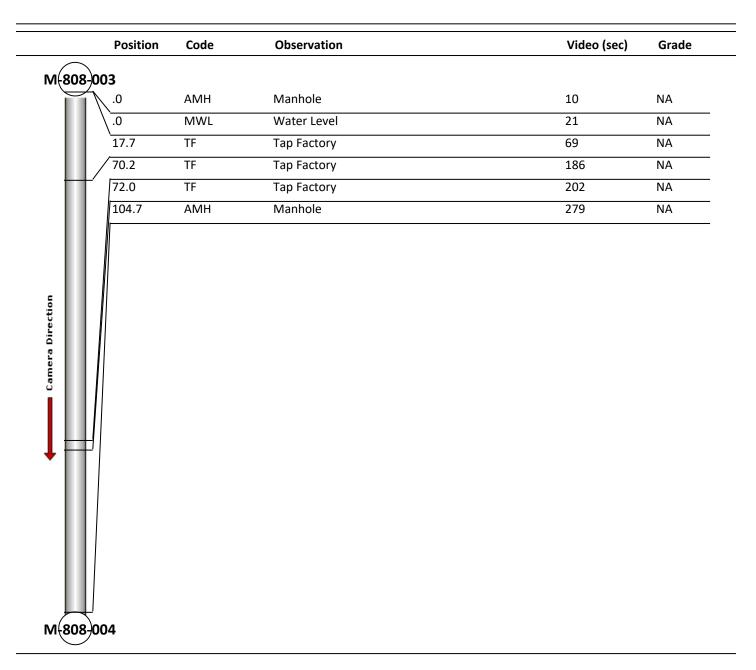
Code: Description:	AMH Manhole
Distance (ft):	.0
Structural Grade:	0
O&M Grade:	0
Clock Start/From:	
Clock To:	
1st Value:	
2nd Value:	
Value Percent:	
Continuous Index:	
Within 8" of Joint:	NO
Remarks:	M-808-003
