## Profile/Photo Observation Report

Street:	<b>Capitol</b>	Flow Control:	<b>Not Controlled</b>
City:	<b>Hobart, IN</b>	Year Renewed:	
Location:	<b>Light Highway</b>	Tape/Media #:	
Purpose:	<b>Maintenance Related</b>	Dia/Height:	<b>8"</b>
Use:	<b>Sanitary</b>	Material:	<b>PVC</b>
Drain Area:	<b>NA</b>	Lining:	<b>Cured in Place</b>
Category:	<b>NA</b>		
Comment:

Location Details:		Direction of Survey:	<b>Downstream</b>
US MH:	<b>M-808-003</b>	DS MH:	<b>M-808-004</b>
		Total Length Surveyed (ft):	<b>258.9</b>

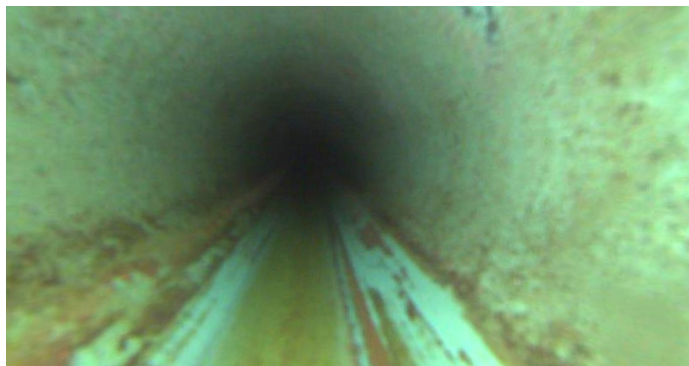
Code: **AMH**  
Description: **Manhole**

Distance (ft): **.0**  
Structural Grade: **0**  
O&M Grade: **0**  
Clock Start/From:  
Clock To:  
1st Value:  
2nd Value:  
Value Percent:  
Continuous Index:  
Within 8" of Joint: **NO**  
Remarks: **M-808-003**

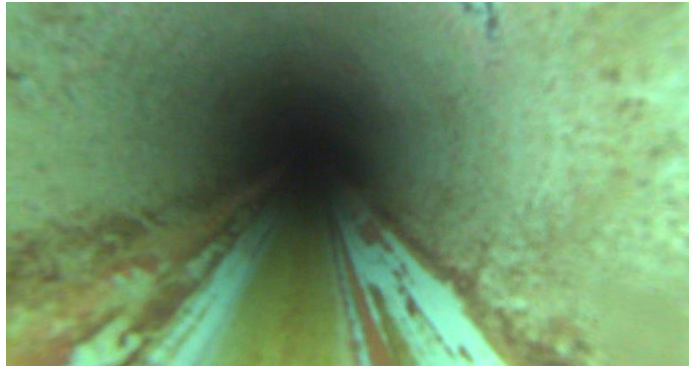
Code: **MWL**  
Description: **Water Level**

Distance (ft): **.0**  
Structural Grade: **0**  
O&M Grade: **0**  
Clock Start/From:  
Clock To:  
1st Value:  
2nd Value:  
Value Percent: **10.000**  
Continuous Index:  
Within 8" of Joint: **NO**  
Remarks:

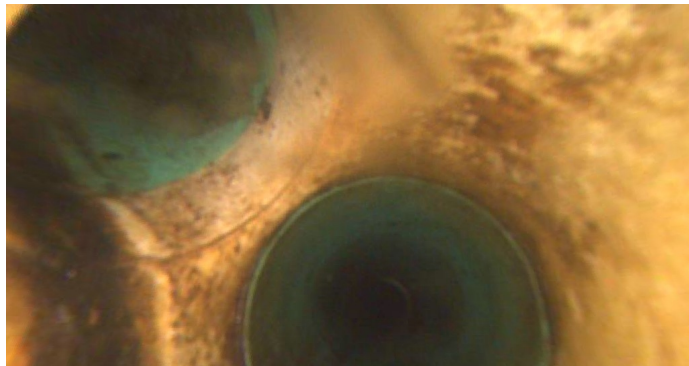
Code: **TF**  
Description: **Tap Factory**

Distance (ft): **72.6**  
Structural Grade: **0**  
O&M Grade: **0**  
Clock Start/From: **10**  
Clock To:  
1st Value: **4.000**  
2nd Value:  
Value Percent:  
Continuous Index:  
Within 8" of Joint:  
Remarks:

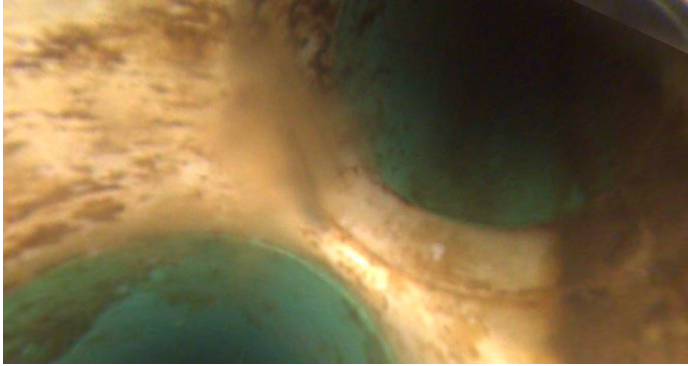
Code: **TF**  
Description: **Tap Factory**

Distance (ft): **76.4**  
Structural Grade: **0**  
O&M Grade: **0**  
Clock Start/From: **2**  
Clock To:  
1st Value: **4.000**  
2nd Value:  
Value Percent:  
Continuous Index:  
Within 8" of Joint:  
Remarks:

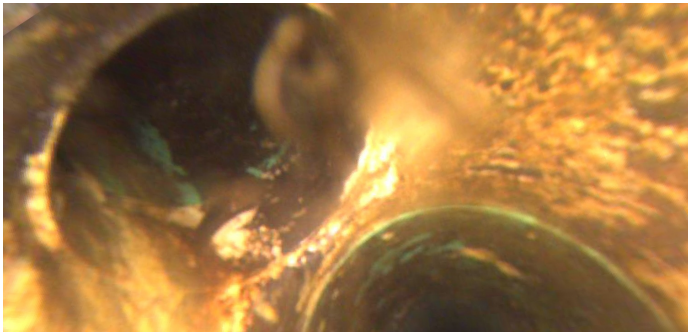
Code: **TF**  
Description: **Tap Factory**

Distance (ft): **177.1**  
Structural Grade: **0**  
O&M Grade: **0**  
Clock Start/From: **11**  
Clock To:  
1st Value: **4.000**  
2nd Value:  
Value Percent:  
Continuous Index:  
Within 8" of Joint:  
Remarks:

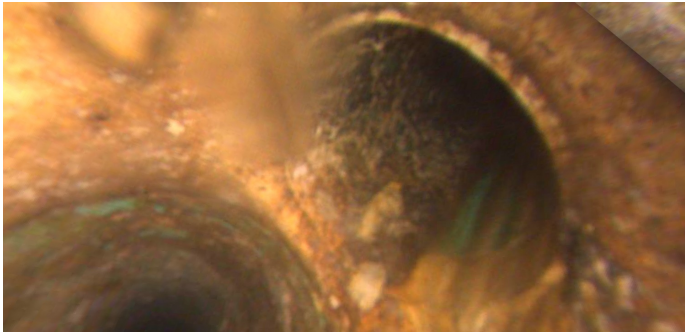
Code: **TF**  
Description: **Tap Factory**

Distance (ft): **236.3**  
Structural Grade: **0**  
O&M Grade: **0**  
Clock Start/From: **2**  
Clock To:  
1st Value: **4.000**  
2nd Value:  
Value Percent:  
Continuous Index:  
Within 8" of Joint:  
Remarks:

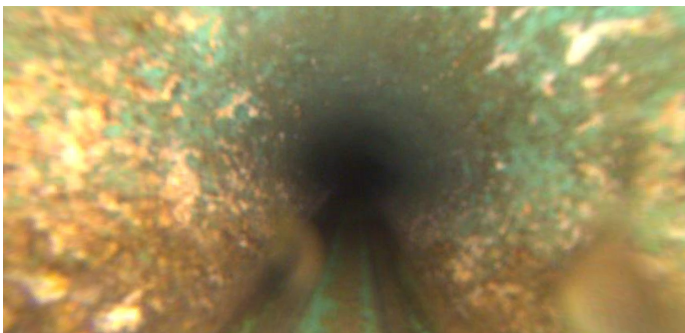
Code: **DAGS**  
Description: **Deposits Attached Grease**

Distance (ft): **237.9**  
Structural Grade: **0**  
O&M Grade: **2**  
Clock Start/From: **8**  
Clock To: **4**  
1st Value:  
2nd Value:  
Value Percent: **5.000**  
Continuous Index:  
Within 8" of Joint: **NO**  
Remarks:

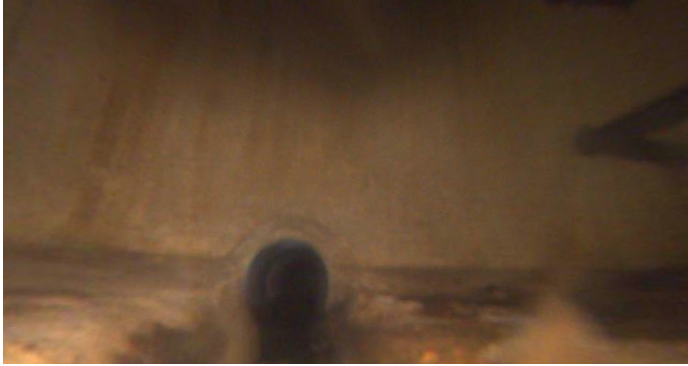
Code:	<b>AMH</b>
Description:	<b>Manhole</b>
Distance (ft):	<b>258.9</b>
Structural Grade:	<b>0</b>
O&M Grade:	<b>0</b>
Clock Start/From:	
Clock To:	
1st Value:	
2nd Value:	
Value Percent:	
Continuous Index:	
Within 8" of Joint:	<b>NO</b>
Remarks:	<b>M-808-004</b>
