Profile/Photo Observation Report

Street:	Oak	Flow Control:	Not Controlled
City:	Hobart, IN	Year Renewed:	
Location:	Sidewalk	Tape/Media #:	
Purpose:	Maintenance Related	Dia/Height:	12"
Use:	Sanitary	Material:	PVC
Drain Area:	NA	Lining:	
Category:	NA		
Comment:	flow direction incorrect.

Location Details:		Direction of Survey:	Downstream
US MH:	M-808-004	DS MH:	M-808-005
		Total Length Surveyed (ft):	100.0

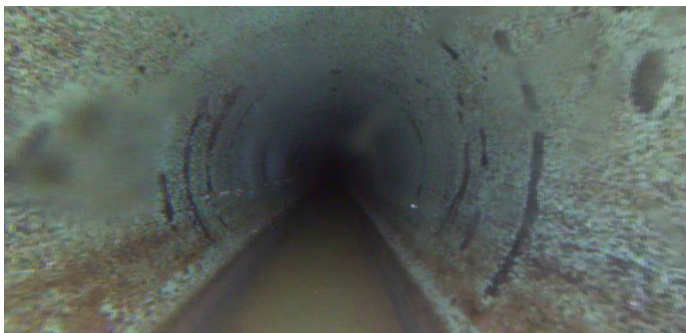
Code: **AMH**
Description: **Manhole**

Distance (ft): **.0**
Structural Grade: **0**
O&M Grade: **0**
Clock Start/From:
Clock To:
1st Value:
2nd Value:
Value Percent:
Continuous Index:
Within 8" of Joint: **NO**
Remarks: **M-808-004**

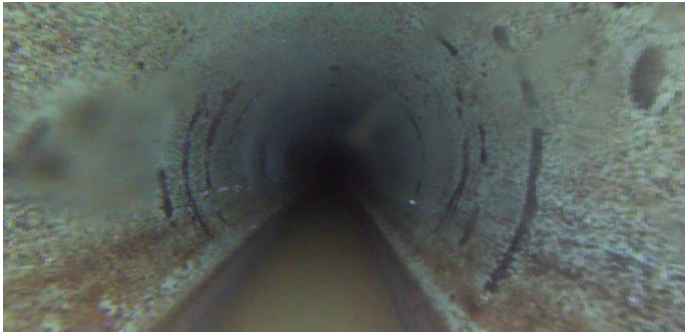
Code:	MWL
Description:	Water Level

Distance (ft):	.0
Structural Grade:	0
O&M Grade:	0
Clock Start/From:	
Clock To:	
1st Value:	
2nd Value:	
Value Percent:	5.000
Continuous Index:	
Within 8" of Joint:	NO
Remarks:

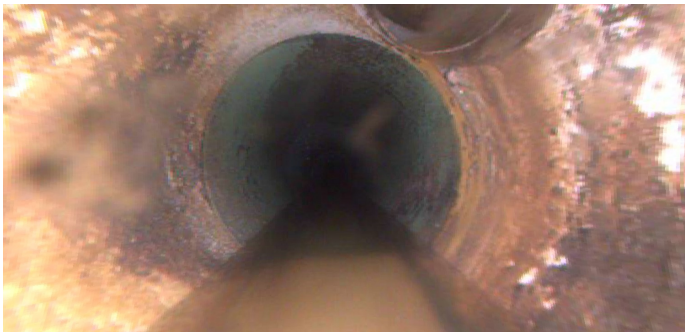
Code:	TF
Description:	Tap Factory

Distance (ft):	31.1
Structural Grade:	0
O&M Grade:	0
Clock Start/From:	1
Clock To:	
1st Value:	4.000
2nd Value:	
Value Percent:	
Continuous Index:	
Within 8" of Joint:	
Remarks:

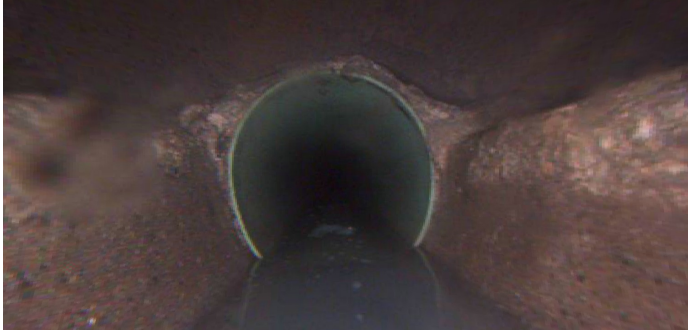
Code:	AMH
Description:	Manhole
Distance (ft):	100.0
Structural Grade:	0
O&M Grade:	0
Clock Start/From:	
Clock To:	
1st Value:	
2nd Value:	
Value Percent:	
Continuous Index:	
Within 8" of Joint:	NO
Remarks:	M-808-005
