## Profile/Photo Observation Report

Date:	<b>03/21/2018</b>	Weather:		Coding:	<b>PACP 6.0</b>
Pipe Length (ft):	<b>189.7</b>	Owner:	<b>NA</b>	Pre Clean:	<b>Not Known</b>
P.O.#:		Surveyor:	<b>Selasie Honu</b>	PSR:	<b>P-808-006-005</b>
Customer:		Clean Date:	<b>01/01/1900</b>	Shape:	<b>C</b>

Location Details:		Direction of Survey:	<b>Upstream</b>
US MH:	<b>M-808-005</b>	DS MH:	<b>M-808-006</b>
		Total Length Surveyed (ft):	<b>184.7</b>

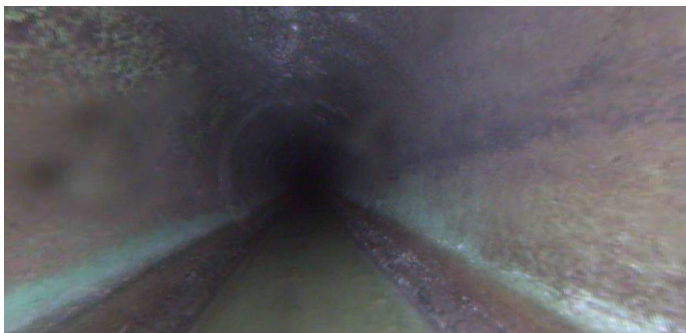
Code: **AMH**  
Description: **Manhole**

Distance (ft): **.0**  
Structural Grade: **0**  
O&M Grade: **0**  
Clock Start/From:  
Clock To:  
1st Value:  
2nd Value:  
Value Percent:  
Continuous Index:  
Within 8" of Joint: **NO**  
Remarks: **M-808-006**

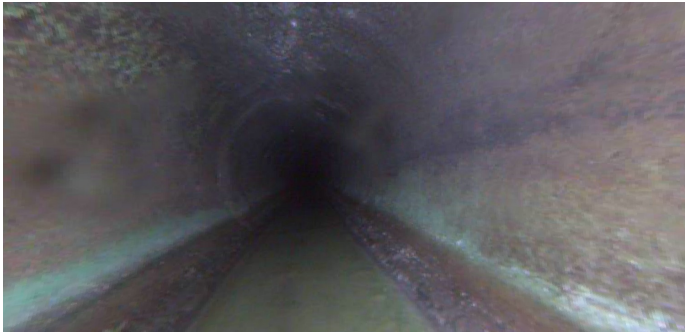
Code:	<b>MWL</b>
Description:	<b>Water Level</b>

Distance (ft):	<b>.0</b>
Structural Grade:	<b>0</b>
O&M Grade:	<b>0</b>
Clock Start/From:	
Clock To:	
1st Value:	
2nd Value:	
Value Percent:	<b>5.000</b>
Continuous Index:	
Within 8" of Joint:	<b>NO</b>
Remarks:

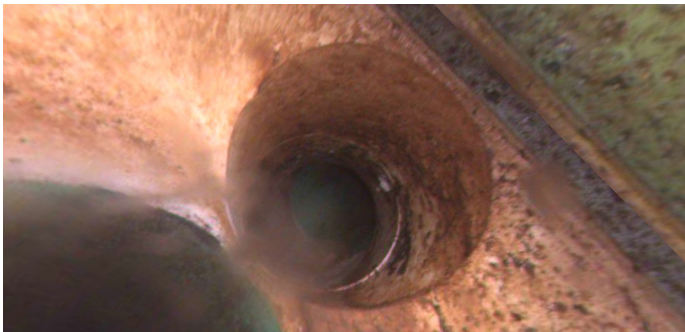
Code:	<b>TF</b>
Description:	<b>Tap Factory</b>

Distance (ft):	<b>22.1</b>
Structural Grade:	<b>0</b>
O&M Grade:	<b>0</b>
Clock Start/From:	<b>10</b>
Clock To:	
1st Value:	<b>4.000</b>
2nd Value:	
Value Percent:	
Continuous Index:	
Within 8" of Joint:	
Remarks:

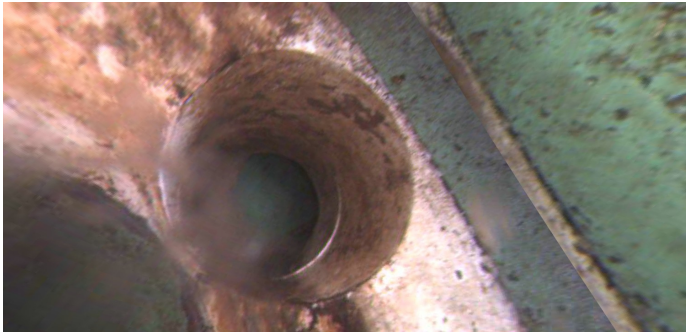
Code: **TF**  
Description: **Tap Factory**

Distance (ft): **98.5**  
Structural Grade: **0**  
O&M Grade: **0**  
Clock Start/From: **10**  
Clock To:  
1st Value: **4.000**  
2nd Value:  
Value Percent:  
Continuous Index:  
Within 8" of Joint:  
Remarks:

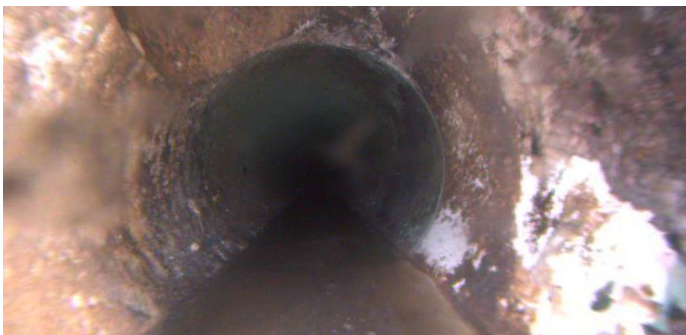
Code: **DAGS**  
Description: **Deposits Attached Grease**

Distance (ft): **162.7**  
Structural Grade: **0**  
O&M Grade: **2**  
Clock Start/From: **8**  
Clock To: **4**  
1st Value:  
2nd Value:  
Value Percent: **5.000**  
Continuous Index:  
Within 8" of Joint: **NO**  
Remarks:

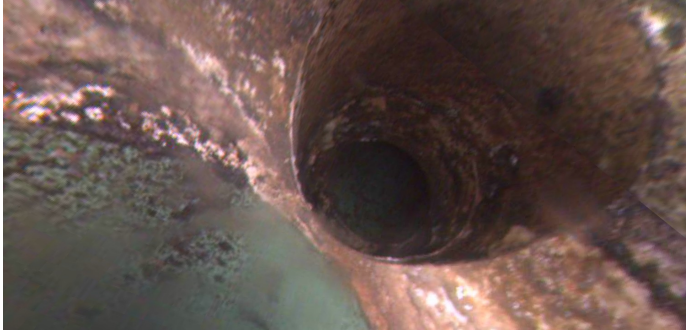
Code: **TF**  
Description: **Tap Factory**

Distance (ft): **163.6**  
Structural Grade: **0**  
O&M Grade: **0**  
Clock Start/From: **10**  
Clock To:  
1st Value: **4.000**  
2nd Value:  
Value Percent:  
Continuous Index:  
Within 8" of Joint:  
Remarks:

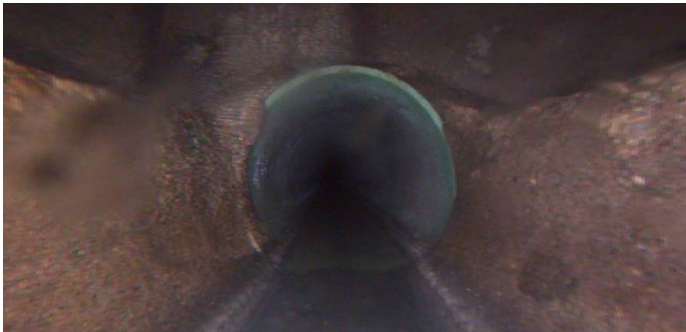
Code: **AMH**  
Description: **Manhole**

Distance (ft): **184.7**  
Structural Grade: **0**  
O&M Grade: **0**  
Clock Start/From:  
Clock To:  
1st Value:  
2nd Value:  
Value Percent:  
Continuous Index:  
Within 8" of Joint: **NO**  
Remarks: **M-808-005**
