Profile/Photo Observation Report

Street:	CAPITOL DR	Flow Control:	Not Controlled
City:	Hobart, IN	Year Renewed:	
Location:	Sidewalk	Tape/Media #:	
Purpose:	Maintenance Related	Dia/Height:	12"
Use:	Sanitary	Material:	PVC
Drain Area:	NA	Lining:	
Category:	NA		
Comment:	flow direction incorrect.

Location Details:		Direction of Survey:	Upstream
US MH:	M-808-007	DS MH:	M-808-008
		Total Length Surveyed (ft):	244.1

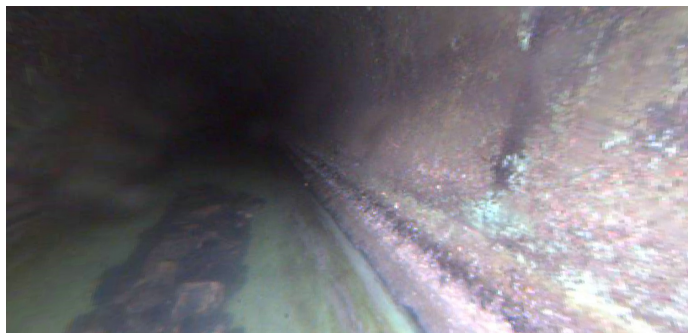
Code: **AMH**
Description: **Manhole**

Distance (ft): **.0**
Structural Grade: **0**
O&M Grade: **0**
Clock Start/From:
Clock To:
1st Value:
2nd Value:
Value Percent:
Continuous Index:
Within 8" of Joint: **NO**
Remarks: **M-808-008**

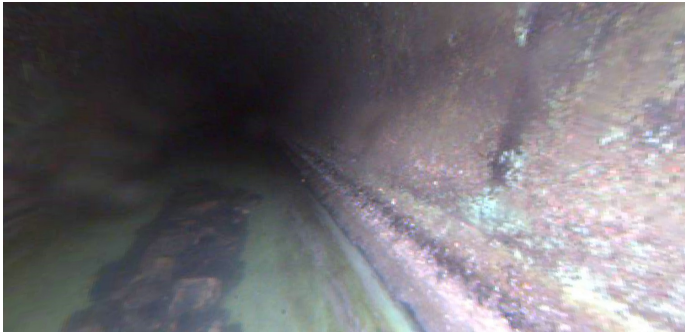
Code:	MWL
Description:	Water Level

Distance (ft):	.0
Structural Grade:	0
O&M Grade:	0
Clock Start/From:	
Clock To:	
1st Value:	
2nd Value:	
Value Percent:	5.000
Continuous Index:	
Within 8" of Joint:	NO
Remarks:

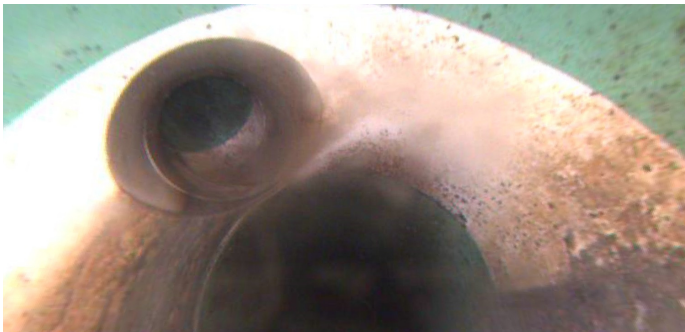
Code:	TF
Description:	Tap Factory

Distance (ft):	51.9
Structural Grade:	0
O&M Grade:	0
Clock Start/From:	1
Clock To:	
1st Value:	4.000
2nd Value:	
Value Percent:	
Continuous Index:	
Within 8" of Joint:	
Remarks:

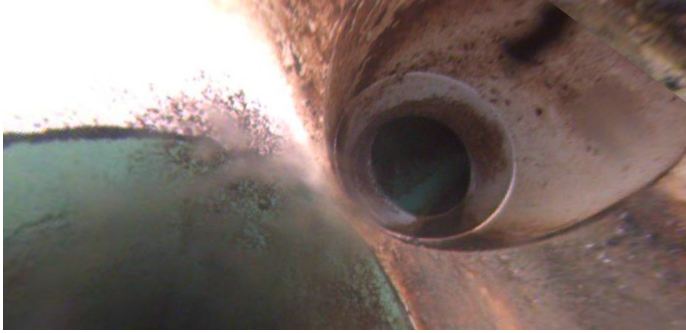
Code: **TF**
Description: **Tap Factory**

Distance (ft): **64.9**
Structural Grade: **0**
O&M Grade: **0**
Clock Start/From: **10**
Clock To:
1st Value: **4.000**
2nd Value:
Value Percent:
Continuous Index:
Within 8" of Joint:
Remarks:

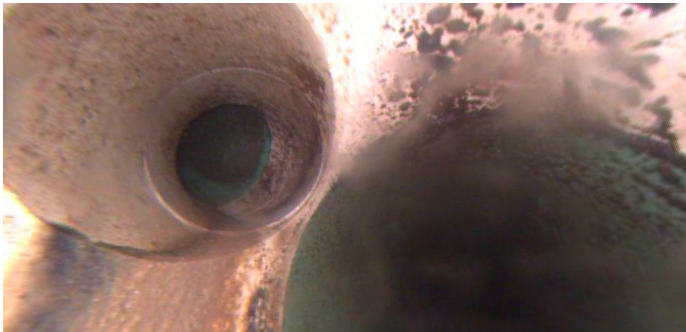
Code: **TF**
Description: **Tap Factory**

Distance (ft): **117.0**
Structural Grade: **0**
O&M Grade: **0**
Clock Start/From: **2**
Clock To:
1st Value: **4.000**
2nd Value:
Value Percent:
Continuous Index:
Within 8" of Joint:
Remarks:

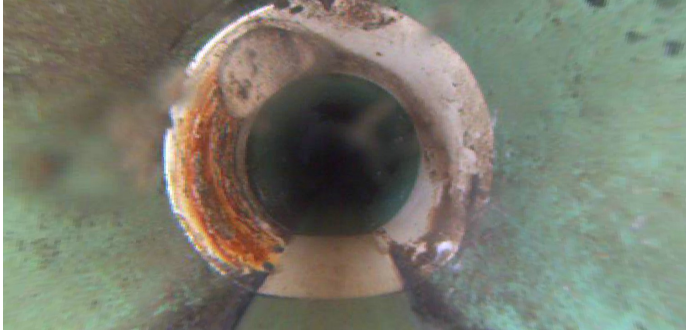
Code: **DAE**
Description: **Deposits Attached Encrustation**

Distance (ft): **129.1**
Structural Grade: **0**
O&M Grade: **2**
Clock Start/From: **7**
Clock To: **10**
1st Value:
2nd Value:
Value Percent: **5.000**
Continuous Index:
Within 8" of Joint: **NO**
Remarks:

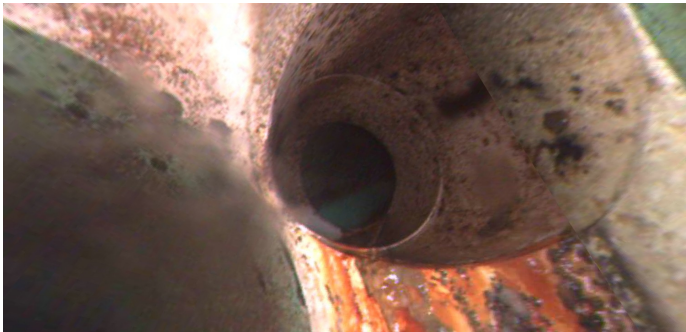
Code: **TF**
Description: **Tap Factory**

Distance (ft): **130.5**
Structural Grade: **0**
O&M Grade: **0**
Clock Start/From: **10**
Clock To:
1st Value: **4.000**
2nd Value:
Value Percent:
Continuous Index:
Within 8" of Joint:
Remarks:

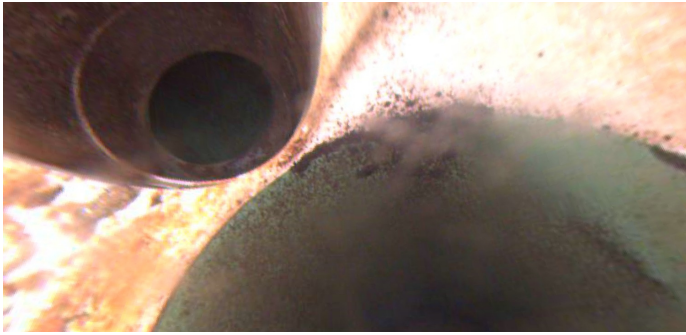
Code: **TF**
Description: **Tap Factory**

Distance (ft): **182.1**
Structural Grade: **0**
O&M Grade: **0**
Clock Start/From: **1**
Clock To:
1st Value: **4.000**
2nd Value:
Value Percent:
Continuous Index:
Within 8" of Joint:
Remarks:

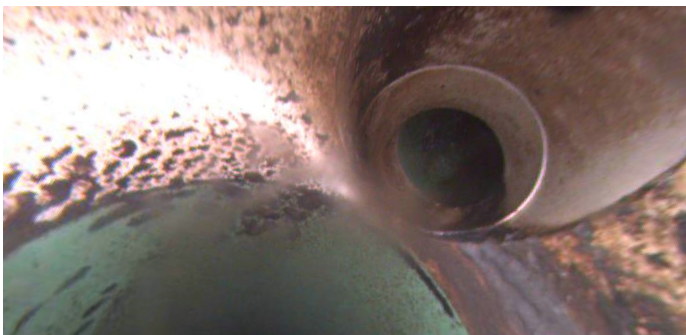
Code: **TF**
Description: **Tap Factory**

Distance (ft): **195.9**
Structural Grade: **0**
O&M Grade: **0**
Clock Start/From: **10**
Clock To:
1st Value: **4.000**
2nd Value:
Value Percent:
Continuous Index:
Within 8" of Joint:
Remarks:

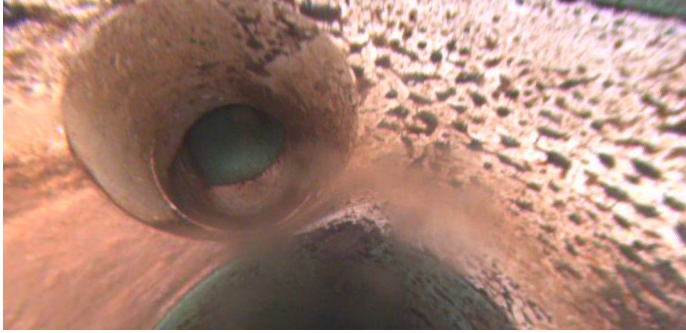
Code: **TF**
Description: **Tap Factory**

Distance (ft): **235.5**
Structural Grade: **0**
O&M Grade: **0**
Clock Start/From: **1**
Clock To:
1st Value: **4.000**
2nd Value:
Value Percent:
Continuous Index:
Within 8" of Joint:
Remarks:

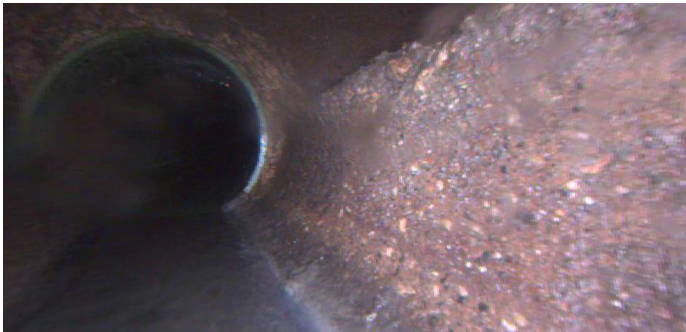
Code: **AMH**
Description: **Manhole**

Distance (ft): **244.1**
Structural Grade: **0**
O&M Grade: **0**
Clock Start/From:
Clock To:
1st Value:
2nd Value:
Value Percent:
Continuous Index:
Within 8" of Joint: **NO**
Remarks: **M-808-007**
