Profile/Photo Observation Report

Date:	03/21/2018	Weather:		Coding:	PACP 6.0
Pipe Length (ft):	260.9	Owner:	NA	Pre Clean:	Not Known
P.O.#:		Surveyor:	Selasie Honu	PSR:	P-808-008-007
Customer:		Clean Date:	01/01/1900	Shape:	C

Street:	Oak	Flow Control:	Not Controlled
City:	Hobart, IN	Year Renewed:	
Location:	Sidewalk	Tape/Media #:	
Purpose:	Maintenance Related	Dia/Height:	12"
Use:	Sanitary	Material:	PVC
Drain Area:	NA	Lining:	
Category:	NA		
Comment:	flow direction incorrect.

Location Details:		Direction of Survey:	Upstream
US MH:	M-808-007	DS MH:	M-808-008
		Total Length Surveyed (ft):	244.1

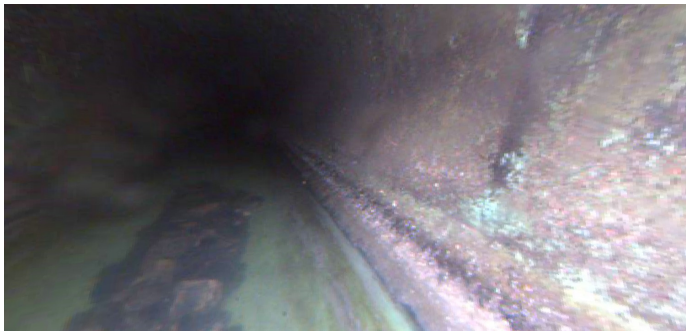
Code: **AMH**
Description: **Manhole**

Distance (ft): **.0**
Structural Grade: **0**
O&M Grade: **0**
Clock Start/From:
Clock To:
1st Value:
2nd Value:
Value Percent:
Continuous Index:
Within 8" of Joint: **NO**
Remarks: **M-808-008**

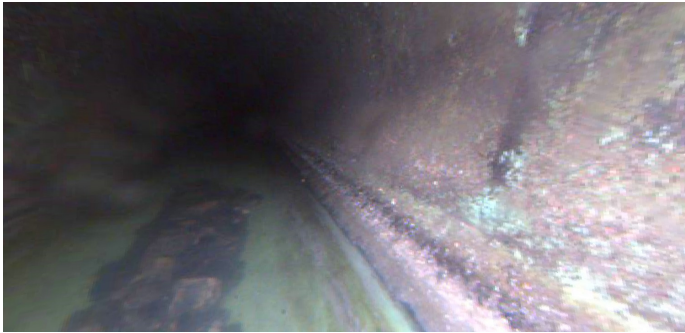
Code:	MWL
Description:	Water Level

Distance (ft):	.0
Structural Grade:	0
O&M Grade:	0
Clock Start/From:	
Clock To:	
1st Value:	
2nd Value:	
Value Percent:	5.000
Continuous Index:	
Within 8" of Joint:	NO
Remarks:

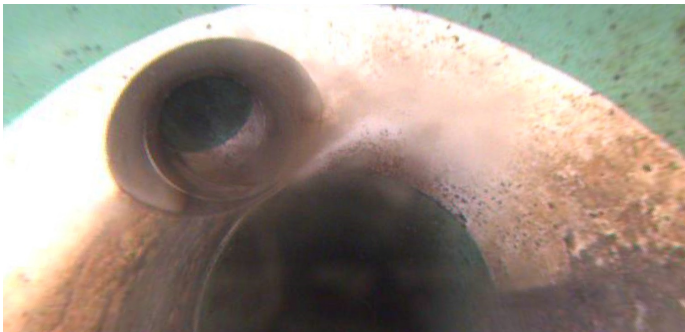
Code:	TF
Description:	Tap Factory

Distance (ft):	51.9
Structural Grade:	0
O&M Grade:	0
Clock Start/From:	1
Clock To:	
1st Value:	4.000
2nd Value:	
Value Percent:	
Continuous Index:	
Within 8" of Joint:	
Remarks:

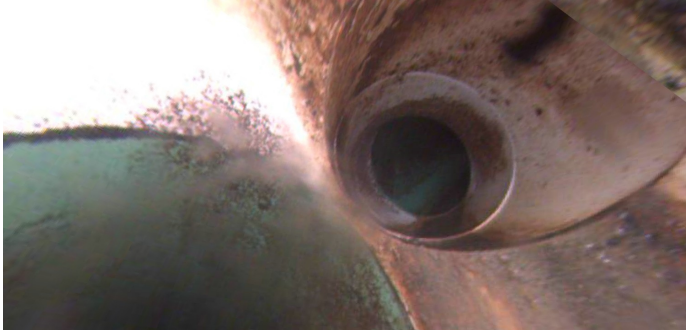
Code: **TF**
Description: **Tap Factory**

Distance (ft): **64.9**
Structural Grade: **0**
O&M Grade: **0**
Clock Start/From: **10**
Clock To:
1st Value: **4.000**
2nd Value:
Value Percent:
Continuous Index:
Within 8" of Joint:
Remarks:

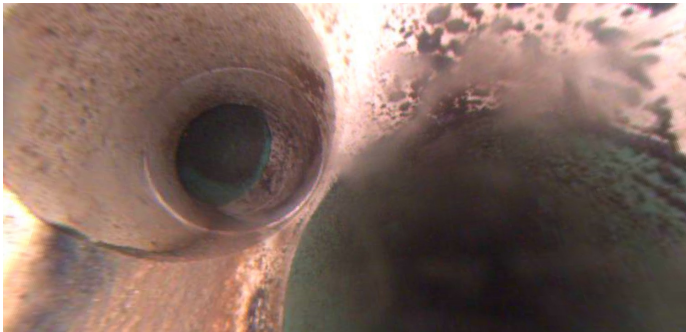
Code: **TF**
Description: **Tap Factory**

Distance (ft): **117.0**
Structural Grade: **0**
O&M Grade: **0**
Clock Start/From: **2**
Clock To:
1st Value: **4.000**
2nd Value:
Value Percent:
Continuous Index:
Within 8" of Joint:
Remarks:

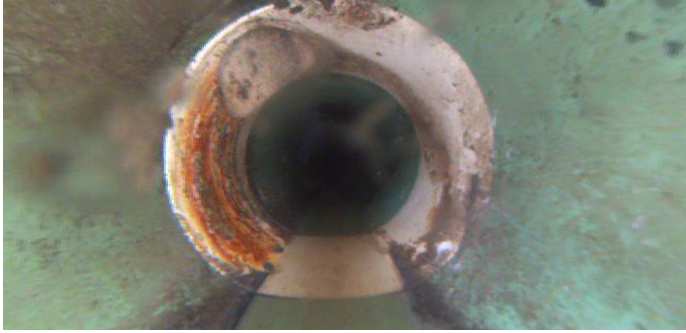
Code: **DAE**
Description: **Deposits Attached Encrustation**

Distance (ft): **129.1**
Structural Grade: **0**
O&M Grade: **2**
Clock Start/From: **7**
Clock To: **10**
1st Value:
2nd Value:
Value Percent: **5.000**
Continuous Index:
Within 8" of Joint: **NO**
Remarks:

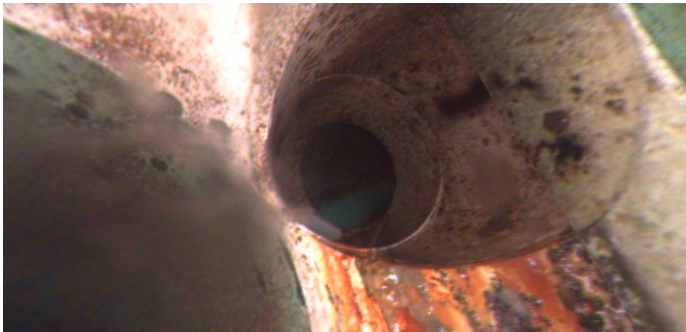
Code: **TF**
Description: **Tap Factory**

Distance (ft): **130.5**
Structural Grade: **0**
O&M Grade: **0**
Clock Start/From: **10**
Clock To:
1st Value: **4.000**
2nd Value:
Value Percent:
Continuous Index:
Within 8" of Joint:
Remarks:

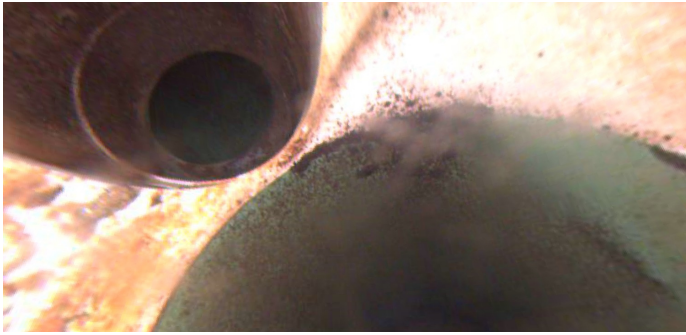
Code: **TF**
Description: **Tap Factory**

Distance (ft): **182.1**
Structural Grade: **0**
O&M Grade: **0**
Clock Start/From: **1**
Clock To:
1st Value: **4.000**
2nd Value:
Value Percent:
Continuous Index:
Within 8" of Joint:
Remarks:

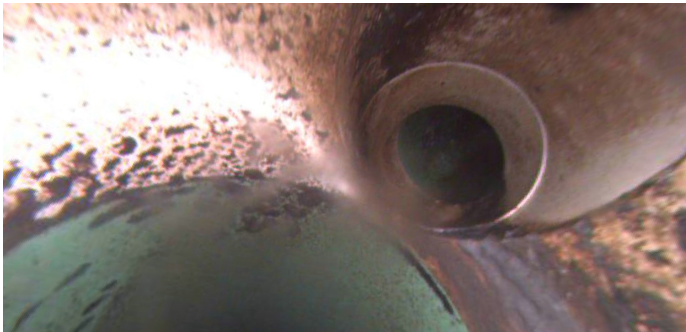
Code: **TF**
Description: **Tap Factory**

Distance (ft): **195.9**
Structural Grade: **0**
O&M Grade: **0**
Clock Start/From: **10**
Clock To:
1st Value: **4.000**
2nd Value:
Value Percent:
Continuous Index:
Within 8" of Joint:
Remarks:

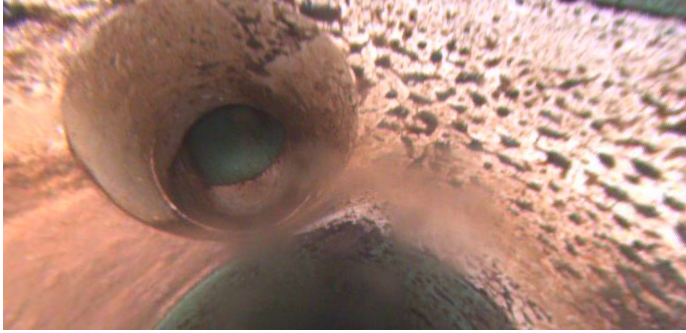
Code: **TF**
Description: **Tap Factory**

Distance (ft): **235.5**
Structural Grade: **0**
O&M Grade: **0**
Clock Start/From: **1**
Clock To:
1st Value: **4.000**
2nd Value:
Value Percent:
Continuous Index:
Within 8" of Joint:
Remarks:

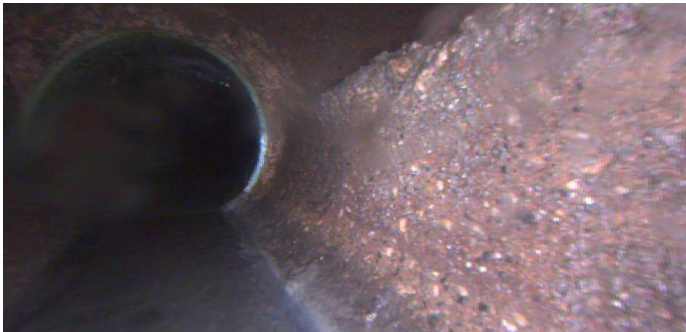
Code: **AMH**
Description: **Manhole**

Distance (ft): **244.1**
Structural Grade: **0**
O&M Grade: **0**
Clock Start/From:
Clock To:
1st Value:
2nd Value:
Value Percent:
Continuous Index:
Within 8" of Joint: **NO**
Remarks: **M-808-007**
