Profile/Photo Observation Report

Date:	03/21/2018	Weather:		Coding:	PACP 6.0
Pipe Length (ft):	251.2	Owner:	NA	Pre Clean:	Not Known
P.O.#:		Surveyor:	Selasie Honu	PSR:	P-808-009-008
Customer:		Clean Date:	01/01/1900	Shape:	C

Street:	Oak	Flow Control:	Not Controlled
City:	Hobart, IN	Year Renewed:	
Location:	Light Highway	Tape/Media #:	
Purpose:	Maintenance Related	Dia/Height:	12"
Use:	Sanitary	Material:	PVC
Drain Area:	NA	Lining:	
Category:	NA		
Comment:	flow is incorrect.

Location Details:		Direction of Survey:	Upstream
US MH:	M-808-008	DS MH:	M-808-009
		Total Length Surveyed (ft):	249.8

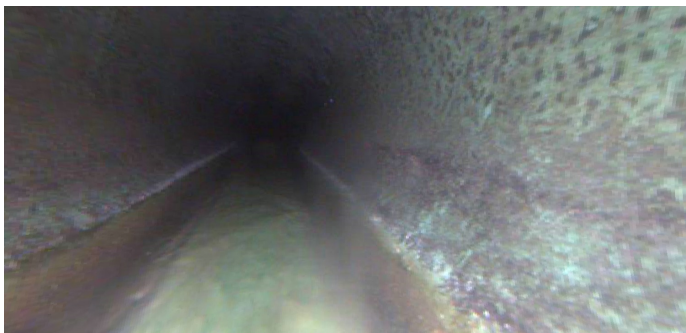
Code: **AMH**
Description: **Manhole**

Distance (ft): **.0**
Structural Grade: **0**
O&M Grade: **0**
Clock Start/From:
Clock To:
1st Value:
2nd Value:
Value Percent:
Continuous Index:
Within 8" of Joint: **NO**
Remarks: **M-808-009**

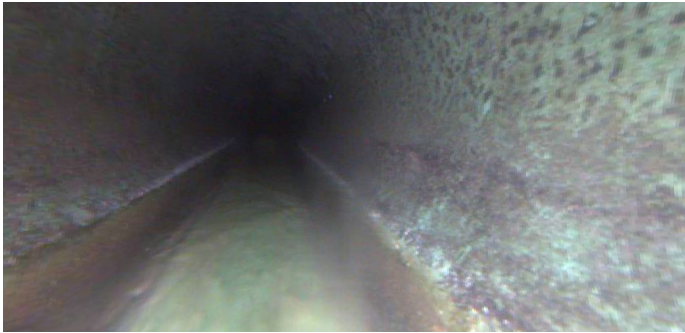
Code:	MWL
Description:	Water Level

Distance (ft):	.0
Structural Grade:	0
O&M Grade:	0
Clock Start/From:	
Clock To:	
1st Value:	
2nd Value:	
Value Percent:	5.000
Continuous Index:	
Within 8" of Joint:	NO
Remarks:

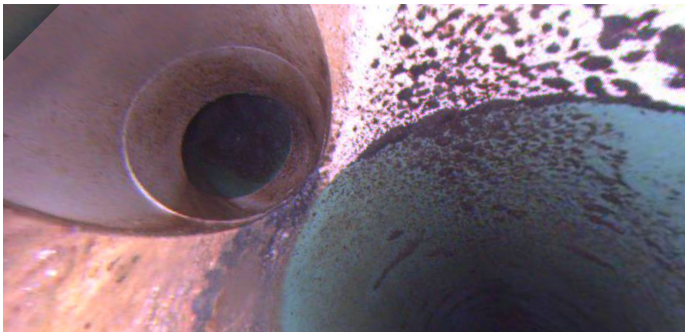
Code:	TF
Description:	Tap Factory

Distance (ft):	39.4
Structural Grade:	0
O&M Grade:	0
Clock Start/From:	2
Clock To:	
1st Value:	4.000
2nd Value:	
Value Percent:	
Continuous Index:	
Within 8" of Joint:	
Remarks:

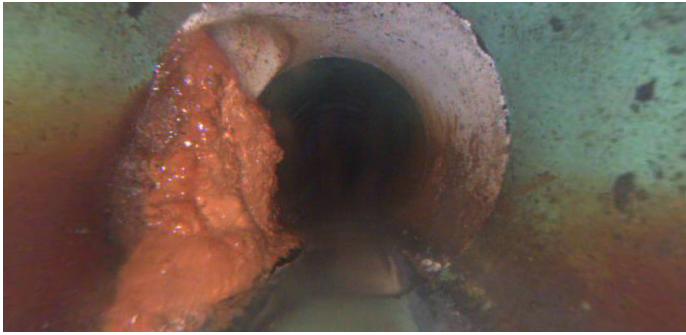
Code: **DAE**
Description: **Deposits Attached Encrustation**

Distance (ft): **52.0**
Structural Grade: **0**
O&M Grade: **3**
Clock Start/From: **7**
Clock To: **10**
1st Value:
2nd Value:
Value Percent: **15.000**
Continuous Index:
Within 8" of Joint: **NO**
Remarks:

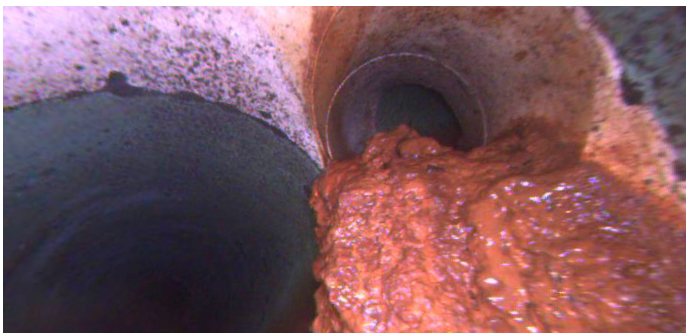
Code: **TFD**
Description: **Tap Factory Defective**

Distance (ft): **53.7**
Structural Grade: **0**
O&M Grade: **2**
Clock Start/From: **10**
Clock To:
1st Value: **4.000**
2nd Value:
Value Percent:
Continuous Index:
Within 8" of Joint:
Remarks: **dae**

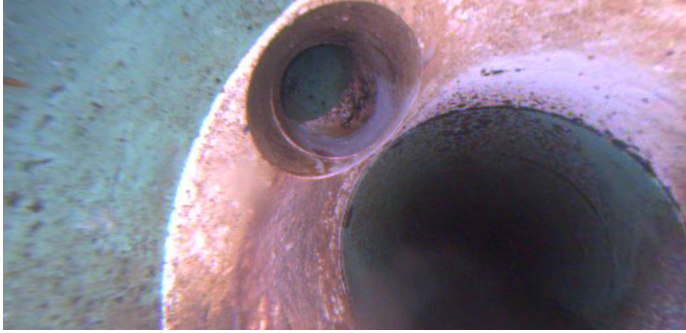
Code: **TF**
Description: **Tap Factory**

Distance (ft): **107.4**
Structural Grade: **0**
O&M Grade: **0**
Clock Start/From: **2**
Clock To:
1st Value: **4.000**
2nd Value:
Value Percent:
Continuous Index:
Within 8" of Joint: **NO**
Remarks:

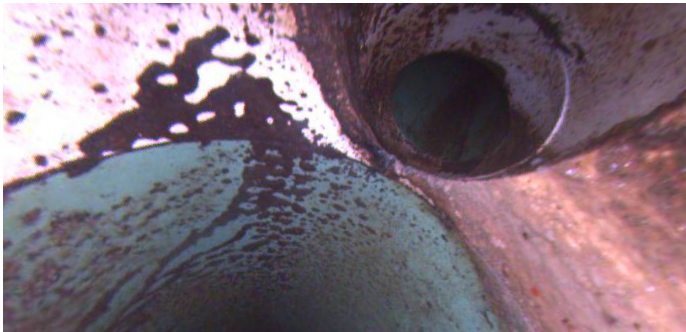
Code: **TF**
Description: **Tap Factory**

Distance (ft): **120.6**
Structural Grade: **0**
O&M Grade: **0**
Clock Start/From: **11**
Clock To:
1st Value: **4.000**
2nd Value:
Value Percent:
Continuous Index:
Within 8" of Joint:
Remarks:

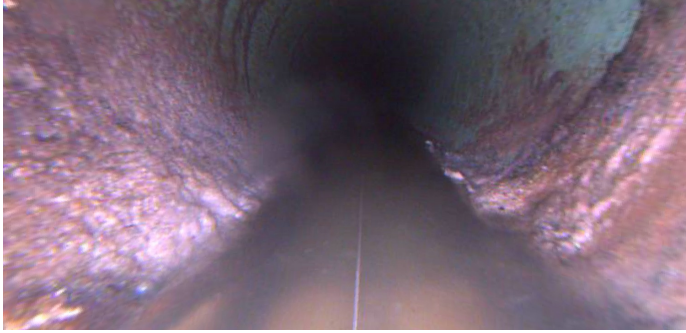
Code: **DAGS**
Description: **Deposits Attached Grease**

Distance (ft): **120.6**
Structural Grade: **0**
O&M Grade: **2**
Clock Start/From: **8**
Clock To: **4**
1st Value:
2nd Value:
Value Percent: **5.000**
Continuous Index:
Within 8" of Joint: **NO**
Remarks:

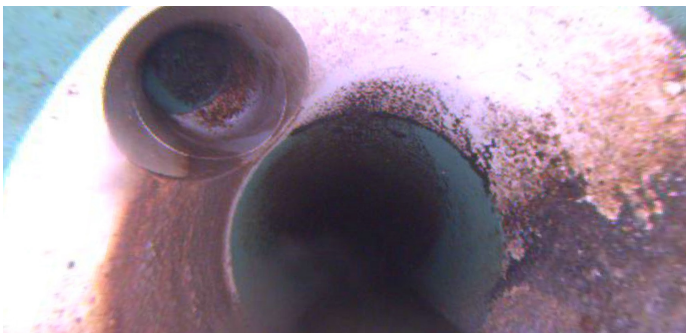
Code: **TF**
Description: **Tap Factory**

Distance (ft): **174.3**
Structural Grade: **0**
O&M Grade: **0**
Clock Start/From: **2**
Clock To:
1st Value: **4.000**
2nd Value:
Value Percent:
Continuous Index:
Within 8" of Joint:
Remarks:

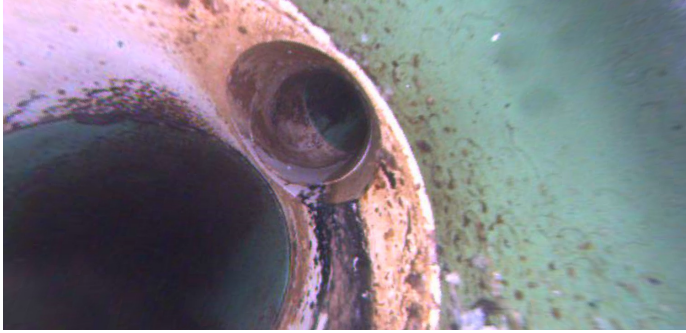
Code: **TF**
Description: **Tap Factory**

Distance (ft): **188.4**
Structural Grade: **0**
O&M Grade: **0**
Clock Start/From: **10**
Clock To:
1st Value: **4.000**
2nd Value:
Value Percent:
Continuous Index:
Within 8" of Joint:
Remarks:

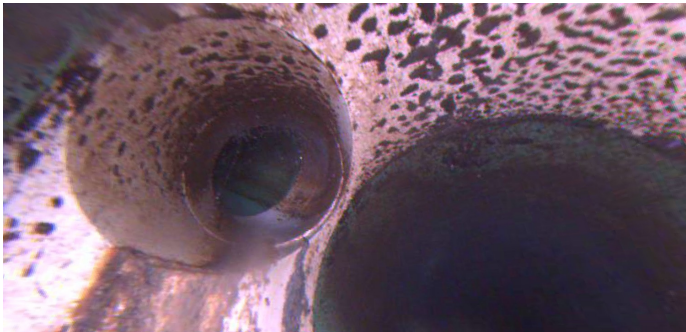
Code: **TF**
Description: **Tap Factory**

Distance (ft): **227.6**
Structural Grade: **0**
O&M Grade: **0**
Clock Start/From: **2**
Clock To:
1st Value: **4.000**
2nd Value:
Value Percent:
Continuous Index:
Within 8" of Joint:
Remarks:

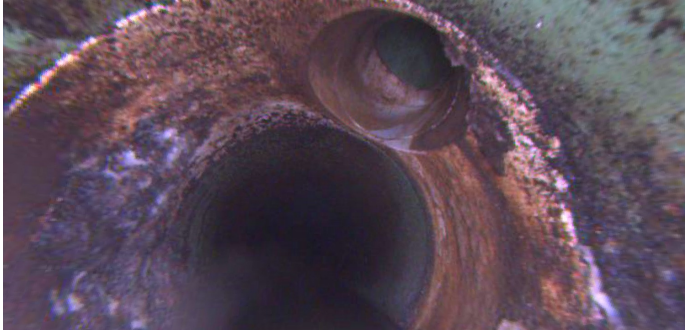
Code: **TF**
Description: **Tap Factory**

Distance (ft): **241.7**
Structural Grade: **0**
O&M Grade: **0**
Clock Start/From: **11**
Clock To:
1st Value: **4.000**
2nd Value:
Value Percent:
Continuous Index:
Within 8" of Joint:
Remarks:

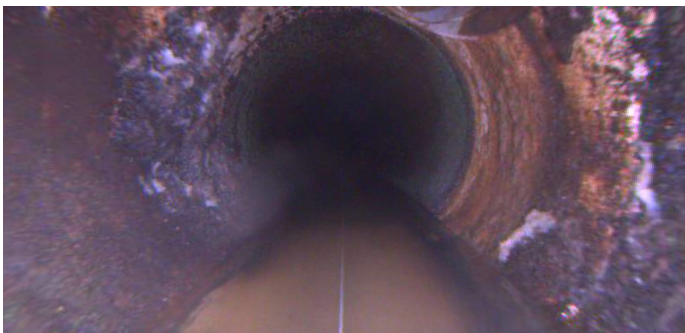
Code: **DAGS**
Description: **Deposits Attached Grease**

Distance (ft): **241.7**
Structural Grade: **0**
O&M Grade: **2**
Clock Start/From: **8**
Clock To: **4**
1st Value:
2nd Value:
Value Percent: **5.000**
Continuous Index:
Within 8" of Joint: **NO**
Remarks:

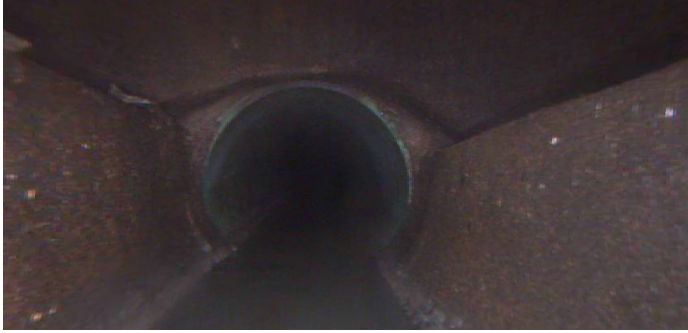
Code:	AMH
Description:	Manhole
Distance (ft):	249.8
Structural Grade:	0
O&M Grade:	0
Clock Start/From:	
Clock To:	
1st Value:	
2nd Value:	
Value Percent:	
Continuous Index:	
Within 8" of Joint:	NO
Remarks:	M-808-008
