Profile/Photo Observation Report

Street:	CAPITOL DR	Flow Control:	Not Controlled
City:	Hobart, IN	Year Renewed:	
Location:	Sidewalk	Tape/Media #:	
Purpose:	Maintenance Related	Dia/Height:	12"
Use:	Sanitary	Material:	PVC
Drain Area:	NA	Lining:	
Category:	NA		
Comment:	Reverse setup. flow direction incorrect.

Location Details:		Direction of Survey:	Downstream
US MH:	M-808-009	DS MH:	M-808-010
		Total Length Surveyed (ft):	209.3

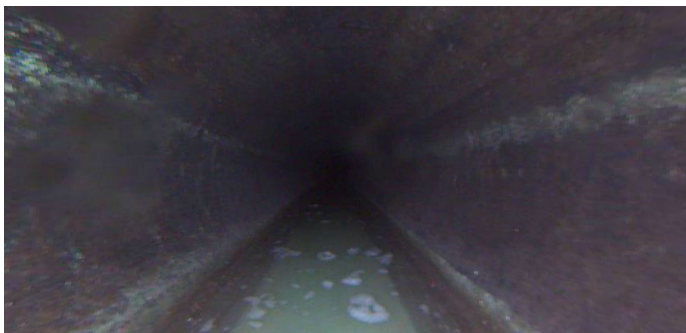
Code: **AMH**
Description: **Manhole**

Distance (ft): **.0**
Structural Grade: **0**
O&M Grade: **0**
Clock Start/From:
Clock To:
1st Value:
2nd Value:
Value Percent:
Continuous Index:
Within 8" of Joint: **NO**
Remarks: **M-808-009**

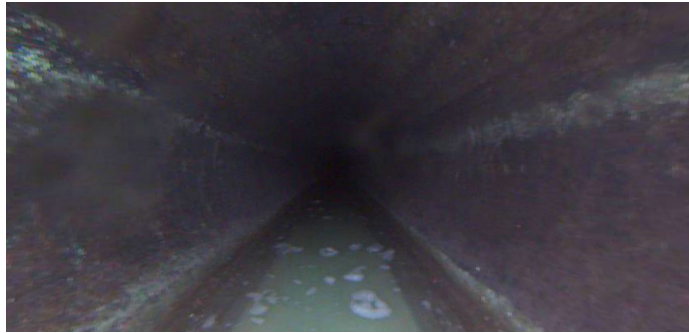
Code: **MWL**
Description: **Water Level**

Distance (ft): **.0**
Structural Grade: **0**
O&M Grade: **0**
Clock Start/From:
Clock To:
1st Value:
2nd Value:
Value Percent: **5.000**
Continuous Index:
Within 8" of Joint: **NO**
Remarks:

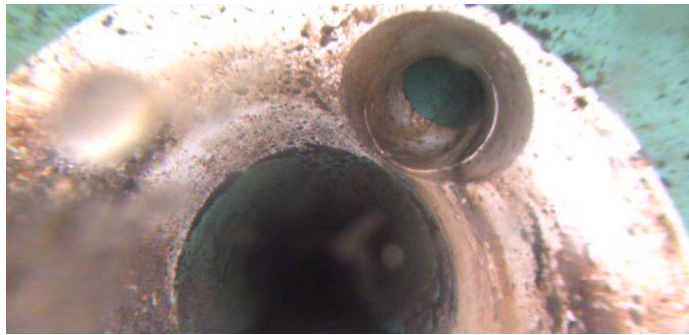
Code: **TF**
Description: **Tap Factory**

Distance (ft): **18.5**
Structural Grade: **0**
O&M Grade: **0**
Clock Start/From: **1**
Clock To:
1st Value: **4.000**
2nd Value:
Value Percent:
Continuous Index:
Within 8" of Joint:
Remarks:

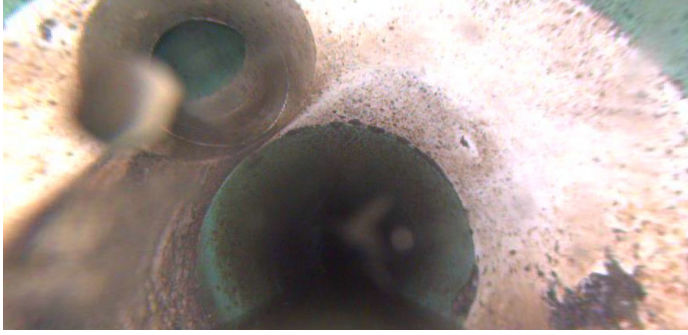
Code: **TF**
Description: **Tap Factory**

Distance (ft): **32.0**
Structural Grade: **0**
O&M Grade: **0**
Clock Start/From: **11**
Clock To:
1st Value: **4.000**
2nd Value:
Value Percent:
Continuous Index:
Within 8" of Joint:
Remarks:

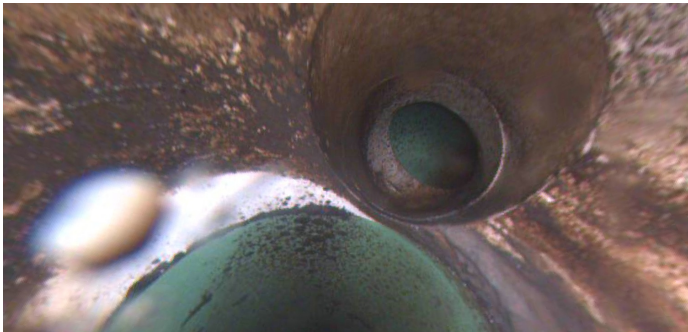
Code: **TF**
Description: **Tap Factory**

Distance (ft): **71.3**
Structural Grade: **0**
O&M Grade: **0**
Clock Start/From: **1**
Clock To:
1st Value: **4.000**
2nd Value:
Value Percent:
Continuous Index:
Within 8" of Joint:
Remarks:

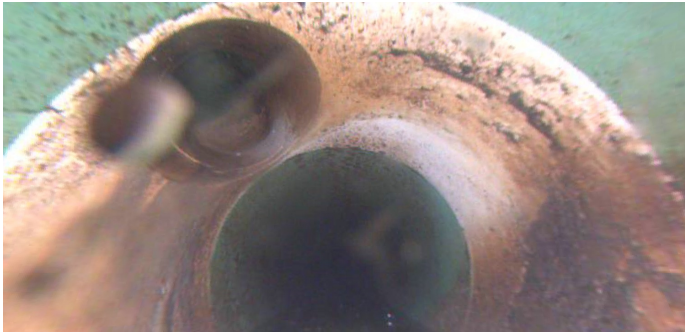
Code: **TF**
Description: **Tap Factory**

Distance (ft): **97.0**
Structural Grade: **0**
O&M Grade: **0**
Clock Start/From: **11**
Clock To:
1st Value: **4.000**
2nd Value:
Value Percent:
Continuous Index:
Within 8" of Joint:
Remarks:

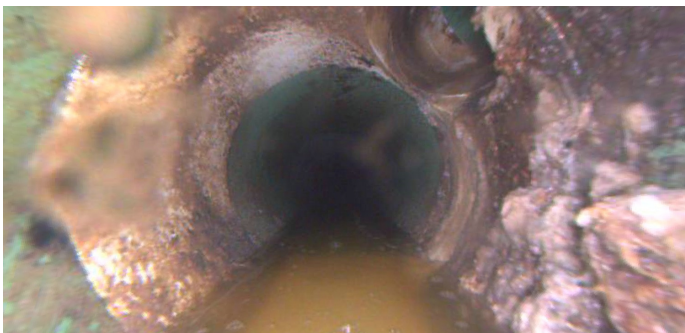
Code: **DAGS**
Description: **Deposits Attached Grease**

Distance (ft): **149.0**
Structural Grade: **0**
O&M Grade: **2**
Clock Start/From: **1**
Clock To: **4**
1st Value:
2nd Value:
Value Percent: **5.000**
Continuous Index:
Within 8" of Joint: **NO**
Remarks:

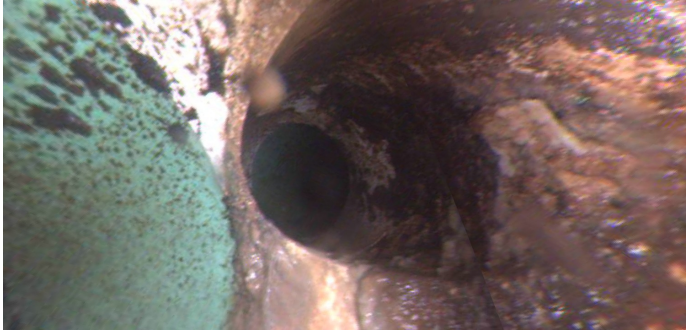
Code: **TF**
Description: **Tap Factory**

Distance (ft): **149.9**
Structural Grade: **0**
O&M Grade: **0**
Clock Start/From: **2**
Clock To:
1st Value: **4.000**
2nd Value:
Value Percent:
Continuous Index:
Within 8" of Joint:
Remarks:

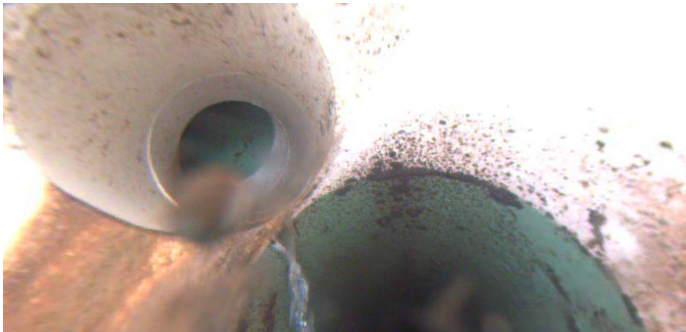
Code: **TFA**
Description: **Tap Factory Active**

Distance (ft): **163.0**
Structural Grade: **0**
O&M Grade: **0**
Clock Start/From: **10**
Clock To:
1st Value: **4.000**
2nd Value:
Value Percent:
Continuous Index:
Within 8" of Joint:
Remarks:

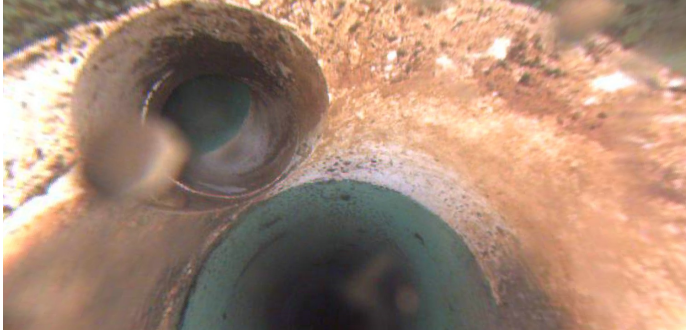
Code: **TF**
Description: **Tap Factory**

Distance (ft): **194.8**
Structural Grade: **0**
O&M Grade: **0**
Clock Start/From: **11**
Clock To:
1st Value: **4.000**
2nd Value:
Value Percent:
Continuous Index:
Within 8" of Joint:
Remarks:

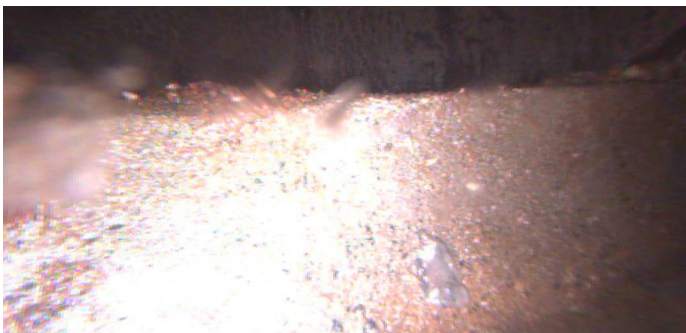
Code: **AMH**
Description: **Manhole**

Distance (ft): **209.3**
Structural Grade: **0**
O&M Grade: **0**
Clock Start/From:
Clock To:
1st Value:
2nd Value:
Value Percent:
Continuous Index:
Within 8" of Joint: **NO**
Remarks: **M-808-010**
