Profile/Photo Observation Report

Date:	03/21/2018	Weather:		Coding:	PACP 6.0
Pipe Length (ft):	213.7	Owner:	NA	Pre Clean:	Not Known
P.O.#:		Surveyor:	Selasie Honu	PSR:	P-808-010-009
Customer:		Clean Date:	01/01/1900	Shape:	C

Street:	Oak	Flow Control:	Not Controlled
City:	Hobart, IN	Year Renewed:	
Location:	Sidewalk	Tape/Media #:	
Purpose:	Maintenance Related	Dia/Height:	12"
Use:	Sanitary	Material:	PVC
Drain Area:	NA	Lining:	
Category:	NA		
Comment:	Reverse setup. flow direction incorrect.

Location Details:		Direction of Survey:	Downstream
US MH:	M-808-009	DS MH:	M-808-010
		Total Length Surveyed (ft):	209.3

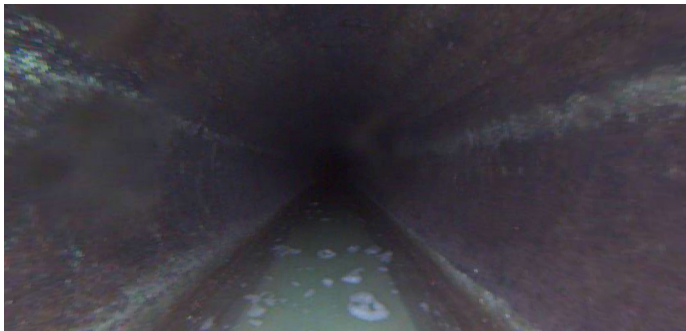
Code: **AMH**
Description: **Manhole**

Distance (ft): **.0**
Structural Grade: **0**
O&M Grade: **0**
Clock Start/From:
Clock To:
1st Value:
2nd Value:
Value Percent:
Continuous Index:
Within 8" of Joint: **NO**
Remarks: **M-808-009**

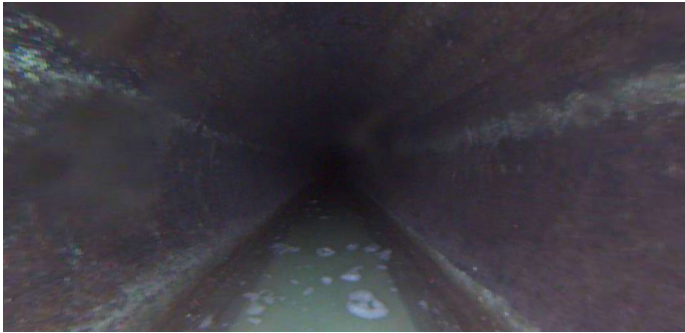
Code:	MWL
Description:	Water Level

Distance (ft):	.0
Structural Grade:	0
O&M Grade:	0
Clock Start/From:	
Clock To:	
1st Value:	
2nd Value:	
Value Percent:	5.000
Continuous Index:	
Within 8" of Joint:	NO
Remarks:

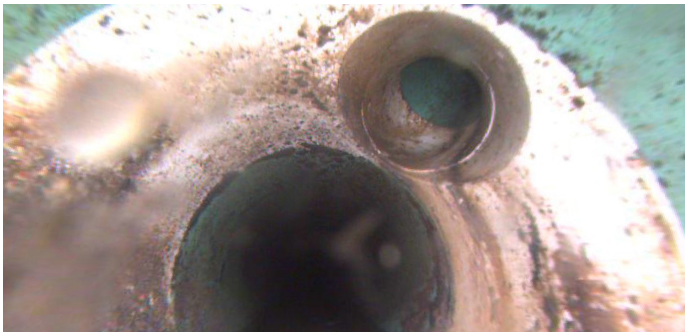
Code:	TF
Description:	Tap Factory

Distance (ft):	18.5
Structural Grade:	0
O&M Grade:	0
Clock Start/From:	1
Clock To:	
1st Value:	4.000
2nd Value:	
Value Percent:	
Continuous Index:	
Within 8" of Joint:	
Remarks:

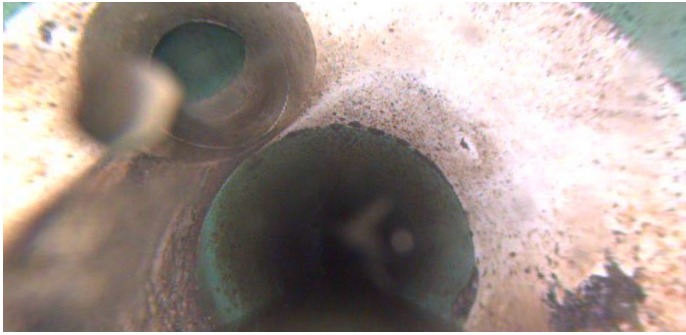
Code: **TF**
Description: **Tap Factory**

Distance (ft): **32.0**
Structural Grade: **0**
O&M Grade: **0**
Clock Start/From: **11**
Clock To:
1st Value: **4.000**
2nd Value:
Value Percent:
Continuous Index:
Within 8" of Joint:
Remarks:

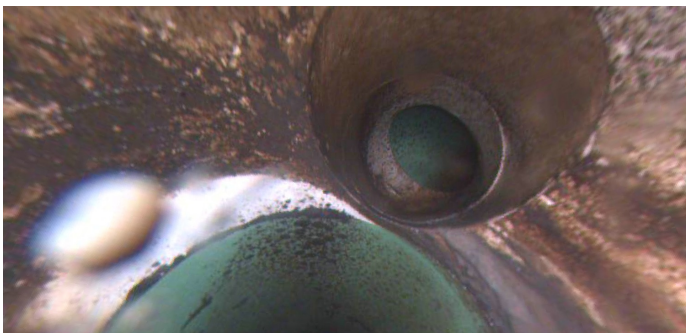
Code: **TF**
Description: **Tap Factory**

Distance (ft): **71.3**
Structural Grade: **0**
O&M Grade: **0**
Clock Start/From: **1**
Clock To:
1st Value: **4.000**
2nd Value:
Value Percent:
Continuous Index:
Within 8" of Joint:
Remarks:

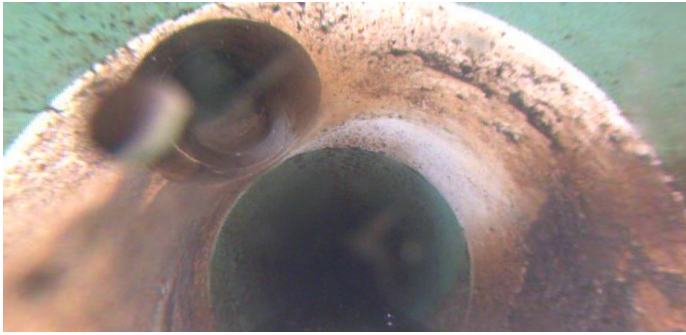
Code: **TF**
Description: **Tap Factory**

Distance (ft): **97.0**
Structural Grade: **0**
O&M Grade: **0**
Clock Start/From: **11**
Clock To:
1st Value: **4.000**
2nd Value:
Value Percent:
Continuous Index:
Within 8" of Joint:
Remarks:

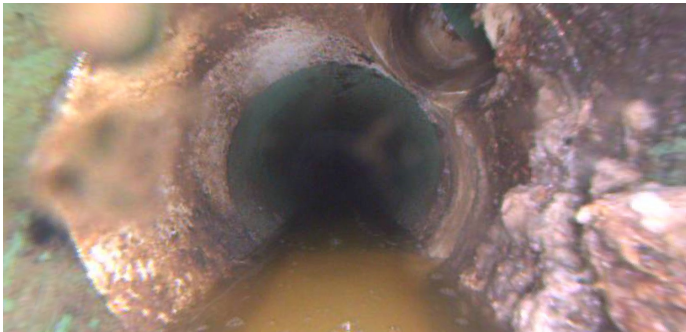
Code: **DAGS**
Description: **Deposits Attached Grease**

Distance (ft): **149.0**
Structural Grade: **0**
O&M Grade: **2**
Clock Start/From: **1**
Clock To: **4**
1st Value:
2nd Value:
Value Percent: **5.000**
Continuous Index:
Within 8" of Joint: **NO**
Remarks:

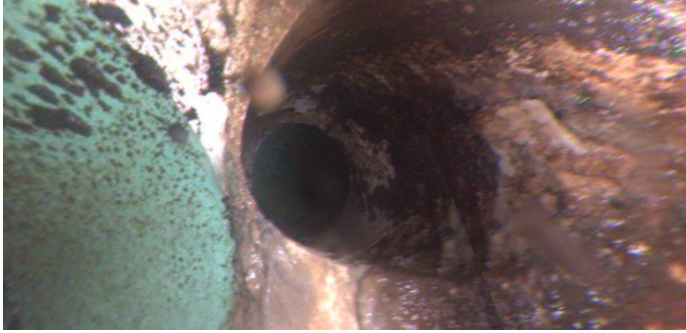
Code: **TF**
Description: **Tap Factory**

Distance (ft): **149.9**
Structural Grade: **0**
O&M Grade: **0**
Clock Start/From: **2**
Clock To:
1st Value: **4.000**
2nd Value:
Value Percent:
Continuous Index:
Within 8" of Joint:
Remarks:

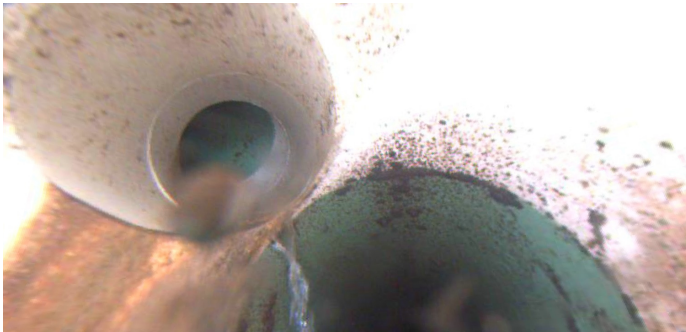
Code: **TFA**
Description: **Tap Factory Active**

Distance (ft): **163.0**
Structural Grade: **0**
O&M Grade: **0**
Clock Start/From: **10**
Clock To:
1st Value: **4.000**
2nd Value:
Value Percent:
Continuous Index:
Within 8" of Joint:
Remarks:

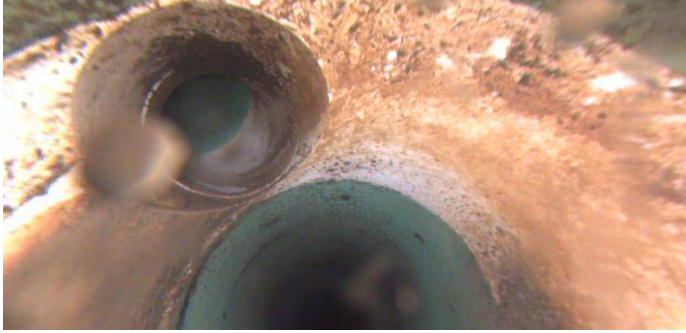
Code: **TF**
Description: **Tap Factory**

Distance (ft): **194.8**
Structural Grade: **0**
O&M Grade: **0**
Clock Start/From: **11**
Clock To:
1st Value: **4.000**
2nd Value:
Value Percent:
Continuous Index:
Within 8" of Joint:
Remarks:

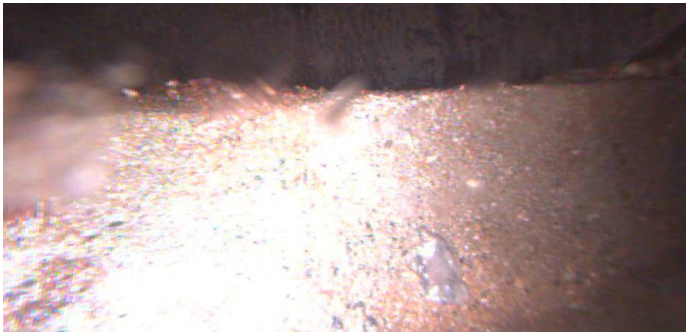
Code: **AMH**
Description: **Manhole**

Distance (ft): **209.3**
Structural Grade: **0**
O&M Grade: **0**
Clock Start/From:
Clock To:
1st Value:
2nd Value:
Value Percent:
Continuous Index:
Within 8" of Joint: **NO**
Remarks: **M-808-010**
