Profile/Photo Observation Report

Date:	03/21/2018	Weather:		Coding:	PACP 6.0
Pipe Length (ft):	213.7	Owner:	NA	Pre Clean:	Not Known
P.O.#:		Surveyor:	Selasie Honu	PSR:	P-808-010-009
Customer:		Clean Date:	01/01/1900	Shape:	C

Street:	CAPITOL DR	Flow Control:	Not Controlled
City:	Hobart, IN	Year Renewed:	
Location:	Light Highway	Tape/Media #:	
Purpose:	Maintenance Related	Dia/Height:	12"
Use:	Sanitary	Material:	PVC
Drain Area:	NA	Lining:	
Category:	NA		
Comment:	battery voltage at 10'.

Location Details:		Direction of Survey:	Upstream
US MH:	M-808-009	DS MH:	M-808-010
		Total Length Surveyed (ft):	11.1

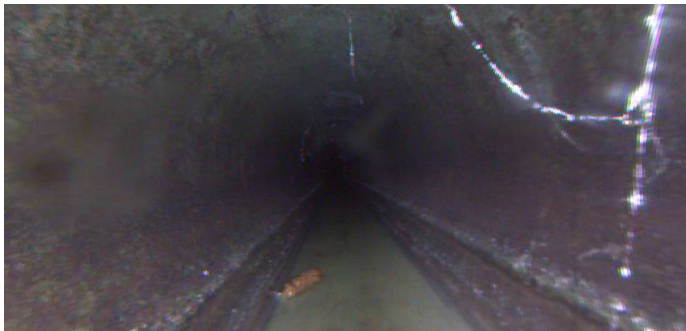
Code: **AMH**
Description: **Manhole**

Distance (ft): **.0**
Structural Grade: **0**
O&M Grade: **0**
Clock Start/From:
Clock To:
1st Value:
2nd Value:
Value Percent:
Continuous Index:
Within 8" of Joint: **NO**
Remarks: **M-808-010**

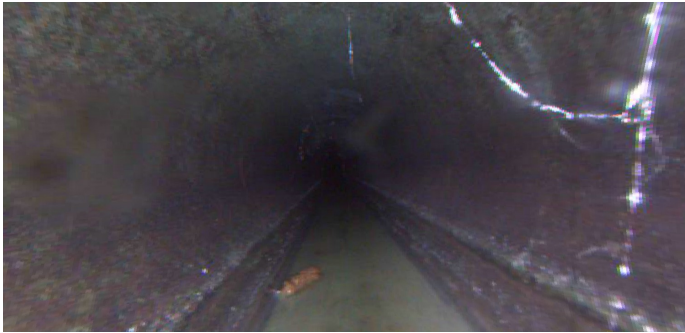
Code:	MWL
Description:	Water Level

Distance (ft):	.0
Structural Grade:	0
O&M Grade:	0
Clock Start/From:	
Clock To:	
1st Value:	
2nd Value:	
Value Percent:	5.000
Continuous Index:	
Within 8" of Joint:	NO
Remarks:

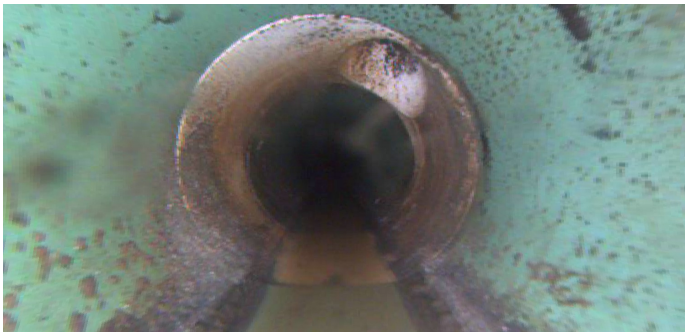
Code:	TF
Description:	Tap Factory

Distance (ft):	10.2
Structural Grade:	0
O&M Grade:	0
Clock Start/From:	1
Clock To:	
1st Value:	4.000
2nd Value:	
Value Percent:	
Continuous Index:	
Within 8" of Joint:	
Remarks:

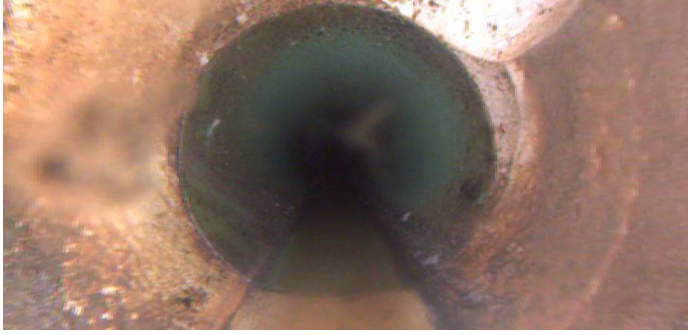
Code:	MSA
Description:	Abandoned Survey
Distance (ft):	11.1
Structural Grade:	0
O&M Grade:	0
Clock Start/From:	
Clock To:	
1st Value:	
2nd Value:	
Value Percent:	
Continuous Index:	
Within 8" of Joint:	NO
Remarks:	camera stopped
