Profile/Photo Observation Report

Street:	Oak	Flow Control:	Not Controlled
City:	Hobart, IN	Year Renewed:	
Location:	Light Highway	Tape/Media #:	
Purpose:	Maintenance Related	Dia/Height:	12"
Use:	Sanitary	Material:	PVC
Drain Area:	NA	Lining:	
Category:	NA		
Comment:	battery voltage at 10'.

Location Details:		Direction of Survey:	Upstream
US MH:	M-808-009	DS MH:	M-808-010
		Total Length Surveyed (ft):	11.1

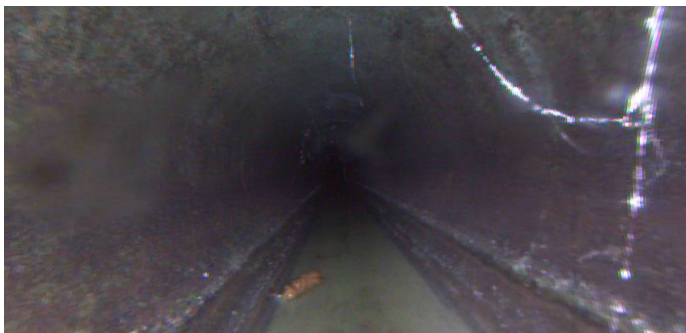
Code: **AMH**
Description: **Manhole**

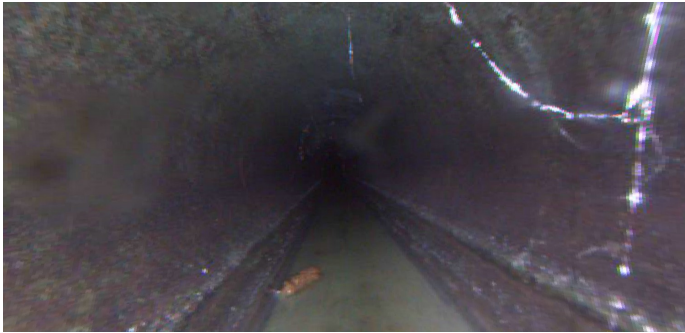
Code:	MWL
Description:	Water Level

Distance (ft):	.0
Structural Grade:	0
O&M Grade:	0
Clock Start/From:	
Clock To:	
1st Value:	
2nd Value:	
Value Percent:	5.000
Continuous Index:	
Within 8" of Joint:	NO
Remarks:

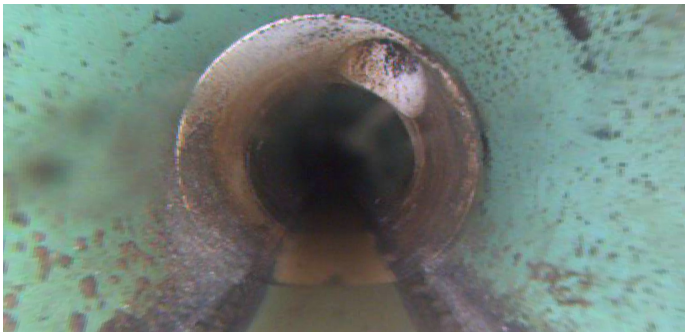
Code:	TF
Description:	Tap Factory

Distance (ft):	10.2
Structural Grade:	0
O&M Grade:	0
Clock Start/From:	1
Clock To:	
1st Value:	4.000
2nd Value:	
Value Percent:	
Continuous Index:	
Within 8" of Joint:	
Remarks:

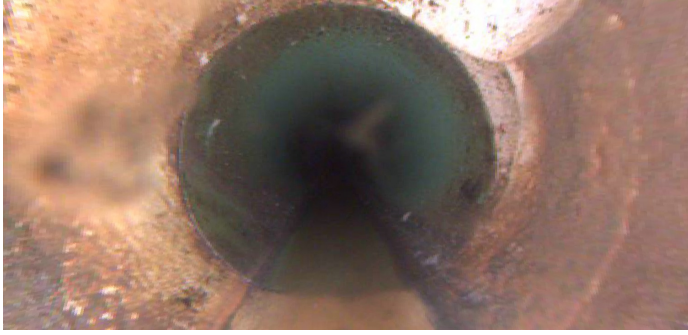
Code:	MSA
Description:	Abandoned Survey
Distance (ft):	11.1
Structural Grade:	0
O&M Grade:	0
Clock Start/From:	
Clock To:	
1st Value:	
2nd Value:	
Value Percent:	
Continuous Index:	
Within 8" of Joint:	NO
Remarks:	camera stopped
