## Profile/Photo Observation Report

| Street: | <b>Oak</b> | Flow Control: | <b>Not Controlled</b> |
| City: | <b>Hobart, IN</b> | Year Renewed: | |
| US MH: | <b>M-808-011</b> | DS MH: | <b>M-808-010</b> |

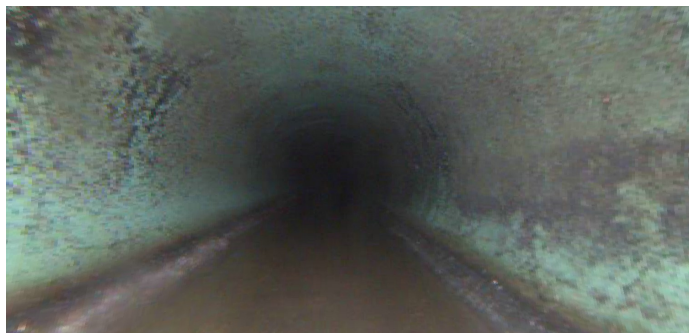
Code: **AMH**  
Description: **Manhole**

Distance (ft): **.0**  
Structural Grade: **0**  
O&M Grade: **0**  
Clock Start/From:  
Clock To:  
1st Value:  
2nd Value:  
Value Percent:  
Continuous Index:  
Within 8" of Joint: **NO**  
Remarks: **M-808-011**

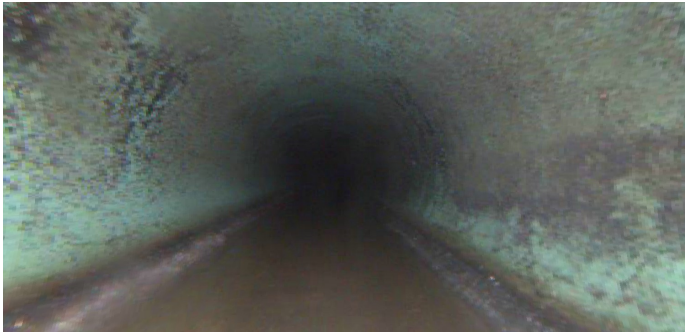
| Code: | <b>MWL</b> |
| Description: | <b>Water Level</b> |

| Distance (ft): | <b>.0</b> |
| Value Percent: | <b>5.000</b> |

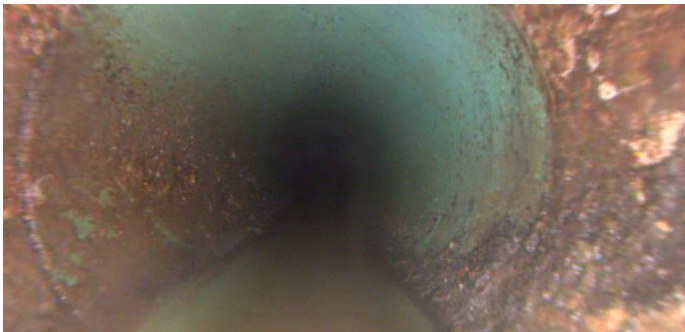
| Code: | <b>DAGS</b> |
| Description: | <b>Deposits Attached Grease</b> |

| Distance (ft): | <b>80.0</b> |
| O&M Grade: | <b>2</b> |
| Clock Start/From: | <b>8</b> |
| Clock To: | <b>4</b> |
| Value Percent: | <b>5.000</b> |

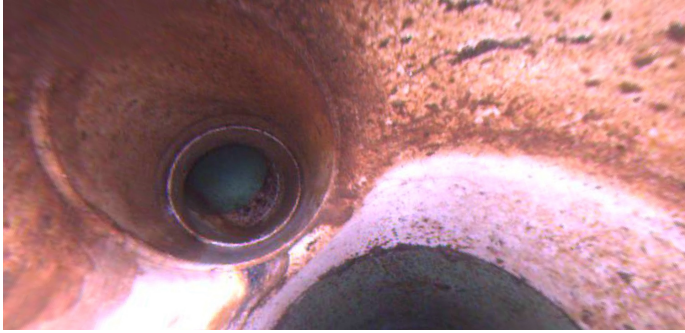
Code: **TF**  
Description: **Tap Factory**

Distance (ft): **80.4**  
Structural Grade: **0**  
O&M Grade: **0**  
Clock Start/From: **1**  
Clock To:  
1st Value: **4.000**  
2nd Value:  
Value Percent:  
Continuous Index:  
Within 8" of Joint:  
Remarks:

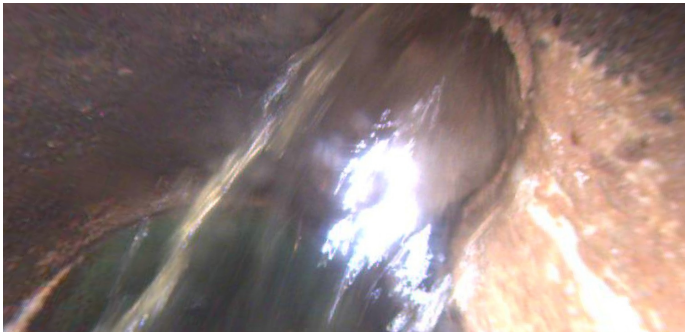
Code: **TFA**  
Description: **Tap Factory Active**

Distance (ft): **160.0**  
Structural Grade: **0**  
O&M Grade: **0**  
Clock Start/From: **1**  
Clock To:  
1st Value: **4.000**  
2nd Value:  
Value Percent:  
Continuous Index:  
Within 8" of Joint:  
Remarks:

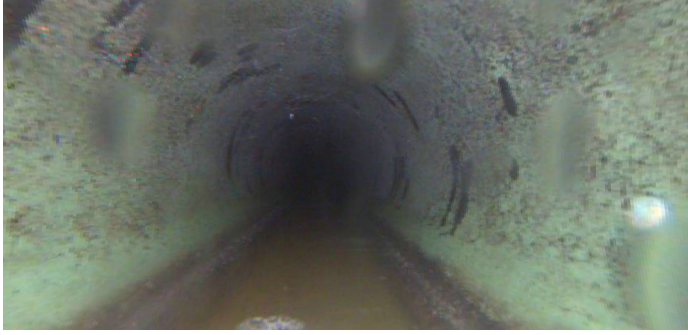
| Code: | <b>MSA</b> |
| Description: | <b>Abandoned Survey</b> |
| Distance (ft): | <b>164.1</b> |
| Remarks: | <b>camera stopped</b> |
