# Profile/Photo Observation Report

Street:	<b>CAPITOL DR &amp; INDEPENDENCE DR</b>	Flow Control:	<b>Not Controlled</b>
City:	<b>Hobart, IN</b>	Year Renewed:	
Location:	<b>Light Highway</b>	Tape/Media #:	
Purpose:	<b>Maintenance Related</b>	Dia/Height:	<b>8"</b>
Use:	<b>Sanitary</b>	Material:	<b>PVC</b>
Drain Area:	<b>NA</b>	Lining:	
Category:	<b>NA</b>		
Comment:	<b>Reverse setup. user set max at 100', flow direction incorrect.</b>		
Location Details:		Direction of Survey:	<b>Upstream</b>
US MH:	<b>M-808-011</b>	DS MH:	<b>M-808-010</b>
		Total Length Surveyed (ft):	<b>101.7</b>

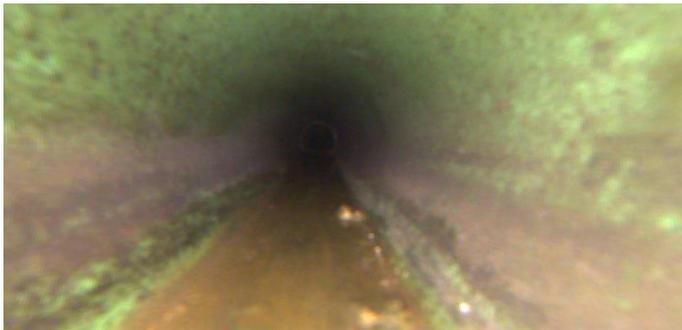
Code: **AMH**  
Description: **Manhole**

Distance (ft): **.0**  
Structural Grade: **0**  
O&M Grade: **0**  
Clock Start/From:  
Clock To:  
1st Value:  
2nd Value:  
Value Percent:  
Continuous Index:  
Within 8" of Joint: **NO**  
Remarks: **M-808-010**

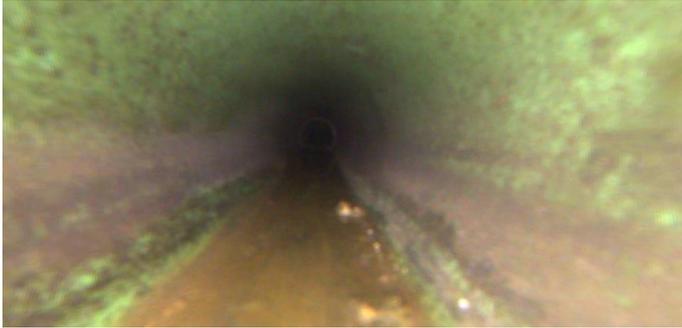
Code: **MWL**  
Description: **Water Level**

Distance (ft): **.0**  
Structural Grade: **0**  
O&M Grade: **0**  
Clock Start/From:  
Clock To:  
1st Value:  
2nd Value:  
Value Percent: **5.000**  
Continuous Index:  
Within 8" of Joint: **NO**  
Remarks:

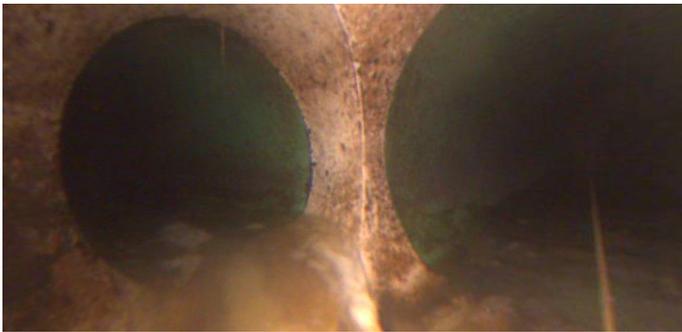
Code: **TFA**  
Description: **Tap Factory Active**

Distance (ft): **6.5**  
Structural Grade: **0**  
O&M Grade: **0**  
Clock Start/From: **3**  
Clock To:  
1st Value: **4.000**  
2nd Value:  
Value Percent:  
Continuous Index:  
Within 8" of Joint:  
Remarks:

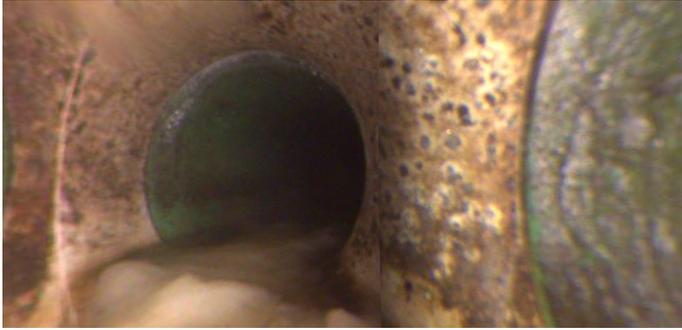
Code: **TFA**  
Description: **Tap Factory Active**

Distance (ft): **18.7**  
Structural Grade: **0**  
O&M Grade: **0**  
Clock Start/From: **9**  
Clock To:  
1st Value: **4.000**  
2nd Value:  
Value Percent:  
Continuous Index:  
Within 8" of Joint:  
Remarks:

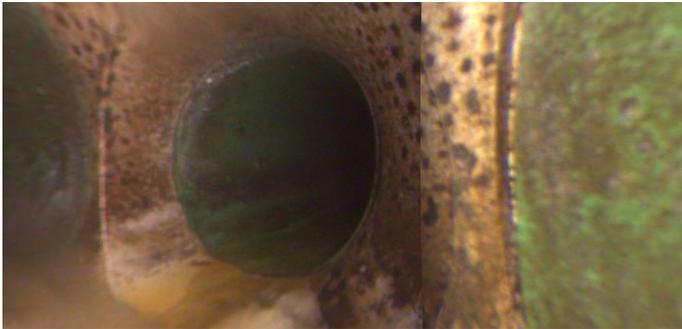
Code: **TF**  
Description: **Tap Factory**

Distance (ft): **20.5**  
Structural Grade: **0**  
O&M Grade: **0**  
Clock Start/From: **9**  
Clock To:  
1st Value: **4.000**  
2nd Value:  
Value Percent:  
Continuous Index:  
Within 8" of Joint:  
Remarks:

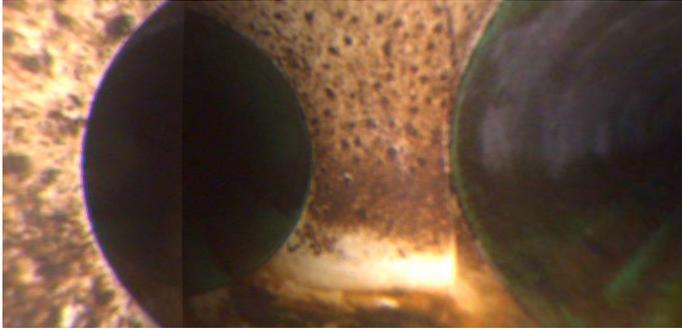
Code: **TF**  
Description: **Tap Factory**

Distance (ft): **21.7**  
Structural Grade: **0**  
O&M Grade: **0**  
Clock Start/From: **9**  
Clock To:  
1st Value: **4.000**  
2nd Value:  
Value Percent:  
Continuous Index:  
Within 8" of Joint:  
Remarks:

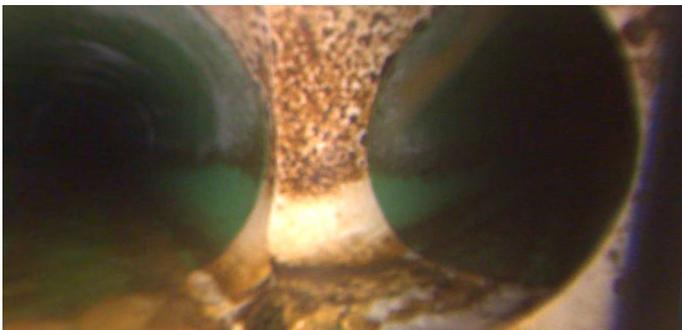
Code: **TFA**  
Description: **Tap Factory Active**

Distance (ft): **68.3**  
Structural Grade: **0**  
O&M Grade: **0**  
Clock Start/From: **3**  
Clock To:  
1st Value: **4.000**  
2nd Value:  
Value Percent:  
Continuous Index:  
Within 8" of Joint:  
Remarks:

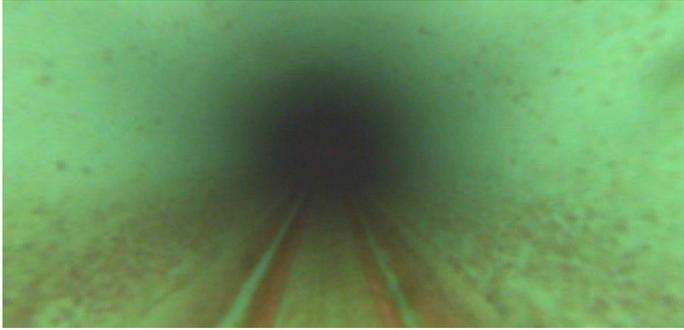
Code: **MSA**  
Description: **Abandoned Survey**

Distance (ft): **101.7**  
Structural Grade: **0**  
O&M Grade: **0**  
Clock Start/From:  
Clock To:  
1st Value:  
2nd Value:  
Value Percent:  
Continuous Index:  
Within 8" of Joint: **NO**  
Remarks: **unknown**
