## Profile/Photo Observation Report

Date:	<b>03/21/2018</b>	Weather:		Coding:	<b>PACP 6.0</b>
Pipe Length (ft):	<b>321.6</b>	Owner:	<b>NA</b>	Pre Clean:	<b>Not Known</b>
P.O.#:		Surveyor:	<b>Selasie Honu</b>	PSR:	<b>P-808-011-010</b>
Customer:		Clean Date:	<b>01/01/1900</b>	Shape:	<b>C</b>

Street:	<b>Oak</b>	Flow Control:	<b>Not Controlled</b>
City:	<b>Hobart, IN</b>	Year Renewed:	
Location:	<b>Light Highway</b>	Tape/Media #:	
Purpose:	<b>Maintenance Related</b>	Dia/Height:	<b>8"</b>
Use:	<b>Sanitary</b>	Material:	<b>PVC</b>
Drain Area:	<b>NA</b>	Lining:	
Category:	<b>NA</b>

Location Details:	Direction of Survey:	<b>Upstream</b>
US MH: <b>M-808-011</b>	DS MH: <b>M-808-010</b>	Total Length Surveyed (ft): <b>101.7</b>

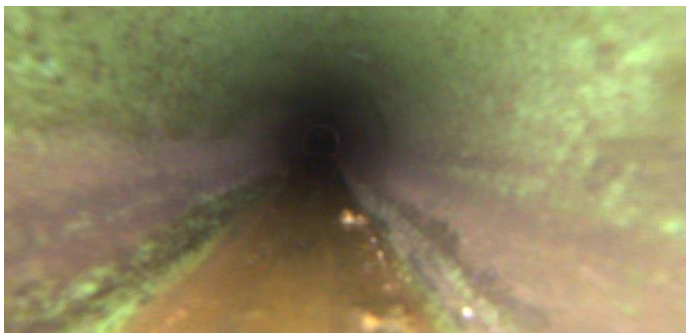
Code: **AMH**  
Description: **Manhole**

Distance (ft): **.0**  
Structural Grade: **0**  
O&M Grade: **0**  
Clock Start/From:  
Clock To:  
1st Value:  
2nd Value:  
Value Percent:  
Continuous Index:  
Within 8" of Joint: **NO**  
Remarks: **M-808-010**

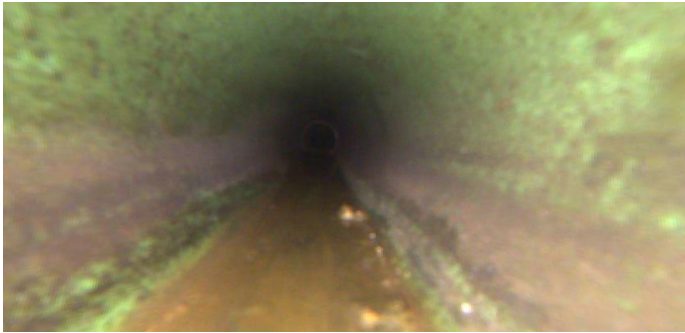
Code:	<b>MWL</b>
Description:	<b>Water Level</b>

Distance (ft):	<b>.0</b>
Structural Grade:	<b>0</b>
O&M Grade:	<b>0</b>
Clock Start/From:	
Clock To:	
1st Value:	
2nd Value:	
Value Percent:	<b>5.000</b>
Continuous Index:	
Within 8" of Joint:	<b>NO</b>
Remarks:

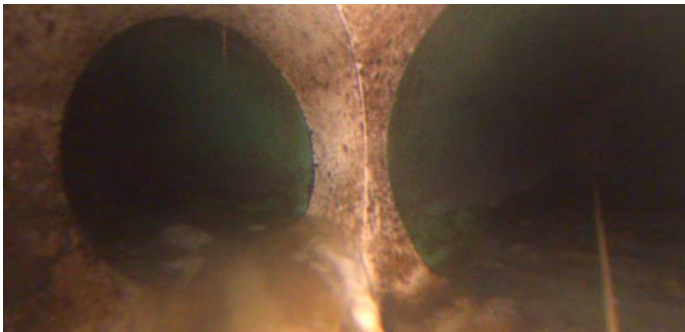
Code:	<b>TFA</b>
Description:	<b>Tap Factory Active</b>

Distance (ft):	<b>6.5</b>
Structural Grade:	<b>0</b>
O&M Grade:	<b>0</b>
Clock Start/From:	<b>3</b>
Clock To:	
1st Value:	<b>4.000</b>
2nd Value:	
Value Percent:	
Continuous Index:	
Within 8" of Joint:	
Remarks:

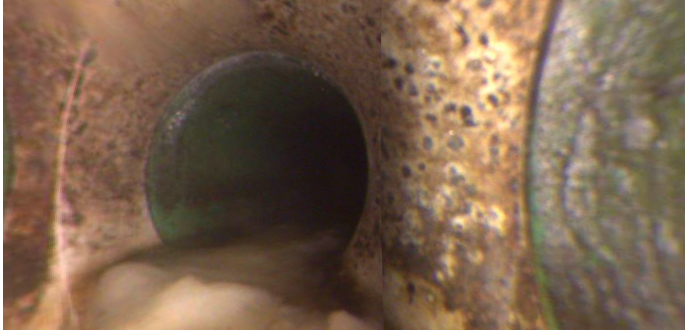
Code: **TFA**  
Description: **Tap Factory Active**

Distance (ft): **18.7**  
Structural Grade: **0**  
O&M Grade: **0**  
Clock Start/From: **9**  
Clock To:  
1st Value: **4.000**  
2nd Value:  
Value Percent:  
Continuous Index:  
Within 8" of Joint:  
Remarks:

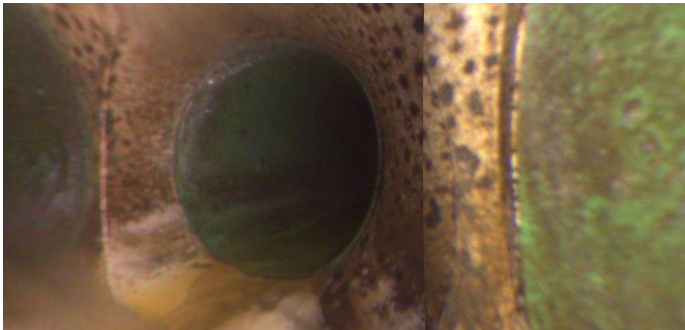
Code: **TF**  
Description: **Tap Factory**

Distance (ft): **20.5**  
Structural Grade: **0**  
O&M Grade: **0**  
Clock Start/From: **9**  
Clock To:  
1st Value: **4.000**  
2nd Value:  
Value Percent:  
Continuous Index:  
Within 8" of Joint:  
Remarks:

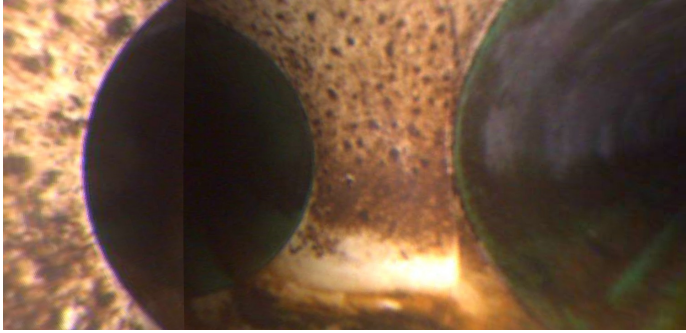
Code: **TF**  
Description: **Tap Factory**

Distance (ft): **21.7**  
Structural Grade: **0**  
O&M Grade: **0**  
Clock Start/From: **9**  
Clock To:  
1st Value: **4.000**  
2nd Value:  
Value Percent:  
Continuous Index:  
Within 8" of Joint:  
Remarks:

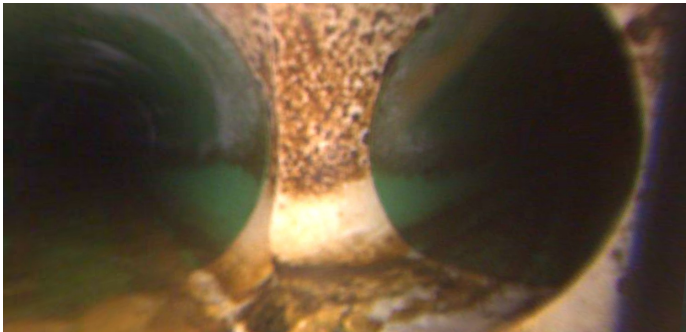
Code: **TFA**  
Description: **Tap Factory Active**

Distance (ft): **68.3**  
Structural Grade: **0**  
O&M Grade: **0**  
Clock Start/From: **3**  
Clock To:  
1st Value: **4.000**  
2nd Value:  
Value Percent:  
Continuous Index:  
Within 8" of Joint:  
Remarks:

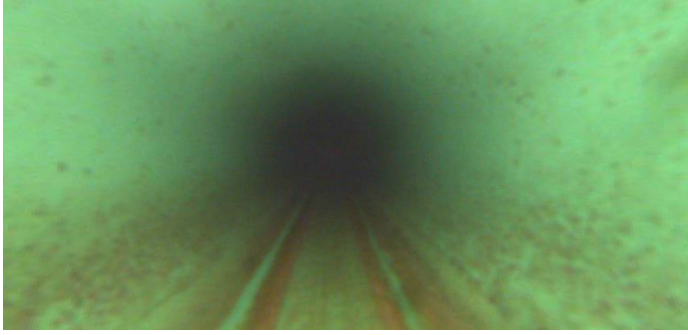
Code:	<b>MSA</b>
Description:	<b>Abandoned Survey</b>
Distance (ft):	<b>101.7</b>
Structural Grade:	<b>0</b>
O&M Grade:	<b>0</b>
Clock Start/From:	
Clock To:	
1st Value:	
2nd Value:	
Value Percent:	
Continuous Index:	
Within 8" of Joint:	<b>NO</b>
Remarks:	<b>unknown</b>
