Profile/Photo Observation Report

Date:	03/21/2018	Weather:		Coding:	PACP 6.0
Pipe Length (ft):	321.6	Owner:	NA	Pre Clean:	Not Known
P.O.#:		Surveyor:	Selasie Honu	PSR:	P-808-011-010
Customer:		Clean Date:	01/01/1900	Shape:	C

Street:	Oak	Flow Control:	Not Controlled
City:	Hobart, IN	Year Renewed:	
Location:	Light Highway	Tape/Media #:	
Purpose:	Maintenance Related	Dia/Height:	12"
Use:	Sanitary	Material:	PVC
Drain Area:	NA	Lining:	
Category:	NA		
Comment:	debris at 311'.

Location Details:		Direction of Survey:	Upstream
US MH:	M-808-011	DS MH:	M-808-010
		Total Length Surveyed (ft):	312.6

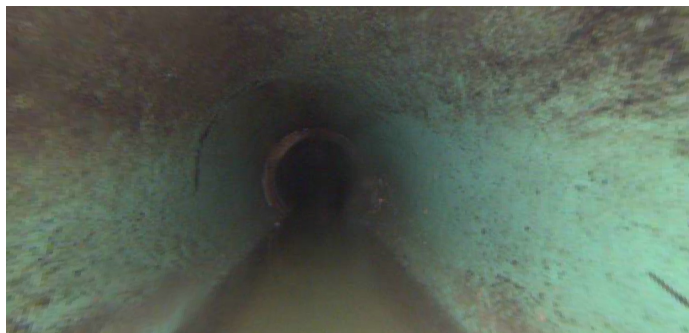
Code: **AMH**
Description: **Manhole**

Distance (ft): **.0**
Structural Grade: **0**
O&M Grade: **0**
Clock Start/From:
Clock To:
1st Value:
2nd Value:
Value Percent:
Continuous Index:
Within 8" of Joint: **NO**
Remarks: **M-808-010**

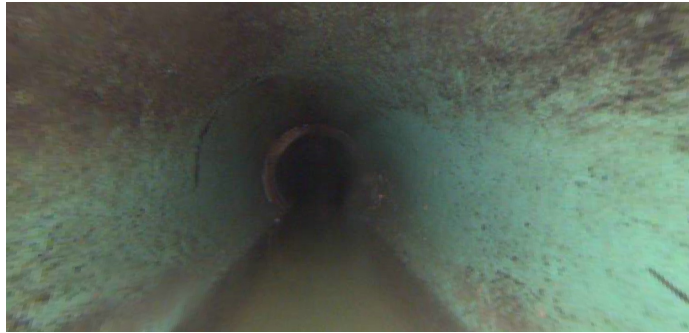
Code: **MWL**
Description: **Water Level**

Distance (ft): **.0**
Structural Grade: **0**
O&M Grade: **0**
Clock Start/From:
Clock To:
1st Value:
2nd Value:
Value Percent: **5.000**
Continuous Index:
Within 8" of Joint: **NO**
Remarks:

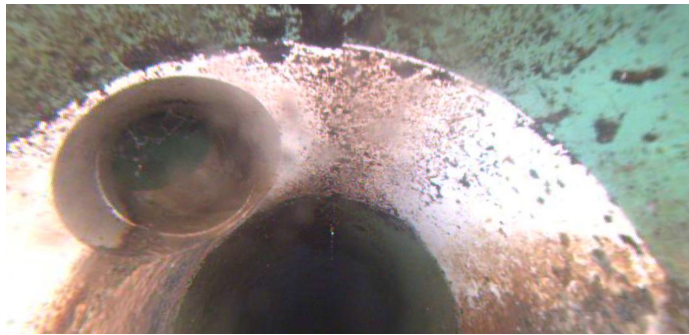
Code: **TF**
Description: **Tap Factory**

Distance (ft): **3.2**
Structural Grade: **0**
O&M Grade: **0**
Clock Start/From: **11**
Clock To:
1st Value: **4.000**
2nd Value:
Value Percent:
Continuous Index:
Within 8" of Joint:
Remarks:

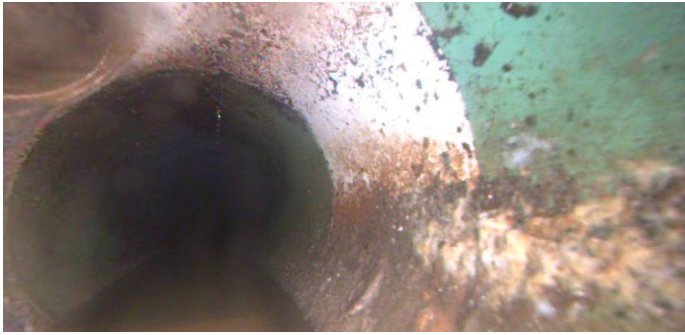
Code: **DAGS**
Description: **Deposits Attached Grease**

Distance (ft): **3.2**
Structural Grade: **0**
O&M Grade: **2**
Clock Start/From: **3**
Clock To: **4**
1st Value:
2nd Value:
Value Percent: **5.000**
Continuous Index:
Within 8" of Joint: **NO**
Remarks:

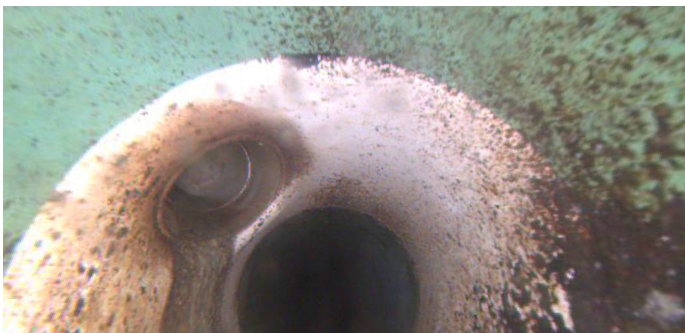
Code: **TF**
Description: **Tap Factory**

Distance (ft): **36.8**
Structural Grade: **0**
O&M Grade: **0**
Clock Start/From: **10**
Clock To:
1st Value: **4.000**
2nd Value:
Value Percent:
Continuous Index:
Within 8" of Joint:
Remarks:

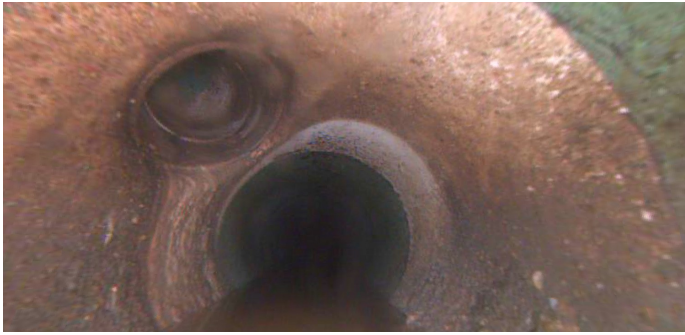
Code: **TF**
Description: **Tap Factory**

Distance (ft): **90.5**
Structural Grade: **0**
O&M Grade: **0**
Clock Start/From: **1**
Clock To:
1st Value: **4.000**
2nd Value:
Value Percent:
Continuous Index:
Within 8" of Joint:
Remarks:

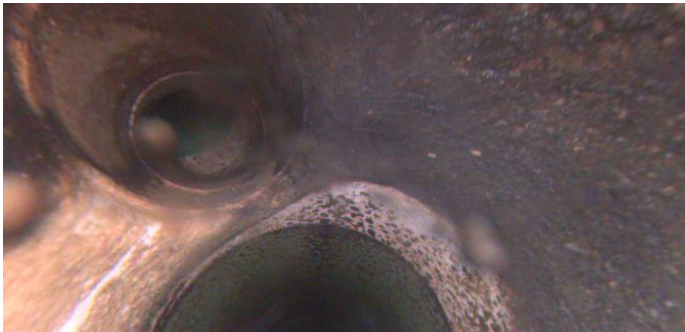
Code: **TF**
Description: **Tap Factory**

Distance (ft): **157.8**
Structural Grade: **0**
O&M Grade: **0**
Clock Start/From: **11**
Clock To:
1st Value: **4.000**
2nd Value:
Value Percent:
Continuous Index:
Within 8" of Joint:
Remarks:

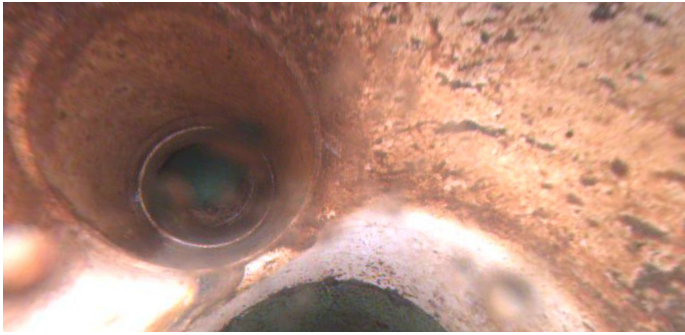
Code: **TF**
Description: **Tap Factory**

Distance (ft): **238.0**
Structural Grade: **0**
O&M Grade: **0**
Clock Start/From: **11**
Clock To:
1st Value: **4.000**
2nd Value:
Value Percent:
Continuous Index:
Within 8" of Joint:
Remarks:

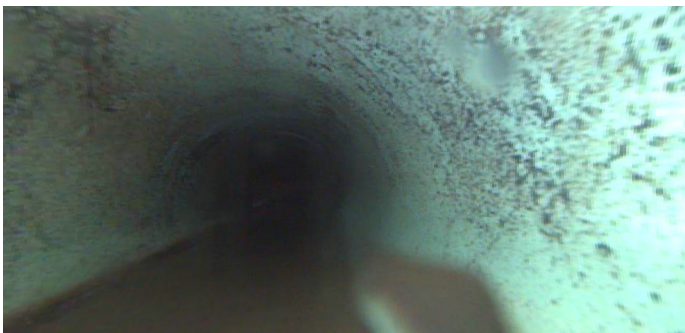
Code: **AMH**
Description: **Manhole**

Distance (ft): **312.6**
Structural Grade: **0**
O&M Grade: **0**
Clock Start/From:
Clock To:
1st Value:
2nd Value:
Value Percent:
Continuous Index:
Within 8" of Joint: **NO**
Remarks: **M-808-011**
