## Profile/Photo Observation Report

Date:	<b>03/21/2018</b>	Weather:		Coding:	<b>PACP 6.0</b>
Pipe Length (ft):	<b>330.7</b>	Owner:	<b>NA</b>	Pre Clean:	<b>Not Known</b>
P.O.#:		Surveyor:	<b>Selasie Honu</b>	PSR:	<b>P-808-021-011</b>
Customer:		Clean Date:	<b>01/01/1900</b>	Shape:	<b>C</b>

Street:	<b>INDEPENDENCE DR</b>	Flow Control:	<b>Not Controlled</b>
City:	<b>Hobart, IN</b>	Year Renewed:	
Location:	<b>Sidewalk</b>	Tape/Media #:	
Purpose:	<b>Maintenance Related</b>	Dia/Height:	<b>8"</b>
Use:	<b>Sanitary</b>	Material:	<b>PVC</b>
Drain Area:	<b>NA</b>	Lining:	
Category:	<b>NA</b>		
Comment:	<b>battery at 306'. flow direction incorrect.</b>

Location Details:		Direction of Survey:	<b>Downstream</b>
US MH:	<b>M-808-011</b>	DS MH:	<b>M-808-021</b>
		Total Length Surveyed (ft):	<b>307.9</b>

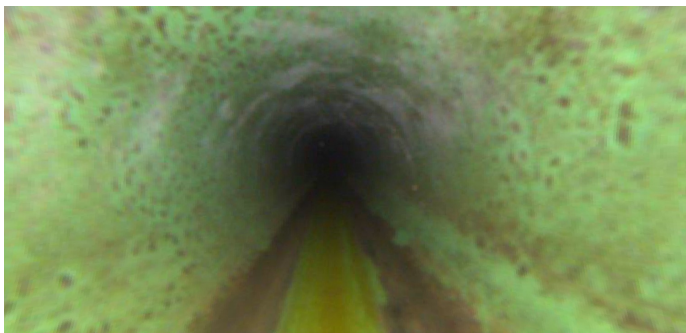
Code: **AMH**  
Description: **Manhole**

Distance (ft): **.0**  
Structural Grade: **0**  
O&M Grade: **0**  
Clock Start/From:  
Clock To:  
1st Value:  
2nd Value:  
Value Percent:  
Continuous Index:  
Within 8" of Joint: **NO**  
Remarks: **M-808-011**

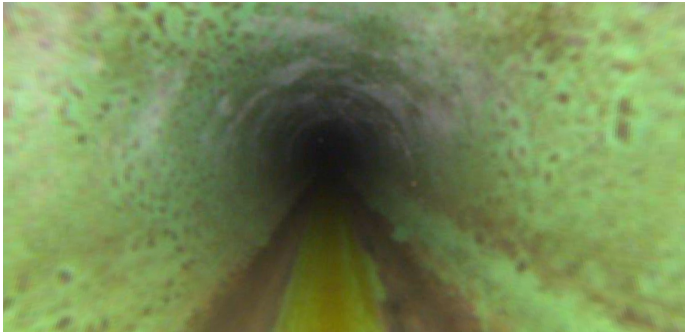
Code:	<b>MWL</b>
Description:	<b>Water Level</b>

Distance (ft):	<b>.0</b>
Structural Grade:	<b>0</b>
O&M Grade:	<b>0</b>
Clock Start/From:	
Clock To:	
1st Value:	
2nd Value:	
Value Percent:	<b>5.000</b>
Continuous Index:	
Within 8" of Joint:	<b>NO</b>
Remarks:

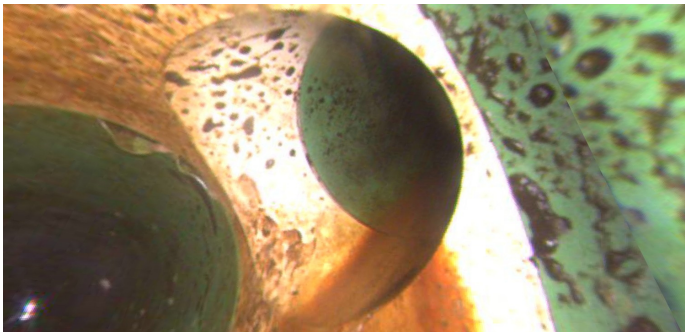
Code:	<b>TFA</b>
Description:	<b>Tap Factory Active</b>

Distance (ft):	<b>45.0</b>
Structural Grade:	<b>0</b>
O&M Grade:	<b>0</b>
Clock Start/From:	<b>10</b>
Clock To:	
1st Value:	<b>4.000</b>
2nd Value:	
Value Percent:	
Continuous Index:	
Within 8" of Joint:	
Remarks:

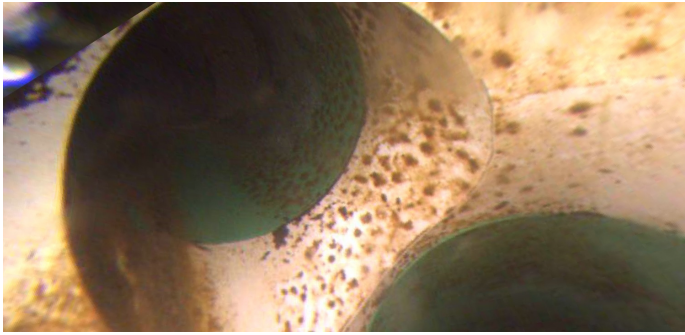
Code: **TFA**  
Description: **Tap Factory Active**

Distance (ft): **46.6**  
Structural Grade: **0**  
O&M Grade: **0**  
Clock Start/From: **2**  
Clock To:  
1st Value: **4.000**  
2nd Value:  
Value Percent:  
Continuous Index:  
Within 8" of Joint:  
Remarks:

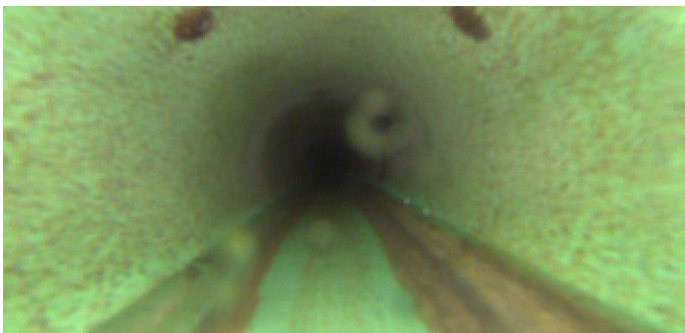
Code: **VC**  
Description: **Vermin Cockroach**

Distance (ft): **49.1**  
Structural Grade: **0**  
O&M Grade: **1**  
Clock Start/From:  
Clock To:  
1st Value:  
2nd Value:  
Value Percent:  
Continuous Index:  
Within 8" of Joint:  
Remarks: **COCKROACH**

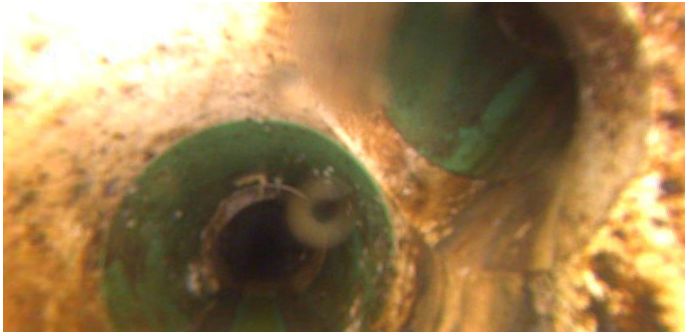
Code: **TF**  
Description: **Tap Factory**

Distance (ft): **117.4**  
Structural Grade: **0**  
O&M Grade: **0**  
Clock Start/From: **2**  
Clock To:  
1st Value: **4.000**  
2nd Value:  
Value Percent:  
Continuous Index:  
Within 8" of Joint:  
Remarks:

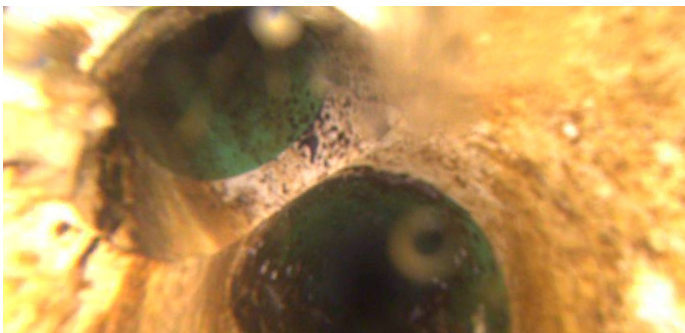
Code: **TF**  
Description: **Tap Factory**

Distance (ft): **119.0**  
Structural Grade: **0**  
O&M Grade: **0**  
Clock Start/From: **11**  
Clock To:  
1st Value: **4.000**  
2nd Value:  
Value Percent:  
Continuous Index:  
Within 8" of Joint:  
Remarks:

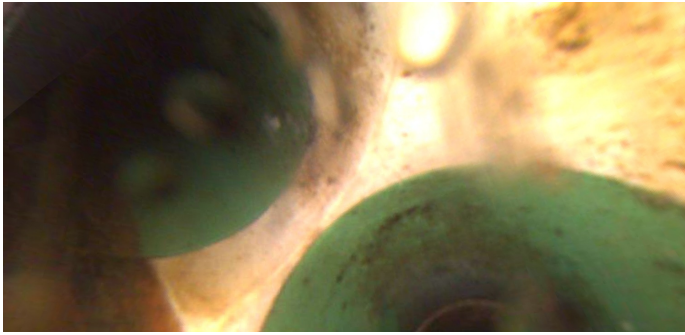
Code: **TFA**  
Description: **Tap Factory Active**

Distance (ft): **186.0**  
Structural Grade: **0**  
O&M Grade: **0**  
Clock Start/From: **10**  
Clock To:  
1st Value: **4.000**  
2nd Value:  
Value Percent:  
Continuous Index:  
Within 8" of Joint:  
Remarks:

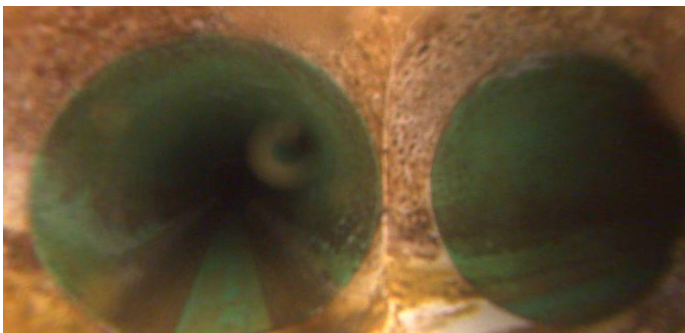
Code: **TFA**  
Description: **Tap Factory Active**

Distance (ft): **187.4**  
Structural Grade: **0**  
O&M Grade: **0**  
Clock Start/From: **3**  
Clock To:  
1st Value: **4.000**  
2nd Value:  
Value Percent:  
Continuous Index:  
Within 8" of Joint:  
Remarks:

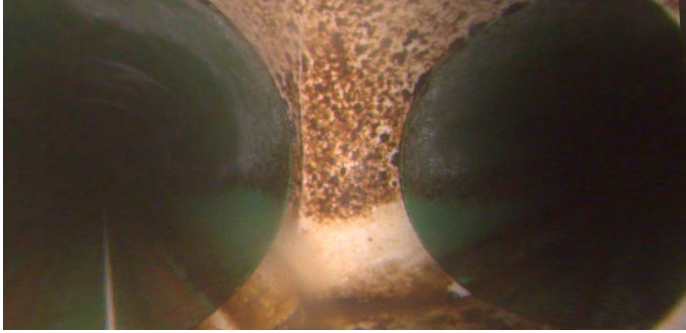
Code: **TF**  
Description: **Tap Factory**

Distance (ft): **254.7**  
Structural Grade: **0**  
O&M Grade: **0**  
Clock Start/From: **9**  
Clock To:  
1st Value: **4.000**  
2nd Value:  
Value Percent:  
Continuous Index:  
Within 8" of Joint:  
Remarks:

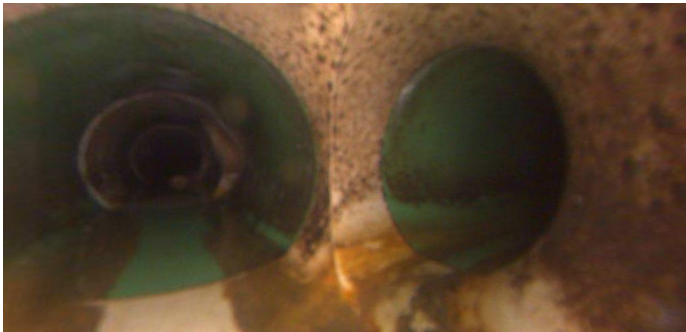
Code: **TF**  
Description: **Tap Factory**

Distance (ft): **300.9**  
Structural Grade: **0**  
O&M Grade: **0**  
Clock Start/From: **3**  
Clock To:  
1st Value: **4.000**  
2nd Value:  
Value Percent:  
Continuous Index:  
Within 8" of Joint:  
Remarks:

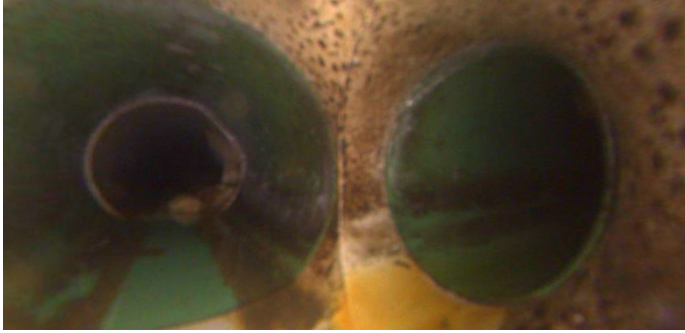
Code: **TF**  
Description: **Tap Factory**

Distance (ft): **302.5**  
Structural Grade: **0**  
O&M Grade: **0**  
Clock Start/From: **3**  
Clock To:  
1st Value: **4.000**  
2nd Value:  
Value Percent:  
Continuous Index:  
Within 8" of Joint:  
Remarks:

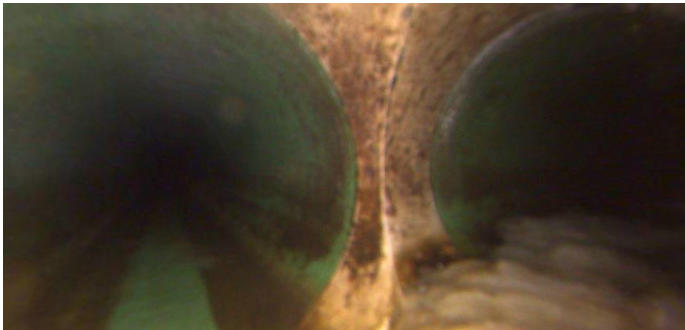
Code: **TFA**  
Description: **Tap Factory Active**

Distance (ft): **304.4**  
Structural Grade: **0**  
O&M Grade: **0**  
Clock Start/From: **3**  
Clock To:  
1st Value: **4.000**  
2nd Value:  
Value Percent:  
Continuous Index:  
Within 8" of Joint:  
Remarks:

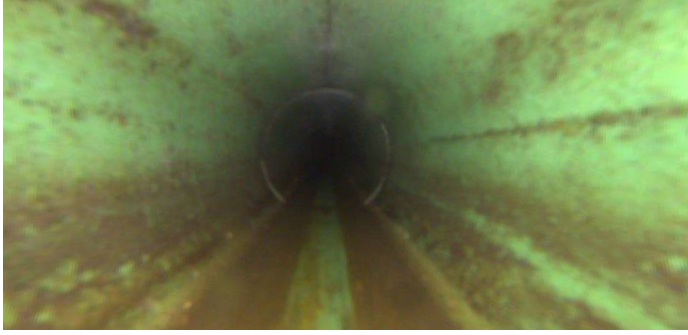
Code:	<b>MSA</b>
Description:	<b>Abandoned Survey</b>
Distance (ft):	<b>307.9</b>
Structural Grade:	<b>0</b>
O&M Grade:	<b>0</b>
Clock Start/From:	
Clock To:	
1st Value:	
2nd Value:	
Value Percent:	
Continuous Index:	
Within 8" of Joint:	<b>NO</b>
Remarks:	<b>UNKNOWN</b>
