## Profile/Photo Observation Report

Street:	<b>Oak</b>	Flow Control:	<b>Not Controlled</b>
City:	<b>Hobart, IN</b>	Year Renewed:	
Location:	<b>Sidewalk</b>	Tape/Media #:	
Purpose:	<b>Maintenance Related</b>	Dia/Height:	<b>8"</b>
Use:	<b>Sanitary</b>	Material:	<b>PVC</b>
Drain Area:	<b>NA</b>	Lining:	
Category:	<b>NA</b>		
Comment:	<b>battery at 306'. flow direction incorrect.</b>

Location Details:		Direction of Survey:	<b>Downstream</b>
US MH:	<b>M-808-011</b>	DS MH:	<b>M-808-021</b>
		Total Length Surveyed (ft):	<b>307.9</b>

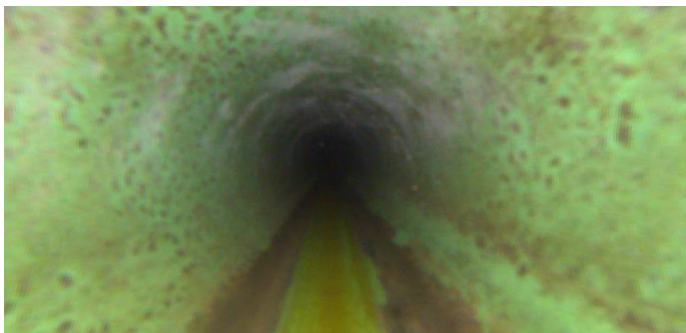
Code: **AMH**  
Description: **Manhole**

Distance (ft): **.0**  
Structural Grade: **0**  
O&M Grade: **0**  
Clock Start/From:  
Clock To:  
1st Value:  
2nd Value:  
Value Percent:  
Continuous Index:  
Within 8" of Joint: **NO**  
Remarks: **M-808-011**

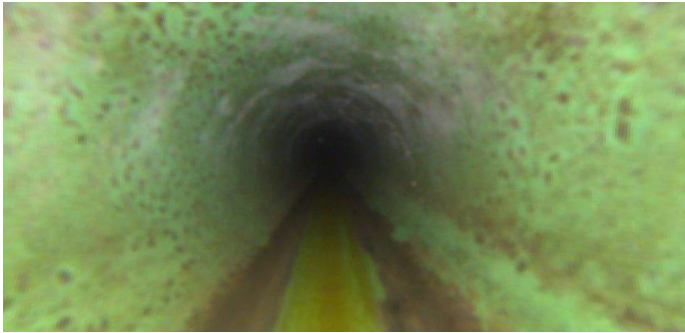
Code:	<b>MWL</b>
Description:	<b>Water Level</b>

Distance (ft):	<b>.0</b>
Structural Grade:	<b>0</b>
O&M Grade:	<b>0</b>
Clock Start/From:	
Clock To:	
1st Value:	
2nd Value:	
Value Percent:	<b>5.000</b>
Continuous Index:	
Within 8" of Joint:	<b>NO</b>
Remarks:

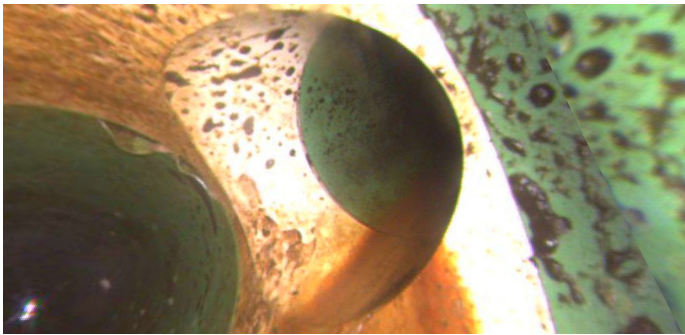
Code:	<b>TFA</b>
Description:	<b>Tap Factory Active</b>

Distance (ft):	<b>45.0</b>
Structural Grade:	<b>0</b>
O&M Grade:	<b>0</b>
Clock Start/From:	<b>10</b>
Clock To:	
1st Value:	<b>4.000</b>
2nd Value:	
Value Percent:	
Continuous Index:	
Within 8" of Joint:	
Remarks:

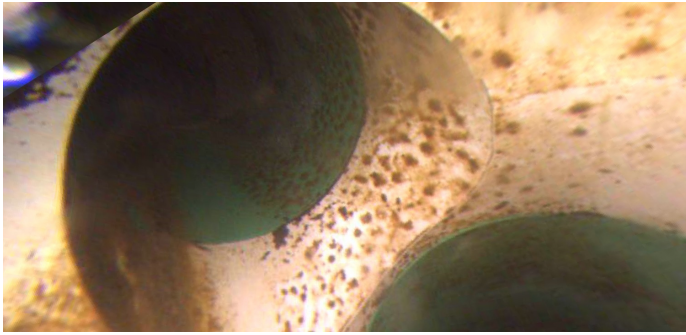
Code: **TFA**  
Description: **Tap Factory Active**

Distance (ft): **46.6**  
Structural Grade: **0**  
O&M Grade: **0**  
Clock Start/From: **2**  
Clock To:  
1st Value: **4.000**  
2nd Value:  
Value Percent:  
Continuous Index:  
Within 8" of Joint:  
Remarks:

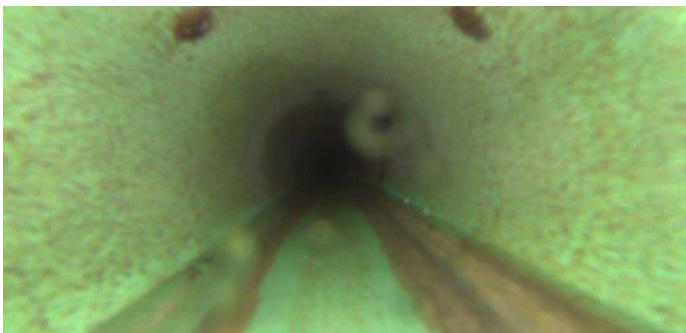
Code: **VC**  
Description: **Vermin Cockroach**

Distance (ft): **49.1**  
Structural Grade: **0**  
O&M Grade: **1**  
Clock Start/From:  
Clock To:  
1st Value:  
2nd Value:  
Value Percent:  
Continuous Index:  
Within 8" of Joint:  
Remarks: **COCKROACH**

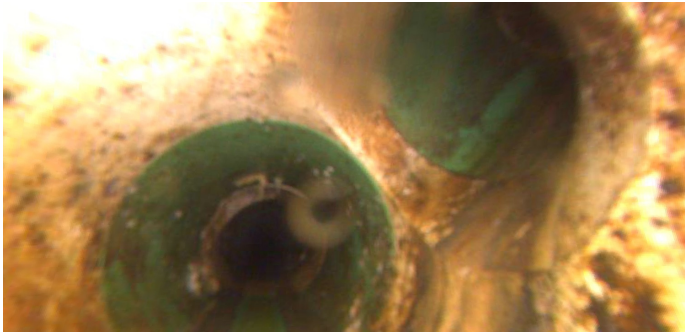
Code: **TF**  
Description: **Tap Factory**

Distance (ft): **117.4**  
Structural Grade: **0**  
O&M Grade: **0**  
Clock Start/From: **2**  
Clock To:  
1st Value: **4.000**  
2nd Value:  
Value Percent:  
Continuous Index:  
Within 8" of Joint:  
Remarks:

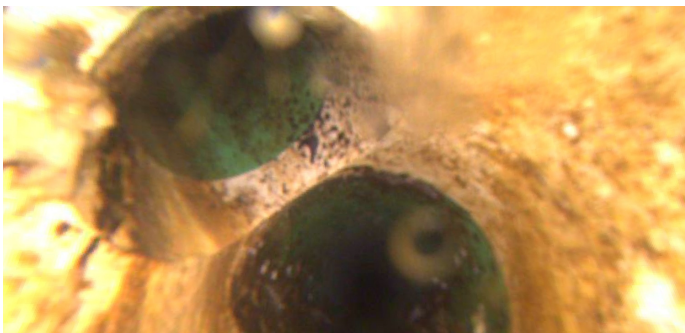
Code: **TF**  
Description: **Tap Factory**

Distance (ft): **119.0**  
Structural Grade: **0**  
O&M Grade: **0**  
Clock Start/From: **11**  
Clock To:  
1st Value: **4.000**  
2nd Value:  
Value Percent:  
Continuous Index:  
Within 8" of Joint:  
Remarks:

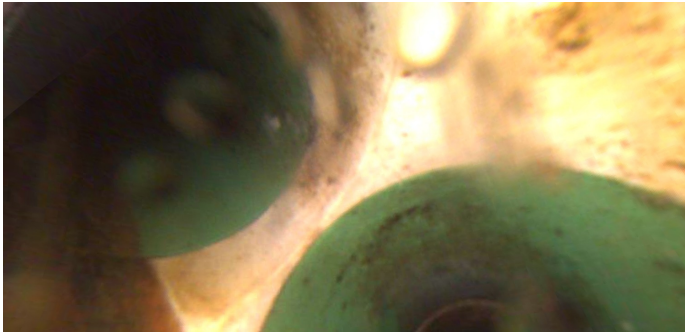
Code: **TFA**  
Description: **Tap Factory Active**

Distance (ft): **186.0**  
Structural Grade: **0**  
O&M Grade: **0**  
Clock Start/From: **10**  
Clock To:  
1st Value: **4.000**  
2nd Value:  
Value Percent:  
Continuous Index:  
Within 8" of Joint:  
Remarks:

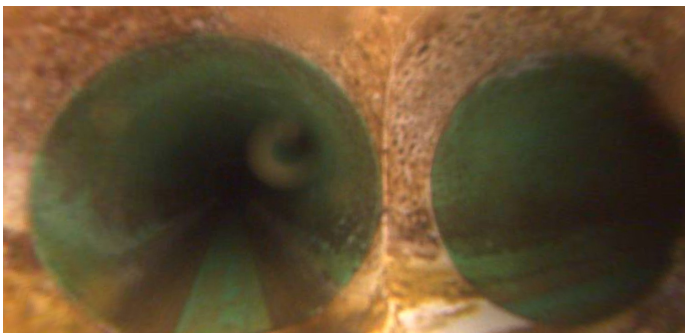
Code: **TFA**  
Description: **Tap Factory Active**

Distance (ft): **187.4**  
Structural Grade: **0**  
O&M Grade: **0**  
Clock Start/From: **3**  
Clock To:  
1st Value: **4.000**  
2nd Value:  
Value Percent:  
Continuous Index:  
Within 8" of Joint:  
Remarks:

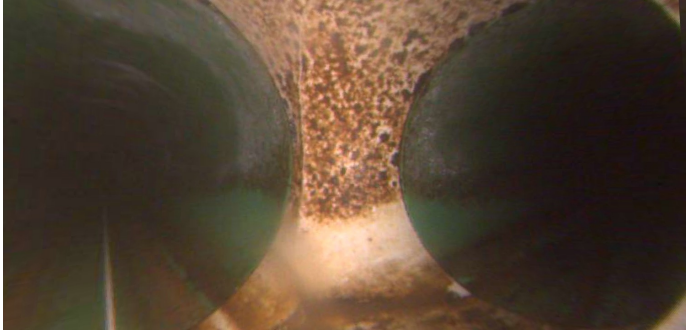
Code: **TF**  
Description: **Tap Factory**

Distance (ft): **254.7**  
Structural Grade: **0**  
O&M Grade: **0**  
Clock Start/From: **9**  
Clock To:  
1st Value: **4.000**  
2nd Value:  
Value Percent:  
Continuous Index:  
Within 8" of Joint:  
Remarks:

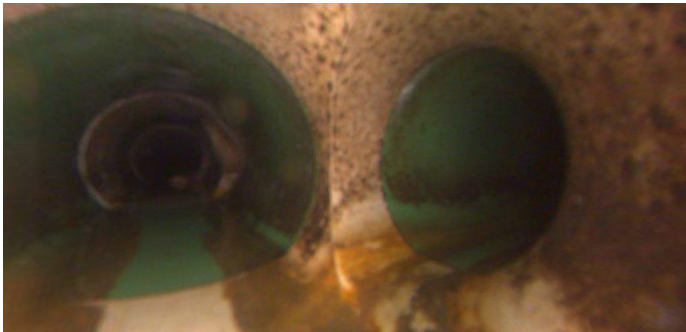
Code: **TF**  
Description: **Tap Factory**

Distance (ft): **300.9**  
Structural Grade: **0**  
O&M Grade: **0**  
Clock Start/From: **3**  
Clock To:  
1st Value: **4.000**  
2nd Value:  
Value Percent:  
Continuous Index:  
Within 8" of Joint:  
Remarks:

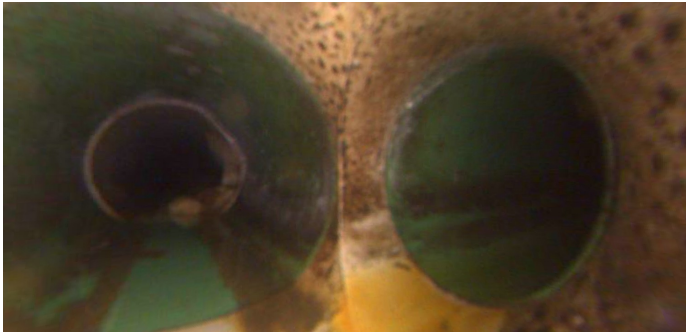
Code: **TF**  
Description: **Tap Factory**

Distance (ft): **302.5**  
Structural Grade: **0**  
O&M Grade: **0**  
Clock Start/From: **3**  
Clock To:  
1st Value: **4.000**  
2nd Value:  
Value Percent:  
Continuous Index:  
Within 8" of Joint:  
Remarks:

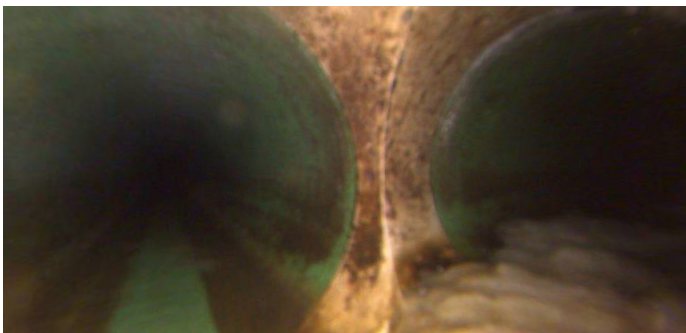
Code: **TFA**  
Description: **Tap Factory Active**

Distance (ft): **304.4**  
Structural Grade: **0**  
O&M Grade: **0**  
Clock Start/From: **3**  
Clock To:  
1st Value: **4.000**  
2nd Value:  
Value Percent:  
Continuous Index:  
Within 8" of Joint:  
Remarks:

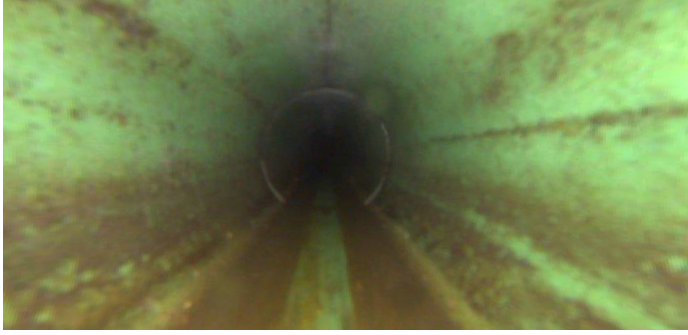
Code:	<b>MSA</b>
Description:	<b>Abandoned Survey</b>
Distance (ft):	<b>307.9</b>
Structural Grade:	<b>0</b>
O&M Grade:	<b>0</b>
Clock Start/From:	
Clock To:	
1st Value:	
2nd Value:	
Value Percent:	
Continuous Index:	
Within 8" of Joint:	<b>NO</b>
Remarks:	<b>UNKNOWN</b>
