Profile/Photo Observation Report

Street:	Liberty Street	Flow Control:	
City:	Hobart, IN	Year Renewed:	
Location:	Light Highway	Tape/Media #:	960
Purpose:	Routine Assessment	Dia/Height:	8"
Use:	Sanitary	Material:	PVC
Drain Area:		Lining:	
Category:	NA		
Comment:

Location Details:		Direction of Survey:	Upstream
US MH:	M-808-14	DS MH:	M-808-18
		Total Length Surveyed (ft):	84.0

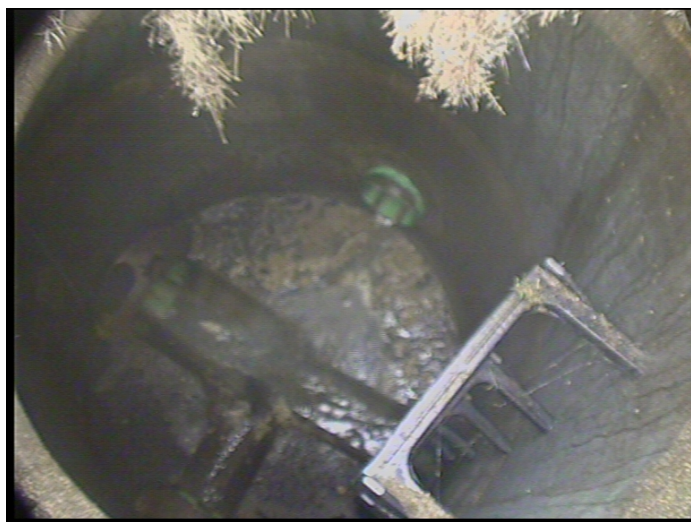
Code: **AMH**
Description: **Manhole**

Distance (ft): **.0**
Structural Grade: **0**
O&M Grade: **0**
Clock Start/From:
Clock To:
1st Value:
2nd Value:
Value Percent:
Continuous Index:
Within 8" of Joint: **NO**
Remarks: **M-808-18**

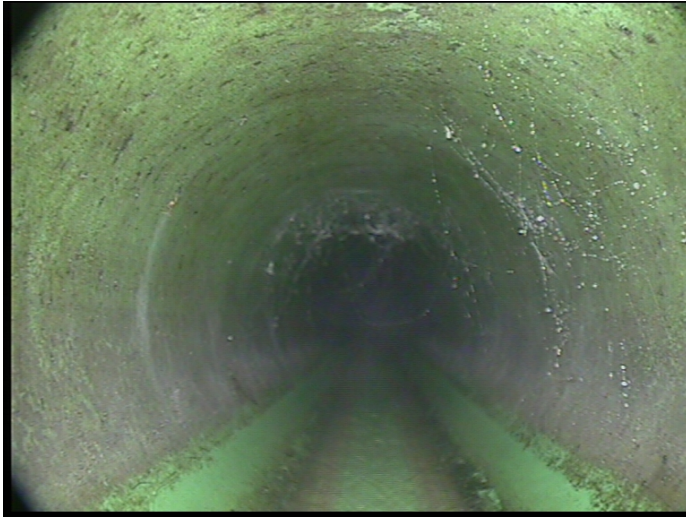
Code:	MWL
Description:	Water Level
Distance (ft):	.0
Structural Grade:	0
O&M Grade:	0
Clock Start/From:	
Clock To:	
1st Value:	
2nd Value:	
Value Percent:	5.000
Continuous Index:	
Within 8" of Joint:	NO
Remarks:

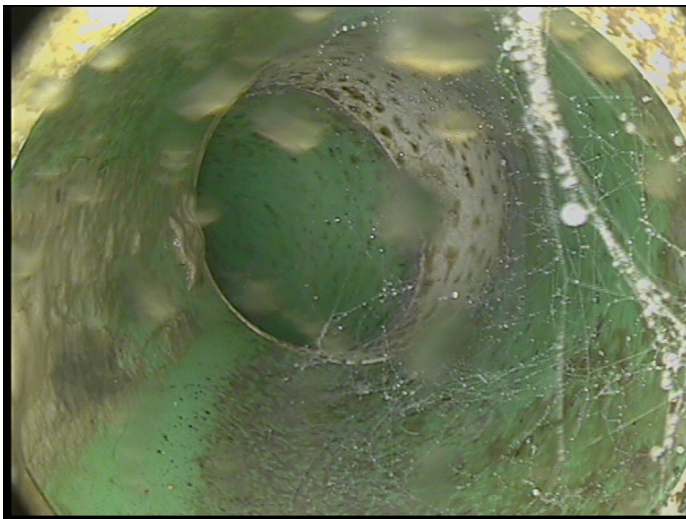
Code:	TF
Description:	Tap Factory
Distance (ft):	72.1
Structural Grade:	0
O&M Grade:	0
Clock Start/From:	10
Clock To:	
1st Value:	4.000
2nd Value:	
Value Percent:	
Continuous Index:	
Within 8" of Joint:	NO
Remarks:

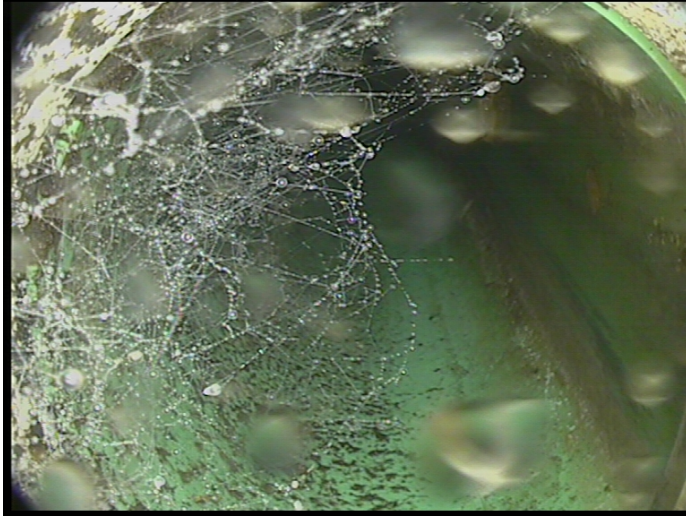
Code: **TF**
Description: **Tap Factory**

Distance (ft): **83.9**
Structural Grade: **0**
O&M Grade: **0**
Clock Start/From: **3**
Clock To:
1st Value: **4.000**
2nd Value:
Value Percent:
Continuous Index:
Within 8" of Joint: **NO**
Remarks:

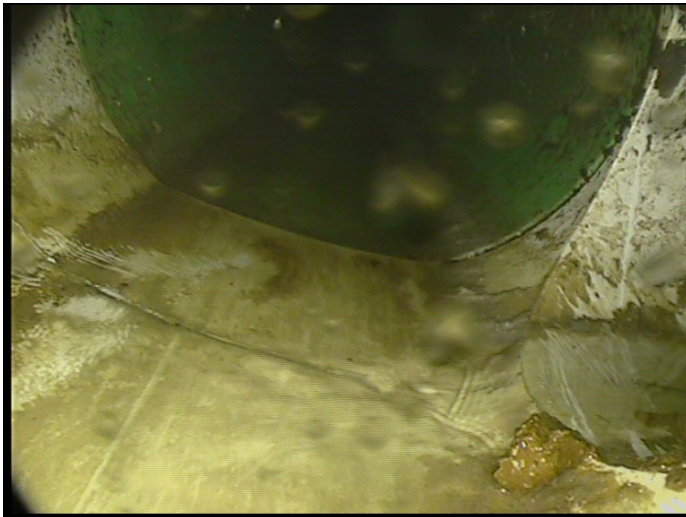
Code: **MSA**
Description: **Abandoned Survey**

Distance (ft): **84.0**
Structural Grade: **0**
O&M Grade: **0**
Clock Start/From:
Clock To:
1st Value:
2nd Value:
Value Percent:
Continuous Index:
Within 8" of Joint: **NO**
Remarks: **Wheels can not pass lateral due to it being low in the pipe**
