## Profile/Photo Observation Report

Street:	<b>LIBERTY ST</b>	Flow Control:	<b>Not Controlled</b>
City:	<b>Hobart, IN</b>	Year Renewed:	
Location:	<b>Light Highway</b>	Tape/Media #:	
Purpose:	<b>Maintenance Related</b>	Dia/Height:	<b>8"</b>
Use:	<b>Sanitary</b>	Material:	<b>PVC</b>
Drain Area:	<b>NA</b>	Lining:	
Category:	<b>NA</b>		
Comment:

Location Details:		Direction of Survey:	<b>Downstream</b>
US MH:	<b>M-808-016</b>	DS MH:	<b>M-808-017</b>
		Total Length Surveyed (ft):	<b>153.1</b>

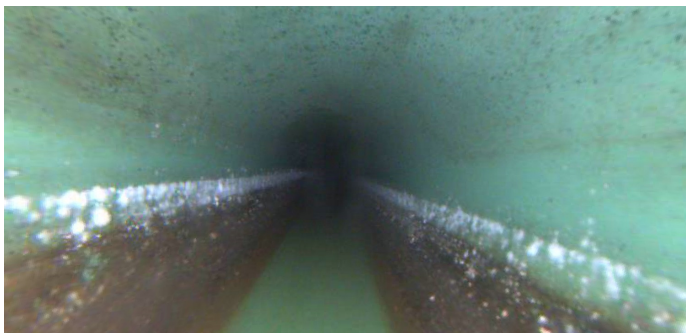
Code: **DAGS**  
Description: **Deposits Attached Grease**

Distance (ft): **.0**  
Structural Grade: **0**  
O&M Grade: **2**  
Clock Start/From: **8**  
Clock To: **4**  
1st Value:  
2nd Value:  
Value Percent: **5.000**  
Continuous Index: **S01**  
Within 8" of Joint: **NO**  
Remarks:

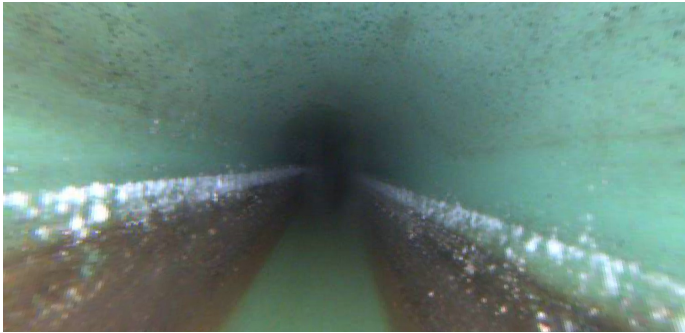
Code:	<b>AMH</b>
Description:	<b>Manhole</b>

Distance (ft):	<b>.0</b>
Structural Grade:	<b>0</b>
O&M Grade:	<b>0</b>
Clock Start/From:	
Clock To:	
1st Value:	
2nd Value:	
Value Percent:	
Continuous Index:	
Within 8" of Joint:	<b>NO</b>
Remarks:	<b>M-808-016</b>

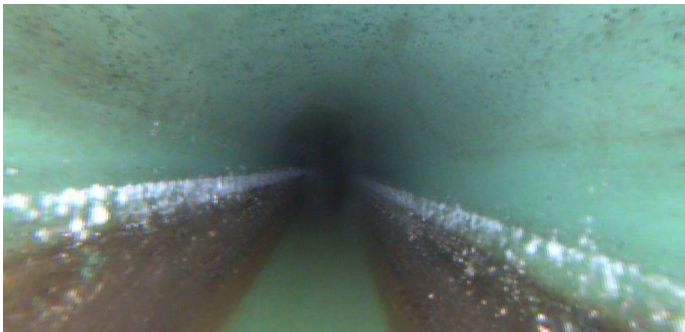
Code:	<b>MWL</b>
Description:	<b>Water Level</b>

Distance (ft):	<b>.0</b>
Structural Grade:	<b>0</b>
O&M Grade:	<b>0</b>
Clock Start/From:	
Clock To:	
1st Value:	
2nd Value:	
Value Percent:	<b>5.000</b>
Continuous Index:	
Within 8" of Joint:	<b>NO</b>
Remarks:

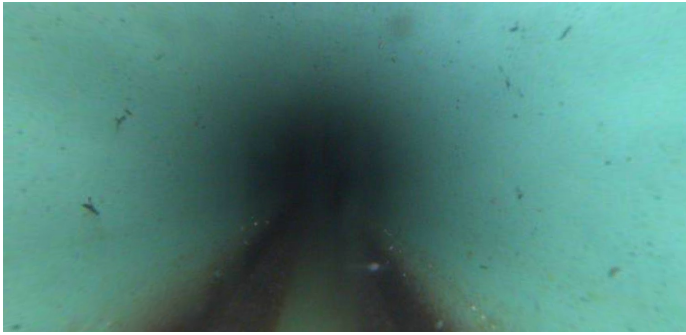
Code: **DAGS**  
Description: **Deposits Attached Grease**

Distance (ft): **41.1**  
Structural Grade: **0**  
O&M Grade: **2**  
Clock Start/From: **8**  
Clock To: **4**  
1st Value:  
2nd Value:  
Value Percent: **5.000**  
Continuous Index: **F01**  
Within 8" of Joint: **NO**  
Remarks:

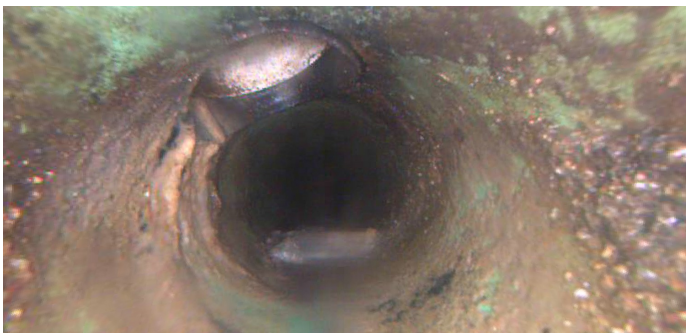
Code: **DAGS**  
Description: **Deposits Attached Grease**

Distance (ft): **145.3**  
Structural Grade: **0**  
O&M Grade: **2**  
Clock Start/From: **8**  
Clock To: **4**  
1st Value:  
2nd Value:  
Value Percent: **5.000**  
Continuous Index:  
Within 8" of Joint: **NO**  
Remarks:

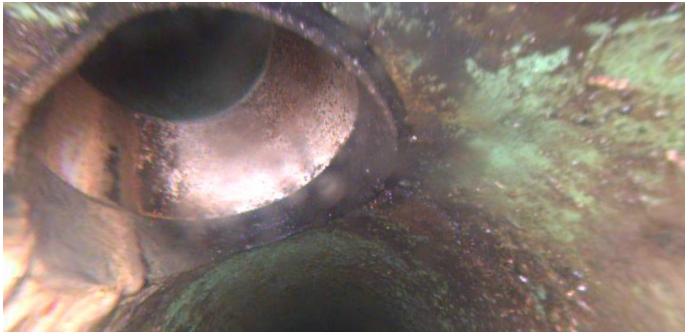
Code: **TBA**  
Description: **Tap Break-in Active**

Distance (ft): **145.7**  
Structural Grade: **0**  
O&M Grade: **0**  
Clock Start/From: **11**  
Clock To:  
1st Value: **4.000**  
2nd Value:  
Value Percent:  
Continuous Index:  
Within 8" of Joint:  
Remarks:

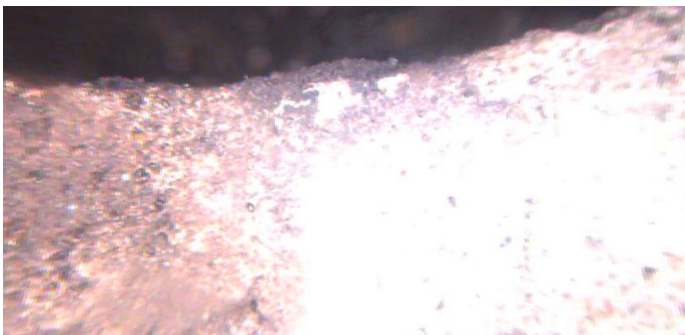
Code: **AMH**  
Description: **Manhole**

Distance (ft): **153.1**  
Structural Grade: **0**  
O&M Grade: **0**  
Clock Start/From:  
Clock To:  
1st Value:  
2nd Value:  
Value Percent:  
Continuous Index:  
Within 8" of Joint: **NO**  
Remarks: **M-808-017**
