Profile/Photo Observation Report

Date:	03/22/2018	Weather:		Coding:	PACP 6.0
Pipe Length (ft):	151.4	Owner:	NA	Pre Clean:	Not Known
P.O.#:		Surveyor:	Selasie Honu	PSR:	P-808-017-016
Customer:		Clean Date:	01/01/1900	Shape:	C

Street:	Oak	Flow Control:	Not Controlled
City:	Hobart, IN	Year Renewed:	
Location:	Light Highway	Tape/Media #:	
Purpose:	Maintenance Related	Dia/Height:	8"
Use:	Sanitary	Material:	PVC
Drain Area:	NA	Lining:	
Category:	NA		
Comment:

Location Details:		Direction of Survey:	Downstream
US MH:	M-808-016	DS MH:	M-808-017
		Total Length Surveyed (ft):	153.1

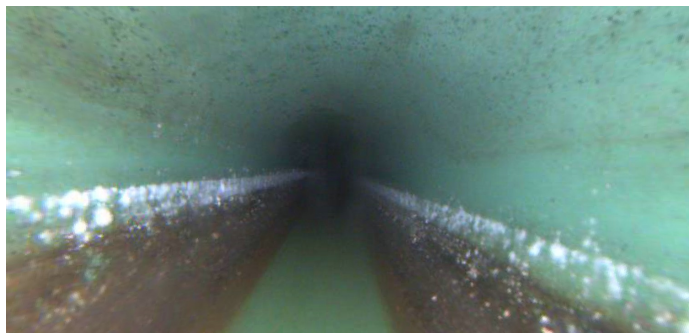
Code: **DAGS**
Description: **Deposits Attached Grease**

Distance (ft): **.0**
Structural Grade: **0**
O&M Grade: **2**
Clock Start/From: **8**
Clock To: **4**
1st Value:
2nd Value:
Value Percent: **5.000**
Continuous Index: **S01**
Within 8" of Joint: **NO**
Remarks:

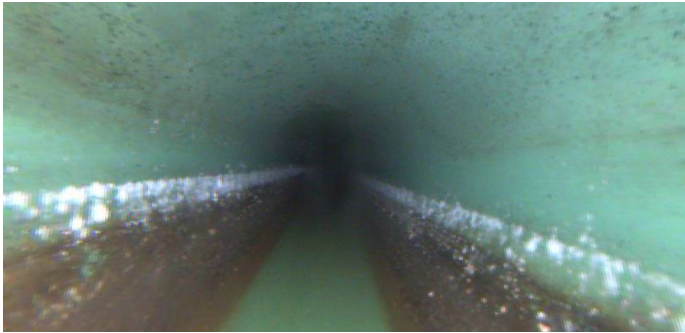
Code:	AMH
Description:	Manhole

Distance (ft):	.0
Structural Grade:	0
O&M Grade:	0
Clock Start/From:	
Clock To:	
1st Value:	
2nd Value:	
Value Percent:	
Continuous Index:	
Within 8" of Joint:	NO
Remarks:	M-808-016

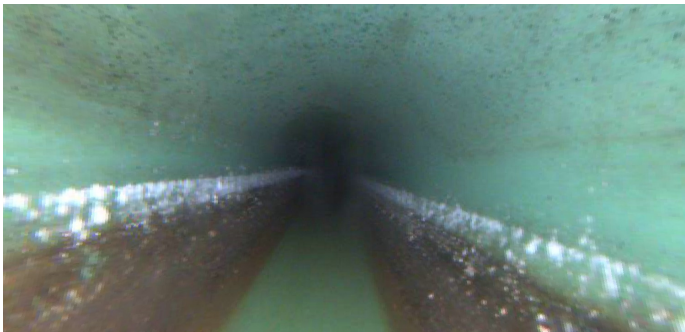
Code:	MWL
Description:	Water Level

Distance (ft):	.0
Structural Grade:	0
O&M Grade:	0
Clock Start/From:	
Clock To:	
1st Value:	
2nd Value:	
Value Percent:	5.000
Continuous Index:	
Within 8" of Joint:	NO
Remarks:

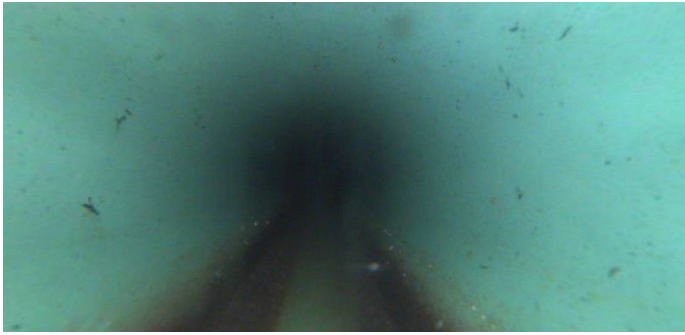
Code: **DAGS**
Description: **Deposits Attached Grease**

Distance (ft): **41.1**
Structural Grade: **0**
O&M Grade: **2**
Clock Start/From: **8**
Clock To: **4**
1st Value:
2nd Value:
Value Percent: **5.000**
Continuous Index: **F01**
Within 8" of Joint: **NO**
Remarks:

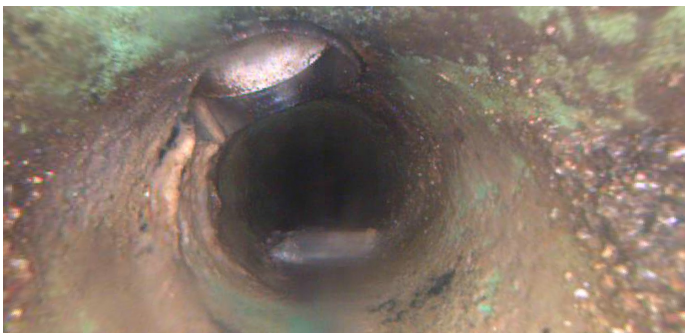
Code: **DAGS**
Description: **Deposits Attached Grease**

Distance (ft): **145.3**
Structural Grade: **0**
O&M Grade: **2**
Clock Start/From: **8**
Clock To: **4**
1st Value:
2nd Value:
Value Percent: **5.000**
Continuous Index:
Within 8" of Joint: **NO**
Remarks:

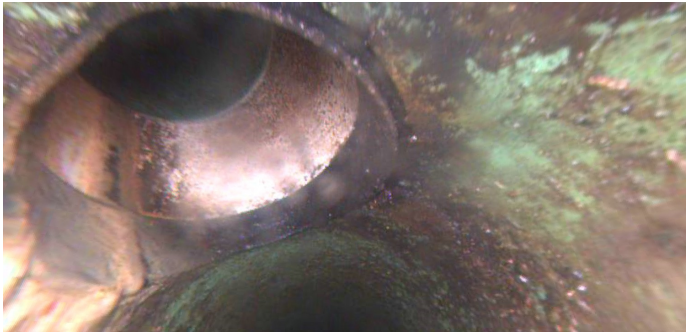
Code: **TBA**
Description: **Tap Break-in Active**

Distance (ft): **145.7**
Structural Grade: **0**
O&M Grade: **0**
Clock Start/From: **11**
Clock To:
1st Value: **4.000**
2nd Value:
Value Percent:
Continuous Index:
Within 8" of Joint:
Remarks:

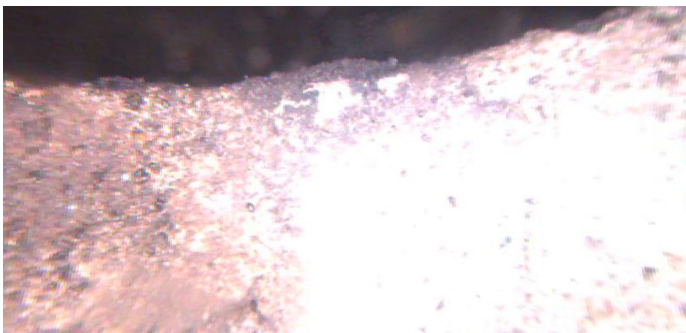
Code: **AMH**
Description: **Manhole**

Distance (ft): **153.1**
Structural Grade: **0**
O&M Grade: **0**
Clock Start/From:
Clock To:
1st Value:
2nd Value:
Value Percent:
Continuous Index:
Within 8" of Joint: **NO**
Remarks: **M-808-017**
