## Profile/Photo Observation Report

Street:	<b>LIBERTY ST</b>	Flow Control:	<b>Not Controlled</b>
City:	<b>Hobart, IN</b>	Year Renewed:	
Location:	<b>Sidewalk</b>	Tape/Media #:	
Purpose:	<b>Maintenance Related</b>	Dia/Height:	<b>8"</b>
Use:	<b>Sanitary</b>	Material:	<b>PVC</b>
Drain Area:	<b>NA</b>	Lining:	
Category:	<b>NA</b>		
Comment:	<b>flow incorrect.</b>

Location Details:		Direction of Survey:	<b>Downstream</b>
US MH:	<b>M-808-019</b>	DS MH:	<b>M-808-020</b>
		Total Length Surveyed (ft):	<b>98.5</b>

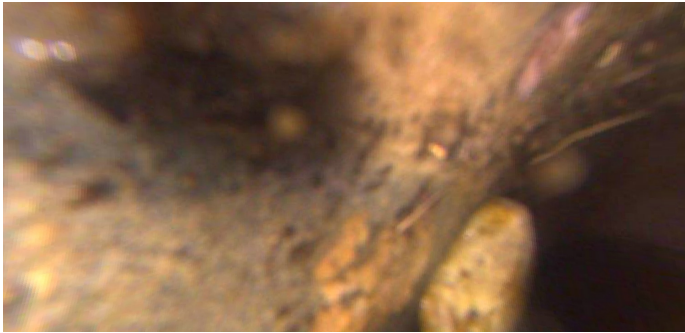
Code:	<b>MWL</b>
Description:	<b>Water Level</b>

Distance (ft):	<b>.0</b>
Structural Grade:	<b>0</b>
O&M Grade:	<b>0</b>
Clock Start/From:	
Clock To:	
1st Value:	
2nd Value:	
Value Percent:	<b>5.000</b>
Continuous Index:	
Within 8" of Joint:	<b>NO</b>
Remarks:

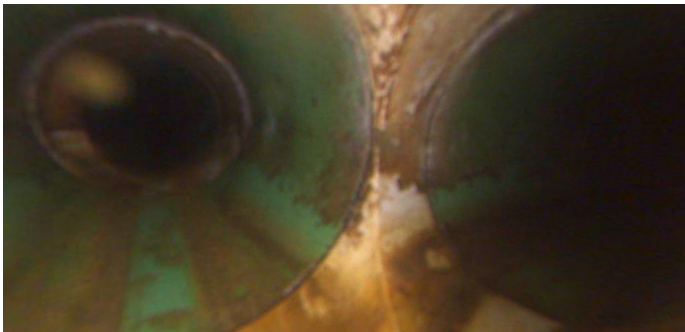
Code:	<b>TFA</b>
Description:	<b>Tap Factory Active</b>

Distance (ft):	<b>54.2</b>
Structural Grade:	<b>0</b>
O&M Grade:	<b>0</b>
Clock Start/From:	<b>3</b>
Clock To:	
1st Value:	<b>4.000</b>
2nd Value:	
Value Percent:	
Continuous Index:	
Within 8" of Joint:	
Remarks:

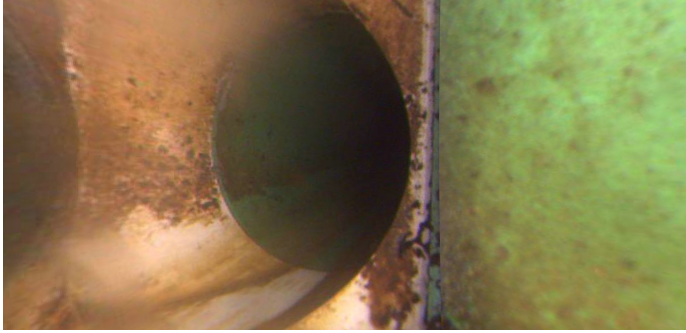
Code: **TFA**  
Description: **Tap Factory Active**

Distance (ft): **56.2**  
Structural Grade: **0**  
O&M Grade: **0**  
Clock Start/From: **9**  
Clock To:  
1st Value: **4.000**  
2nd Value:  
Value Percent:  
Continuous Index:  
Within 8" of Joint:  
Remarks:

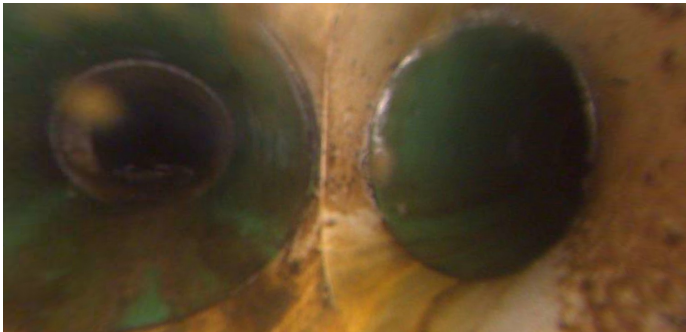
Code: **TF**  
Description: **Tap Factory**

Distance (ft): **89.6**  
Structural Grade: **0**  
O&M Grade: **0**  
Clock Start/From: **3**  
Clock To:  
1st Value: **4.000**  
2nd Value:  
Value Percent:  
Continuous Index:  
Within 8" of Joint:  
Remarks:

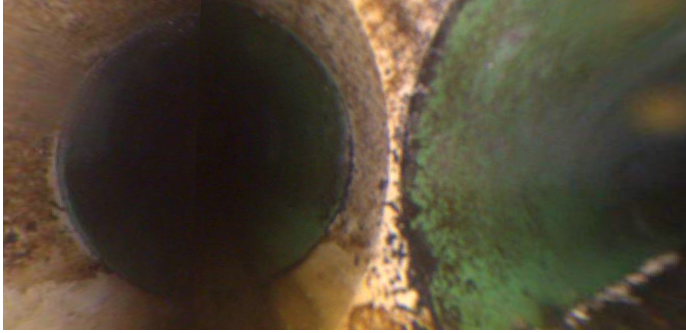
Code: **TF**  
Description: **Tap Factory**

Distance (ft): **91.5**  
Structural Grade: **0**  
O&M Grade: **0**  
Clock Start/From: **9**  
Clock To:  
1st Value: **4.000**  
2nd Value:  
Value Percent:  
Continuous Index:  
Within 8" of Joint:  
Remarks:
