Profile/Photo Observation Report

Street:	UNION CT	Flow Control:	Not Controlled
City:	Hobart, IN	Year Renewed:	
Location:	Light Highway	Tape/Media #:	
Purpose:	Maintenance Related	Dia/Height:	8"
Use:	Sanitary	Material:	PVC
Drain Area:	NA	Lining:	Cured in Place
Category:	NA		
Comment:	Flow direction wrong. Reverse setup.		
Location Details:		Direction of Survey:	Downstream
US MH:	M-808-023	DS MH:	M-808-024
		Total Length Surveyed (ft):	202.9

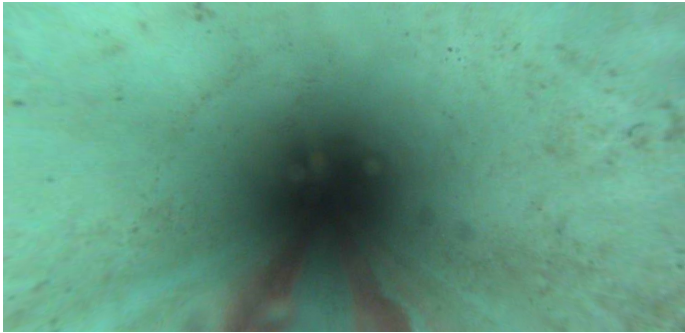
Code:	MWL
Description:	Water Level

Distance (ft):	.0
Structural Grade:	0
O&M Grade:	0
Clock Start/From:	
Clock To:	
1st Value:	
2nd Value:	
Value Percent:	5.000
Continuous Index:	
Within 8" of Joint:	NO
Remarks:

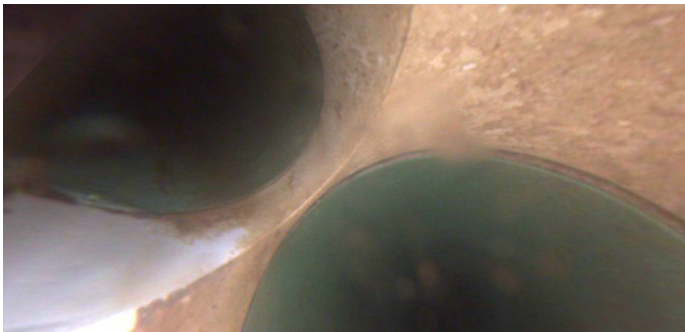
Code:	TF
Description:	Tap Factory

Distance (ft):	30.1
Structural Grade:	0
O&M Grade:	0
Clock Start/From:	10
Clock To:	
1st Value:	4.000
2nd Value:	
Value Percent:	
Continuous Index:	
Within 8" of Joint:	
Remarks:

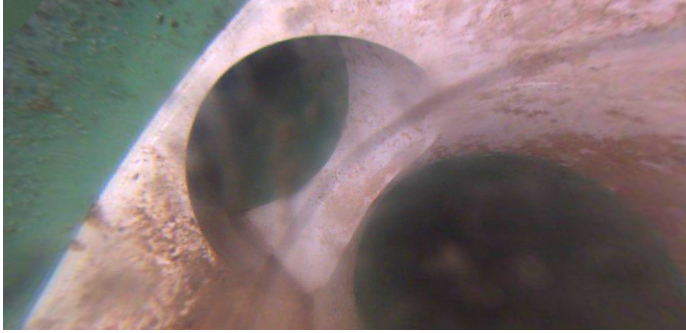
Code: **TF**
Description: **Tap Factory**

Distance (ft): **50.4**
Structural Grade: **0**
O&M Grade: **0**
Clock Start/From: **2**
Clock To:
1st Value: **4.000**
2nd Value:
Value Percent:
Continuous Index:
Within 8" of Joint:
Remarks:

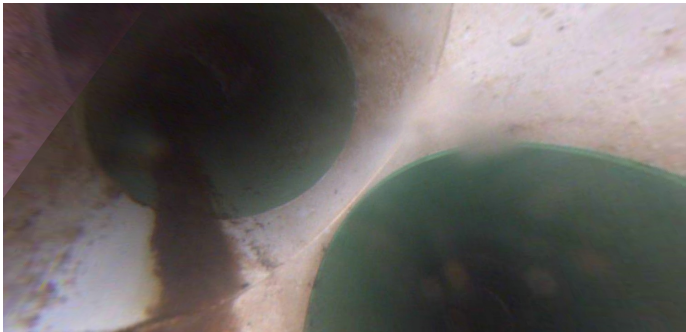
Code: **TF**
Description: **Tap Factory**

Distance (ft): **104.5**
Structural Grade: **0**
O&M Grade: **0**
Clock Start/From: **10**
Clock To:
1st Value: **4.000**
2nd Value:
Value Percent:
Continuous Index:
Within 8" of Joint:
Remarks:

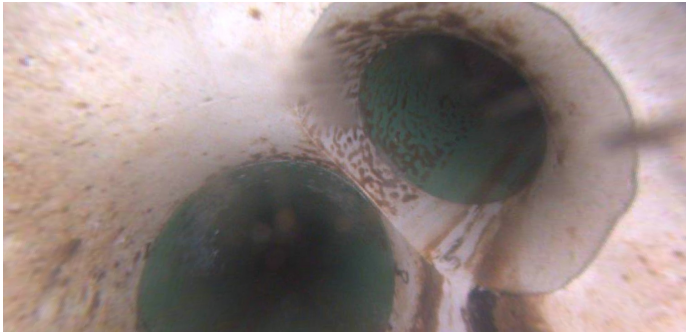
Code: **TF**
Description: **Tap Factory**

Distance (ft): **108.3**
Structural Grade: **0**
O&M Grade: **0**
Clock Start/From: **2**
Clock To:
1st Value: **4.000**
2nd Value:
Value Percent:
Continuous Index:
Within 8" of Joint:
Remarks:

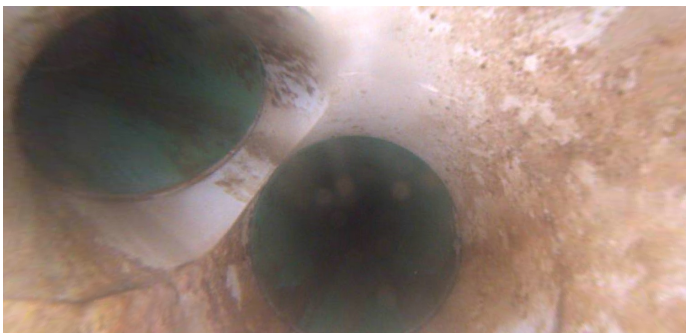
Code: **TF**
Description: **Tap Factory**

Distance (ft): **179.2**
Structural Grade: **0**
O&M Grade: **0**
Clock Start/From: **10**
Clock To:
1st Value: **4.000**
2nd Value:
Value Percent:
Continuous Index:
Within 8" of Joint:
Remarks:

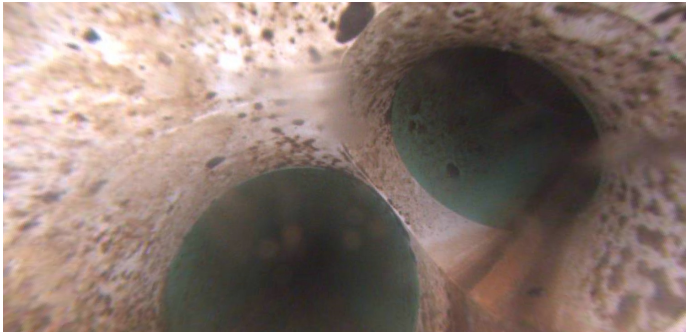
Code: **TF**
Description: **Tap Factory**

Distance (ft): **183.5**
Structural Grade: **0**
O&M Grade: **0**
Clock Start/From: **2**
Clock To:
1st Value: **4.000**
2nd Value:
Value Percent:
Continuous Index:
Within 8" of Joint:
Remarks:

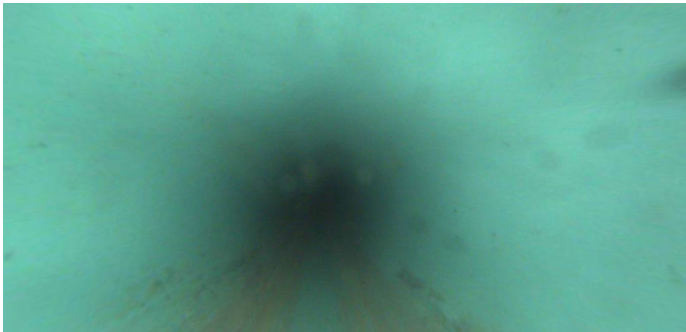
Code: **MSA**
Description: **Abandoned Survey**

Distance (ft): **202.9**
Structural Grade: **0**
O&M Grade: **0**
Clock Start/From:
Clock To:
1st Value:
2nd Value:
Value Percent:
Continuous Index:
Within 8" of Joint: **NO**
Remarks: **unknown**
