Profile/Photo Observation Report

Date:	03/31/2018	Weather:		Coding:	PACP 6.0
Pipe Length (ft):	330.0	Owner:	NA	Pre Clean:	Not Known
P.O.#:		Surveyor:	Jen Costello	PSR:	P-808-024-023
Customer:		Clean Date:	01/01/1900	Shape:	C

Street:	Union	Flow Control:	Not Controlled
City:	Hobart, IN	Year Renewed:	
Location:	Light Highway	Tape/Media #:	
Purpose:	Maintenance Related	Dia/Height:	8"
Use:	Sanitary	Material:	PVC
Drain Area:	NA	Lining:	Cured in Place
Category:	NA		
Comment:	Flow direction wrong. Reverse setup.		
Location Details:		Direction of Survey:	Downstream
US MH:	M-808-023	DS MH:	M-808-024
		Total Length Surveyed (ft):	202.9

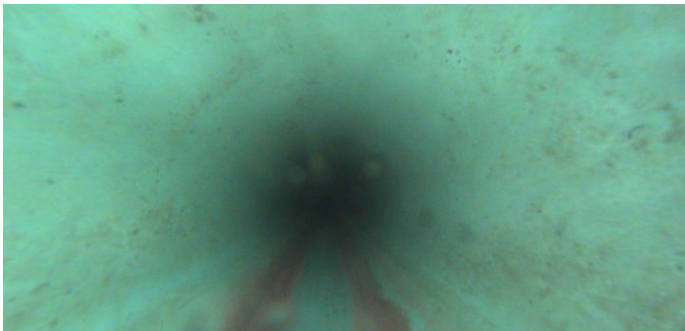
Code: **AMH**
Description: **Manhole**

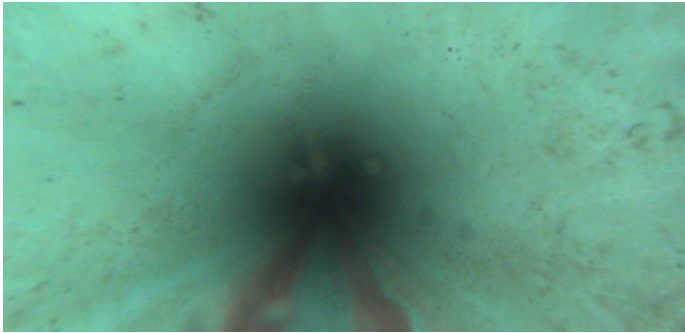
Code:	MWL
Description:	Water Level

Distance (ft):	.0
Structural Grade:	0
O&M Grade:	0
Clock Start/From:	
Clock To:	
1st Value:	
2nd Value:	
Value Percent:	5.000
Continuous Index:	
Within 8" of Joint:	NO
Remarks:

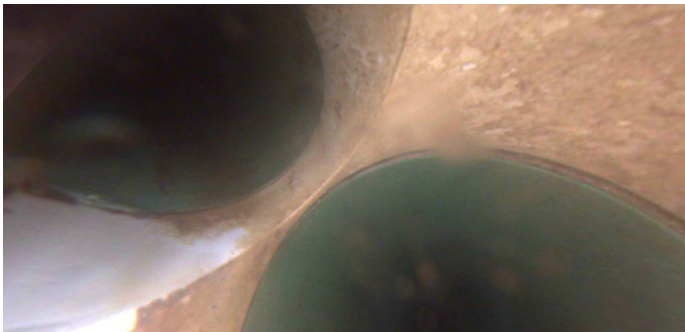
Code:	TF
Description:	Tap Factory

Distance (ft):	30.1
Structural Grade:	0
O&M Grade:	0
Clock Start/From:	10
Clock To:	
1st Value:	4.000
2nd Value:	
Value Percent:	
Continuous Index:	
Within 8" of Joint:	
Remarks:

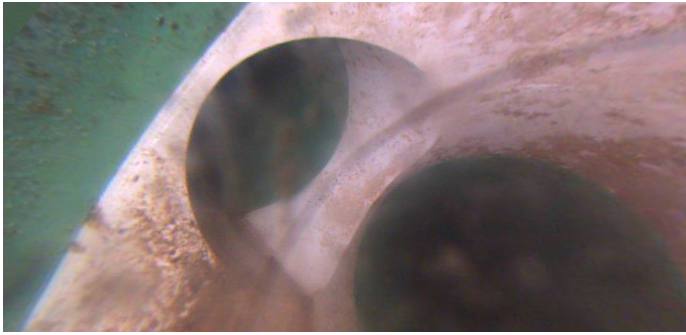
Code: **TF**
Description: **Tap Factory**

Distance (ft): **50.4**
Structural Grade: **0**
O&M Grade: **0**
Clock Start/From: **2**
Clock To:
1st Value: **4.000**
2nd Value:
Value Percent:
Continuous Index:
Within 8" of Joint:
Remarks:

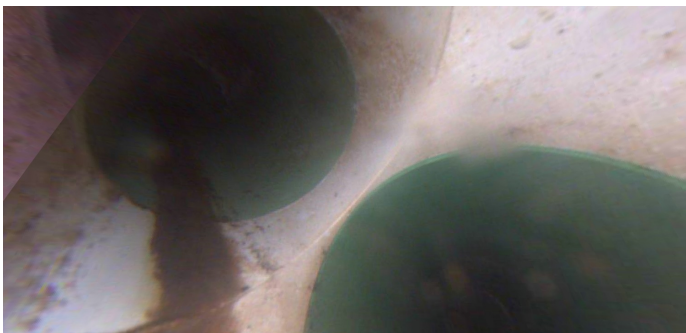
Code: **TF**
Description: **Tap Factory**

Distance (ft): **104.5**
Structural Grade: **0**
O&M Grade: **0**
Clock Start/From: **10**
Clock To:
1st Value: **4.000**
2nd Value:
Value Percent:
Continuous Index:
Within 8" of Joint:
Remarks:

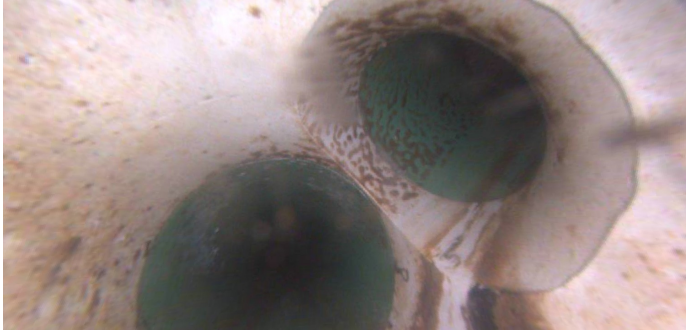
Code: **TF**
Description: **Tap Factory**

Distance (ft): **108.3**
Structural Grade: **0**
O&M Grade: **0**
Clock Start/From: **2**
Clock To:
1st Value: **4.000**
2nd Value:
Value Percent:
Continuous Index:
Within 8" of Joint:
Remarks:

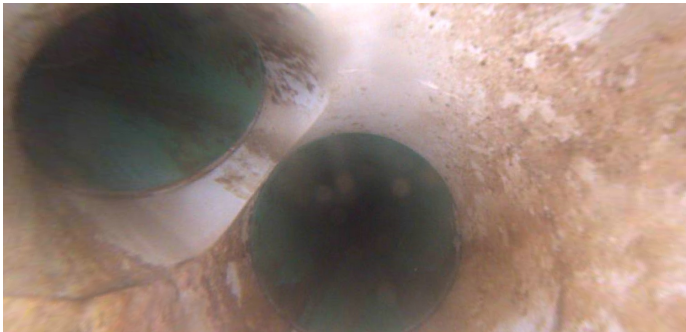
Code: **TF**
Description: **Tap Factory**

Distance (ft): **179.2**
Structural Grade: **0**
O&M Grade: **0**
Clock Start/From: **10**
Clock To:
1st Value: **4.000**
2nd Value:
Value Percent:
Continuous Index:
Within 8" of Joint:
Remarks:

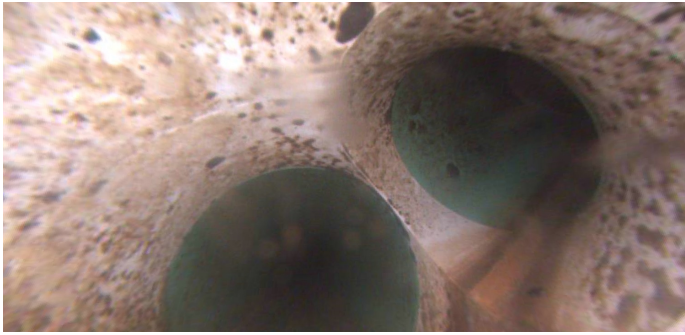
Code: **TF**
Description: **Tap Factory**

Distance (ft): **183.5**
Structural Grade: **0**
O&M Grade: **0**
Clock Start/From: **2**
Clock To:
1st Value: **4.000**
2nd Value:
Value Percent:
Continuous Index:
Within 8" of Joint:
Remarks:

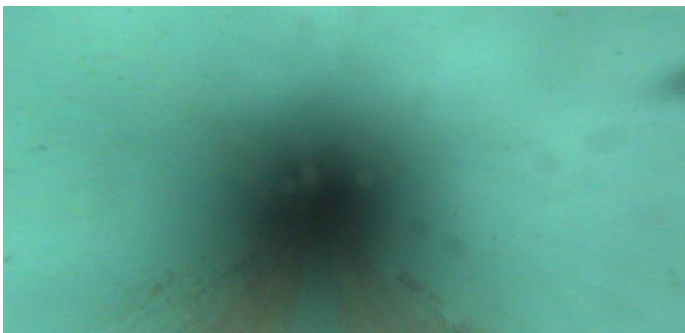
Code: **MSA**
Description: **Abandoned Survey**

Distance (ft): **202.9**
Structural Grade: **0**
O&M Grade: **0**
Clock Start/From:
Clock To:
1st Value:
2nd Value:
Value Percent:
Continuous Index:
Within 8" of Joint: **NO**
Remarks: **unknown**
