## Profile/Photo Observation Report

Street:	<b>Oak</b>	Flow Control:	<b>Not Controlled</b>
City:	<b>Hobart, IN</b>	Year Renewed:	
Location:	<b>Ditch</b>	Tape/Media #:	
Purpose:	<b>Maintenance Related</b>	Dia/Height:	<b>12"</b>
Use:	<b>Sanitary</b>	Material:	<b>PVC</b>
Drain Area:	<b>NA</b>	Lining:	
Category:	<b>NA</b>		
Comment:	<b>sludge at 314'.</b>

Location Details:		Direction of Survey:	<b>Upstream</b>
US MH:	<b>M-808-025</b>	DS MH:	<b>M-808-026</b>
		Total Length Surveyed (ft):	<b>315.5</b>

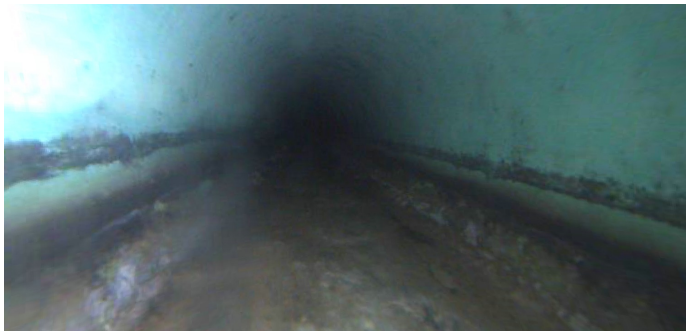
Code: **DAGS**  
Description: **Deposits Attached Grease**

Distance (ft): **.0**  
Structural Grade: **0**  
O&M Grade: **2**  
Clock Start/From: **8**  
Clock To: **4**  
1st Value:  
2nd Value:  
Value Percent: **5.000**  
Continuous Index: **S01**  
Within 8" of Joint: **NO**  
Remarks:

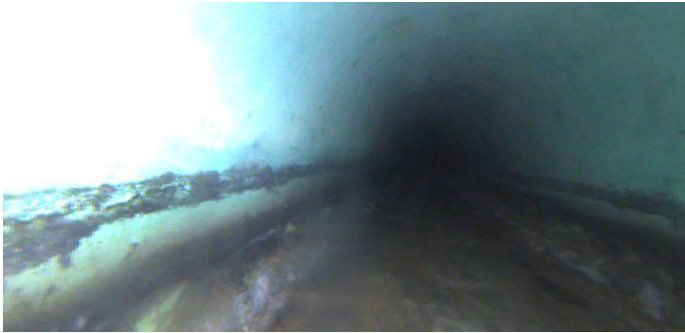
Code:	<b>AMH</b>
Description:	<b>Manhole</b>

Distance (ft):	<b>.0</b>
Structural Grade:	<b>0</b>
O&M Grade:	<b>0</b>
Clock Start/From:	
Clock To:	
1st Value:	
2nd Value:	
Value Percent:	
Continuous Index:	
Within 8" of Joint:	<b>NO</b>
Remarks:	<b>M-808-026</b>

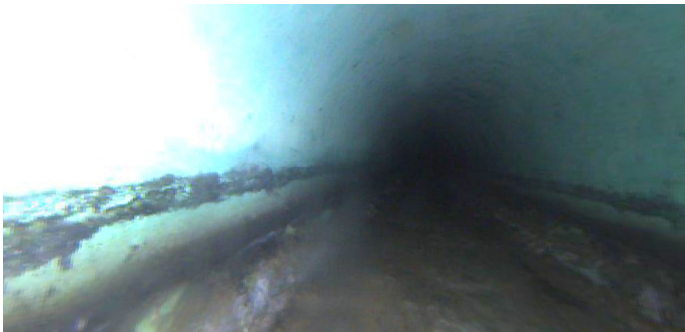
Code:	<b>MWL</b>
Description:	<b>Water Level</b>

Distance (ft):	<b>.0</b>
Structural Grade:	<b>0</b>
O&M Grade:	<b>0</b>
Clock Start/From:	
Clock To:	
1st Value:	
2nd Value:	
Value Percent:	<b>5.000</b>
Continuous Index:	
Within 8" of Joint:	<b>NO</b>
Remarks:

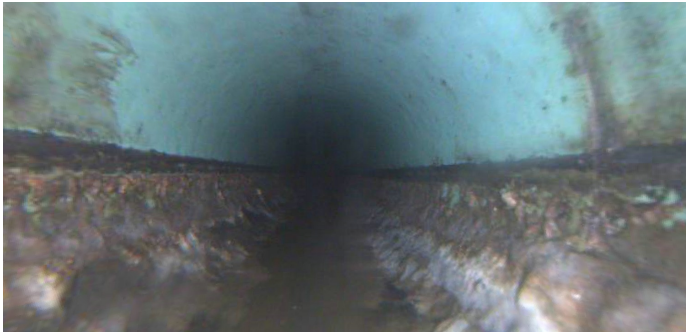
Code: **DAGS**  
Description: **Deposits Attached Grease**

Distance (ft): **315.5**  
Structural Grade: **0**  
O&M Grade: **2**  
Clock Start/From: **8**  
Clock To: **4**  
1st Value:  
2nd Value:  
Value Percent: **5.000**  
Continuous Index: **F01**  
Within 8" of Joint: **NO**  
Remarks:

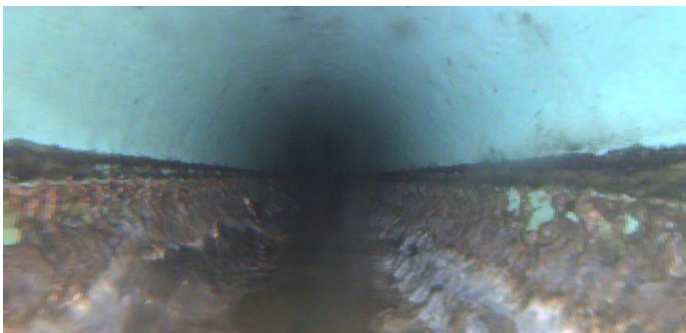
Code: **MSA**  
Description: **Abandoned Survey**

Distance (ft): **315.5**  
Structural Grade: **0**  
O&M Grade: **0**  
Clock Start/From:  
Clock To:  
1st Value:  
2nd Value:  
Value Percent:  
Continuous Index:  
Within 8" of Joint: **NO**  
Remarks: **CAMERA STOPPED**
