Profile/Photo Observation Report

Street:	S HOBART RD	Flow Control:	Not Controlled
City:	Hobart, IN	Year Renewed:	
Location:	Ditch	Tape/Media #:	
Purpose:	Maintenance Related	Dia/Height:	12"
Use:	Sanitary	Material:	PVC
Drain Area:	NA	Lining:	
Category:	NA		
Comment:	Reverse setup. possible sludge at 313'.

Location Details:		Direction of Survey:	Downstream
US MH:	M-808-026	DS MH:	M-808-027
		Total Length Surveyed (ft):	315.1

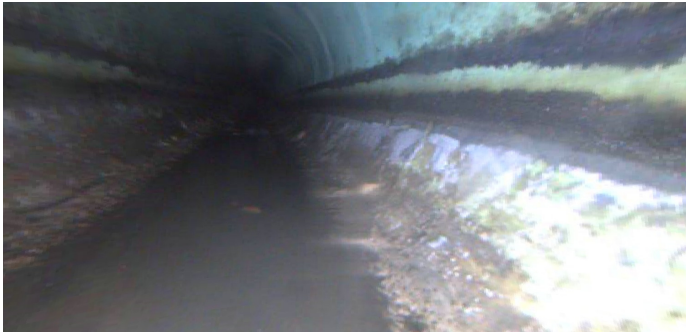
Code:	AMH
Description:	Manhole

Distance (ft):	.0
Structural Grade:	0
O&M Grade:	0
Clock Start/From:	
Clock To:	
1st Value:	
2nd Value:	
Value Percent:	
Continuous Index:	
Within 8" of Joint:	NO
Remarks:	M-808-026

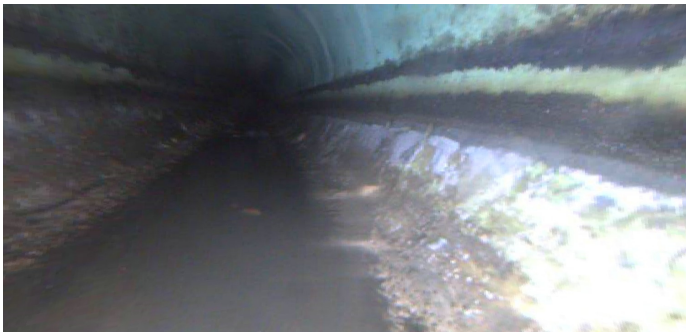
Code:	MWL
Description:	Water Level

Distance (ft):	.0
Structural Grade:	0
O&M Grade:	0
Clock Start/From:	
Clock To:	
1st Value:	
2nd Value:	
Value Percent:	5.000
Continuous Index:	
Within 8" of Joint:	NO
Remarks:

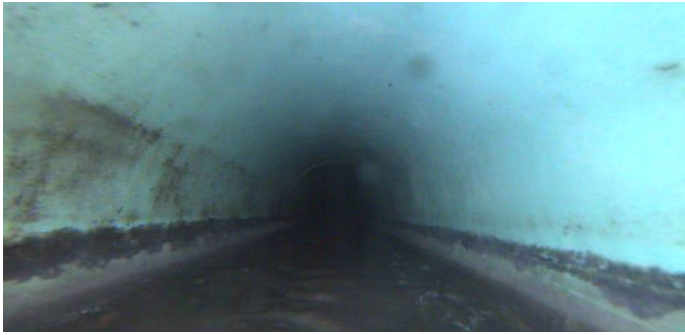
Code: **DAGS**
Description: **Deposits Attached Grease**

Distance (ft): **46.7**
Structural Grade: **0**
O&M Grade: **2**
Clock Start/From: **8**
Clock To: **4**
1st Value:
2nd Value:
Value Percent: **5.000**
Continuous Index: **F01**
Within 8" of Joint: **NO**
Remarks:

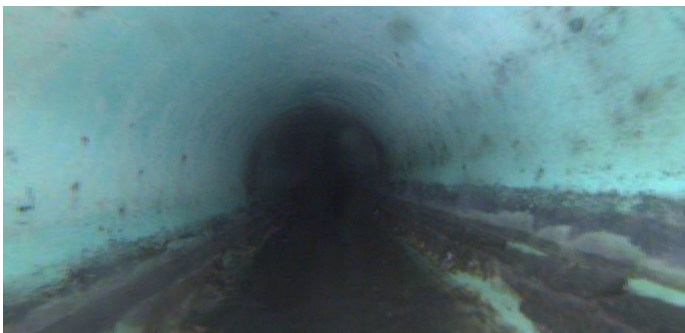
Code: **MSA**
Description: **Abandoned Survey**

Distance (ft): **315.1**
Structural Grade: **0**
O&M Grade: **0**
Clock Start/From:
Clock To:
1st Value:
2nd Value:
Value Percent:
Continuous Index:
Within 8" of Joint: **NO**
Remarks: **CAMERA STOPPED**
