Profile/Photo Observation Report

| Street: | Hobart | Flow Control: | Not Controlled |

| US MH: | M-808-028 | DS MH: | M-808-029 |

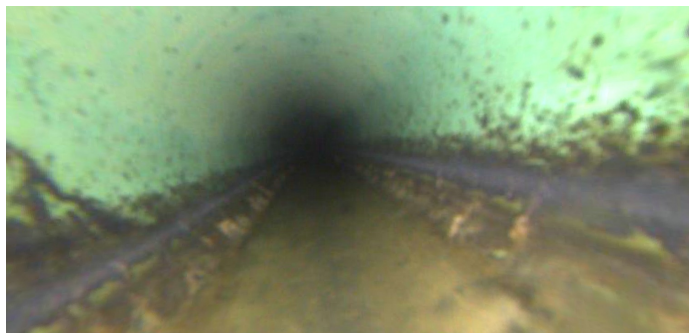
Code: **AMH**
Description: **Manhole**

Distance (ft): **.0**
Structural Grade: **0**
O&M Grade: **0**
Clock Start/From:
Clock To:
1st Value:
2nd Value:
Value Percent:
Continuous Index:
Within 8" of Joint: **NO**
Remarks: **M-808-029**

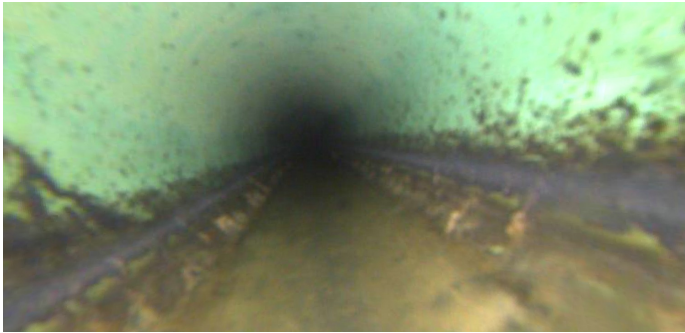
| Code: | MWL |
| Description: | Water Level |

| Value Percent: | 10.000 |

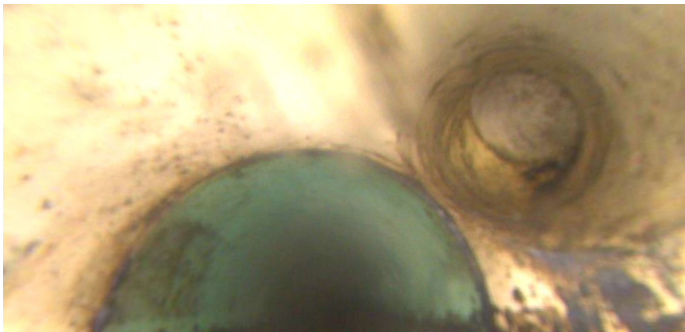
| Code: | TF |
| Description: | Tap Factory |

| Distance (ft): | 302.2 |
| Clock Start/From: | 2 |
| 1st Value: | 4.000 |

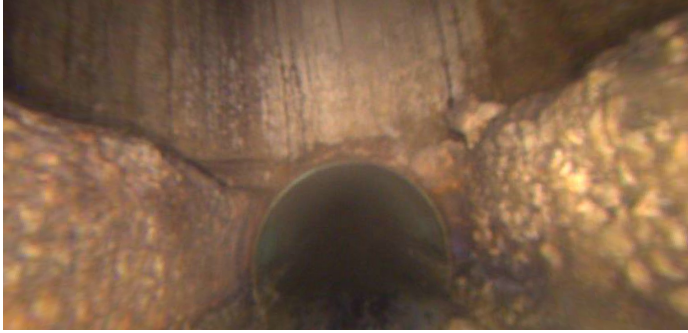
| Code: | AMH |
| Description: | Manhole |
| Distance (ft): | 401.9 |
| Remarks: | M-808-028 |
