Profile/Photo Observation Report

Date:	04/05/2018	Weather:		Coding:	PACP 6.0
Pipe Length (ft):	391.8	Owner:	NA	Pre Clean:	Not Known
P.O.#:		Surveyor:	Jen Costello	PSR:	P-808-029-030
Customer:		Clean Date:	01/01/1900	Shape:	C

Street:	S HOBART RD	Flow Control:	Not Controlled
City:	Hobart, IN	Year Renewed:	
Location:	Ditch	Tape/Media #:	
Purpose:	Maintenance Related	Dia/Height:	12"
Use:	Sanitary	Material:	PVC
Drain Area:	NA	Lining:	Cured in Place
Category:	NA		
Comment:	Flow direction wrong. Reverse setup.		
Location Details:		Direction of Survey:	Downstream
US MH:	M-808-030	DS MH:	M-808-029
		Total Length Surveyed (ft):	7.4

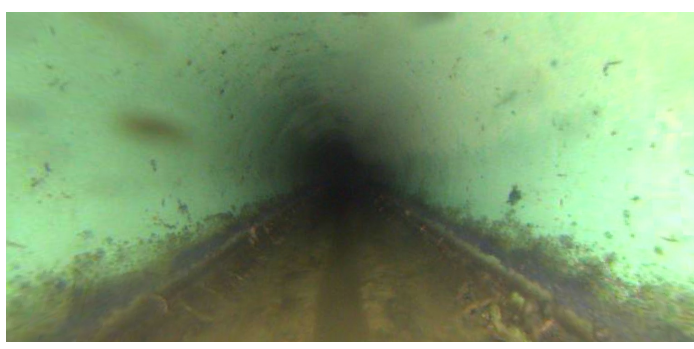
Code: **AMH**
Description: **Manhole**

Distance (ft): **.0**
Structural Grade: **0**
O&M Grade: **0**
Clock Start/From:
Clock To:
1st Value:
2nd Value:
Value Percent:
Continuous Index:
Within 8" of Joint: **NO**
Remarks: **M-808-030**

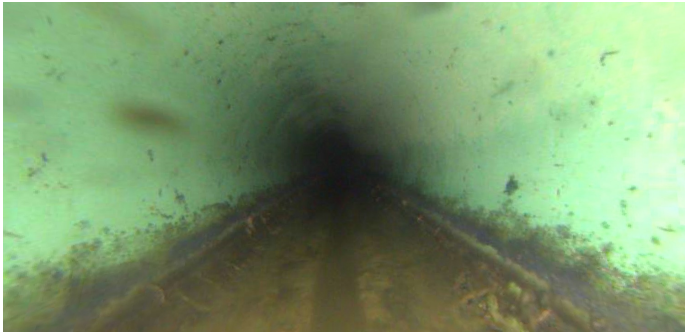
Code:	MWL
Description:	Water Level

Distance (ft):	.0
Structural Grade:	0
O&M Grade:	0
Clock Start/From:	
Clock To:	
1st Value:	
2nd Value:	
Value Percent:	10.000
Continuous Index:	
Within 8" of Joint:	NO
Remarks:

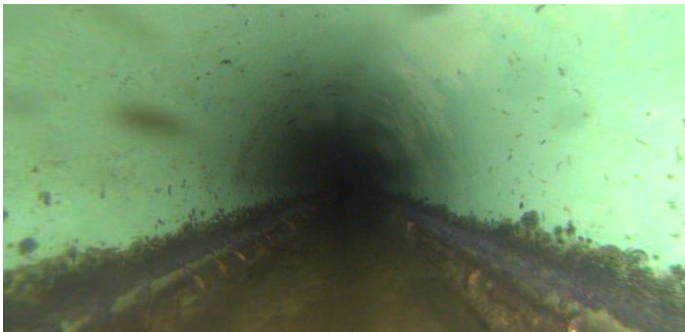
Code:	MSA
Description:	Abandoned Survey

Distance (ft):	7.4
Structural Grade:	0
O&M Grade:	0
Clock Start/From:	
Clock To:	
1st Value:	
2nd Value:	
Value Percent:	
Continuous Index:	
Within 8" of Joint:	NO
Remarks:	unknown
