Profile/Photo Observation Report

| Street: | S HOBART RD | Flow Control: | Not Controlled |
| City: | Hobart, IN | Year Renewed: | |
| US MH: | M-808-030 | DS MH: | M-808-029 |

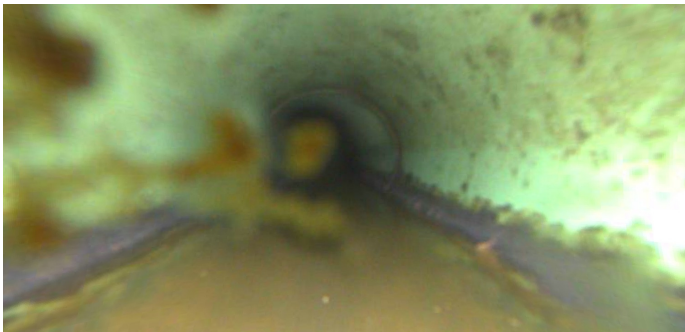
| Code: | MSA |
| Description: | Abandoned Survey |

| Distance (ft): | 25.6 |
| Remarks: | debris |
