Profile/Photo Observation Report

Street:	Hobart	Flow Control:	Not Controlled
City:	Hobart, IN	Year Renewed:	
Location:	Ditch	Tape/Media #:	
Purpose:	Maintenance Related	Dia/Height:	12"
Use:	Sanitary	Material:	PVC
Drain Area:	NA	Lining:	Cured in Place
Category:	NA		
Comment:	Flow direction wrong. Redeployment.		
Location Details:		Direction of Survey:	Downstream
US MH:	M-808-030	DS MH:	M-808-029
		Total Length Surveyed (ft):	25.6

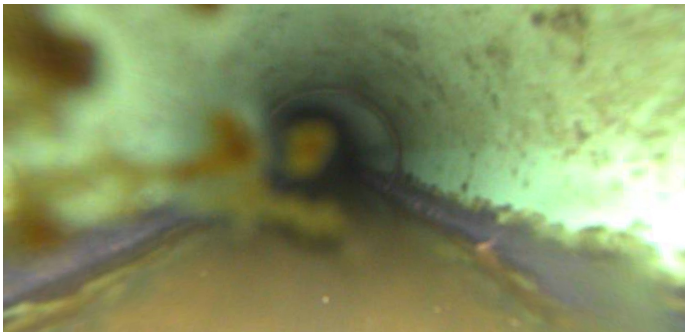
Code:	MSA
Description:	Abandoned Survey

Distance (ft):	25.6
Structural Grade:	0
O&M Grade:	0
Clock Start/From:	
Clock To:	
1st Value:	
2nd Value:	
Value Percent:	
Continuous Index:	
Within 8" of Joint:	NO
Remarks:	debris
