Profile/Photo Observation Report

Street:	S HOBART RD	Flow Control:	Not Controlled
City:	Hobart, IN	Year Renewed:	
Location:	Light Highway	Tape/Media #:	
Purpose:	Routine Assessment	Dia/Height:	12"
Use:	Sanitary	Material:	PVC
Drain Area:	NA	Lining:	
Category:	NA		
Comment:

Location Details:		Direction of Survey:	Upstream
US MH:	M-808-030	DS MH:	M-808-029
		Total Length Surveyed (ft):	336.0

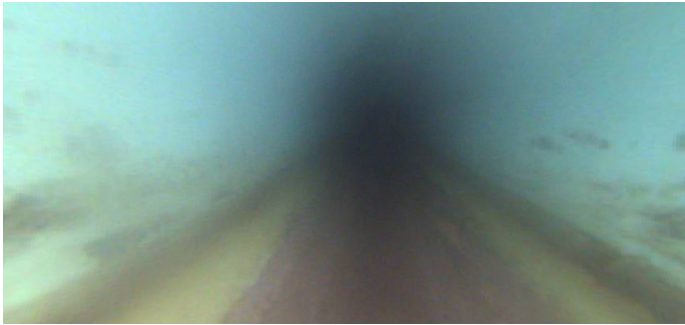
Code:	MWL
Description:	Water Level

Distance (ft):	.0
Structural Grade:	0
O&M Grade:	0
Clock Start/From:	
Clock To:	
1st Value:	
2nd Value:	
Value Percent:	5.000
Continuous Index:	
Within 8" of Joint:	NO
Remarks:

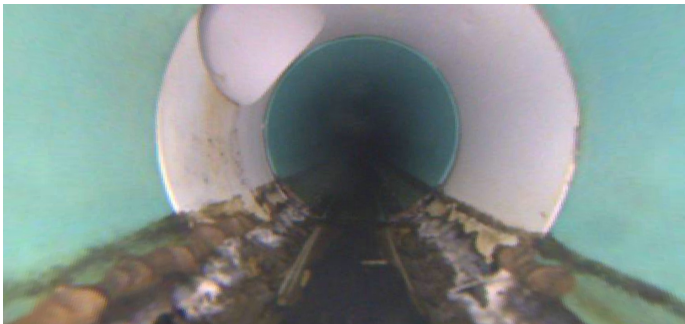
Code:	TF
Description:	Tap Factory

Distance (ft):	160.4
Structural Grade:	0
O&M Grade:	0
Clock Start/From:	10
Clock To:	
1st Value:	4.000
2nd Value:	
Value Percent:	
Continuous Index:	
Within 8" of Joint:	
Remarks:

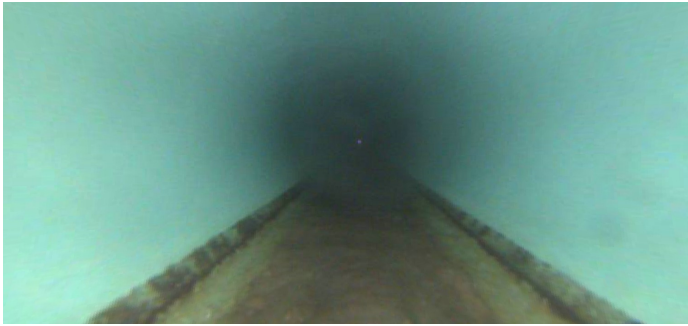
Code:	MSA
Description:	Abandoned Survey
Distance (ft):	336.0
Structural Grade:	0
O&M Grade:	0
Clock Start/From:	
Clock To:	
1st Value:	
2nd Value:	
Value Percent:	
Continuous Index:	
Within 8" of Joint:	NO
Remarks:	camera stopped
