Profile/Photo Observation Report

Street:	Hobart Rd.	Flow Control:	Not Controlled
City:	Hobart, IN	Year Renewed:	
Location:	Light Highway	Tape/Media #:	
Purpose:	Routine Assessment	Dia/Height:	12"
Use:	Sanitary	Material:	PVC
Drain Area:	NA	Lining:	
Category:	NA		
Comment:

Location Details:		Direction of Survey:	Upstream
US MH:	M-808-030	DS MH:	M-808-029
		Total Length Surveyed (ft):	336.0

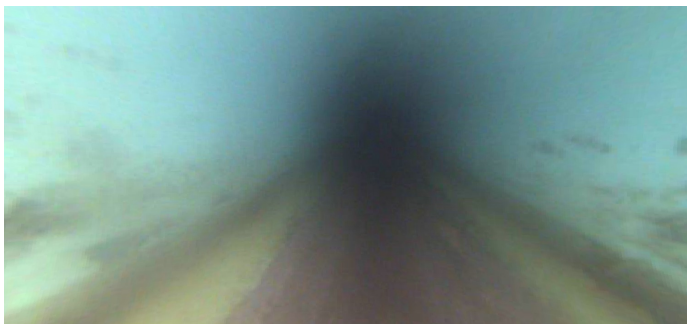
Code: **AMH**
Description: **Manhole**

Distance (ft): **.0**
Structural Grade: **0**
O&M Grade: **0**
Clock Start/From:
Clock To:
1st Value:
2nd Value:
Value Percent:
Continuous Index:
Within 8" of Joint: **NO**
Remarks: **M-808-029**

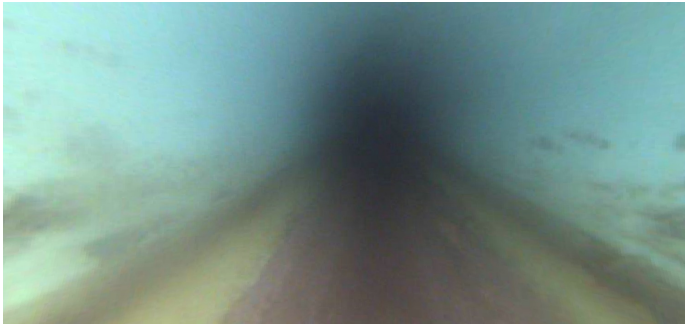
Code:	MWL
Description:	Water Level

Distance (ft):	.0
Structural Grade:	0
O&M Grade:	0
Clock Start/From:	
Clock To:	
1st Value:	
2nd Value:	
Value Percent:	5.000
Continuous Index:	
Within 8" of Joint:	NO
Remarks:

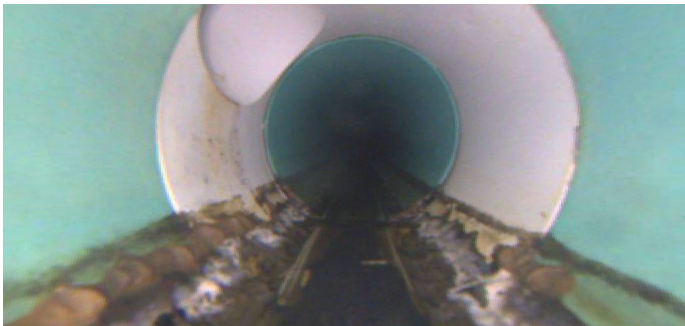
Code:	TF
Description:	Tap Factory

Distance (ft):	160.4
Structural Grade:	0
O&M Grade:	0
Clock Start/From:	10
Clock To:	
1st Value:	4.000
2nd Value:	
Value Percent:	
Continuous Index:	
Within 8" of Joint:	
Remarks:

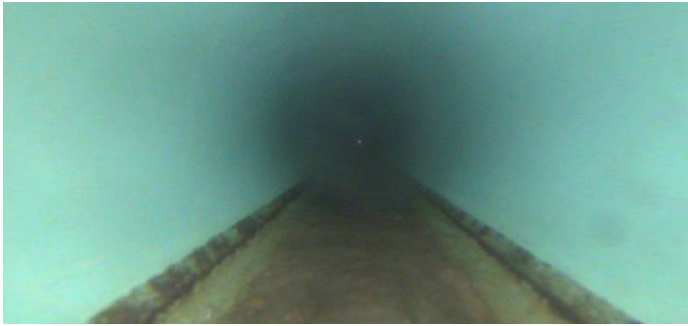
Code:	MSA
Description:	Abandoned Survey
Distance (ft):	336.0
Structural Grade:	0
O&M Grade:	0
Clock Start/From:	
Clock To:	
1st Value:	
2nd Value:	
Value Percent:	
Continuous Index:	
Within 8" of Joint:	NO
Remarks:	camera stopped
