Profile/Photo Observation Report

Street:	S HOBART RD	Flow Control:	Not Controlled
City:	Hobart, IN	Year Renewed:	
Location:	Light Highway	Tape/Media #:	
Purpose:	Maintenance Related	Dia/Height:	12"
Use:	Sanitary	Material:	PVC
Drain Area:	NA	Lining:	Cured in Place
Category:	NA		
Comment:	Flow direction wrong. Reverse setup. Debris at 54'.		
Location Details:		Direction of Survey:	Downstream
US MH:	M-808-031	DS MH:	M-808-030
		Total Length Surveyed (ft):	56.3

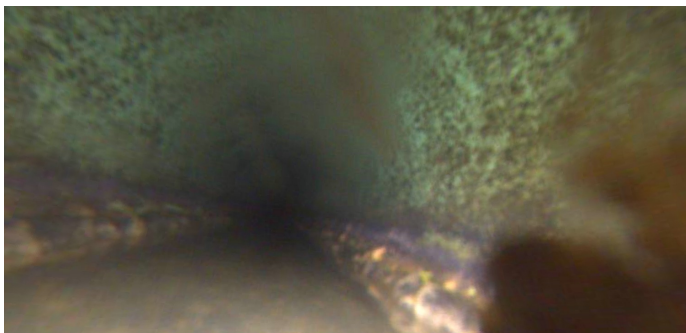
Code: **AMH**
Description: **Manhole**

Distance (ft): **.0**
Structural Grade: **0**
O&M Grade: **0**
Clock Start/From:
Clock To:
1st Value:
2nd Value:
Value Percent:
Continuous Index:
Within 8" of Joint: **NO**
Remarks: **M-808-031**

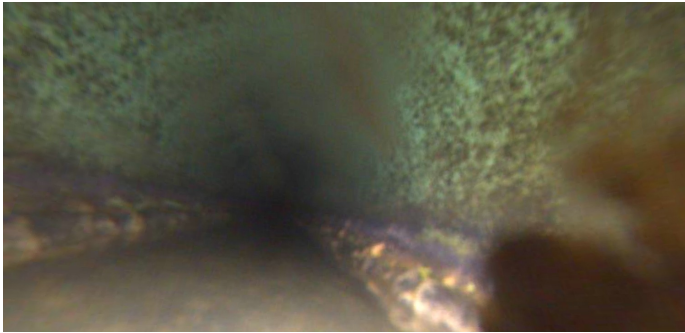
Code:	MWL
Description:	Water Level

Distance (ft):	.0
Structural Grade:	0
O&M Grade:	0
Clock Start/From:	
Clock To:	
1st Value:	
2nd Value:	
Value Percent:	10.000
Continuous Index:	
Within 8" of Joint:	NO
Remarks:

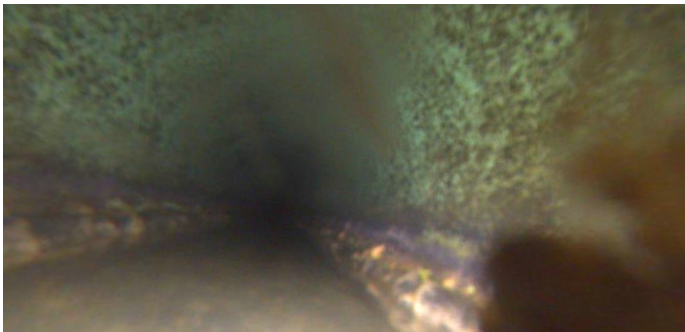
Code:	DAGS
Description:	Deposits Attached Grease

Distance (ft):	.0
Structural Grade:	0
O&M Grade:	2
Clock Start/From:	8
Clock To:	4
1st Value:	
2nd Value:	
Value Percent:	5.000
Continuous Index:	
Within 8" of Joint:	NO
Remarks:

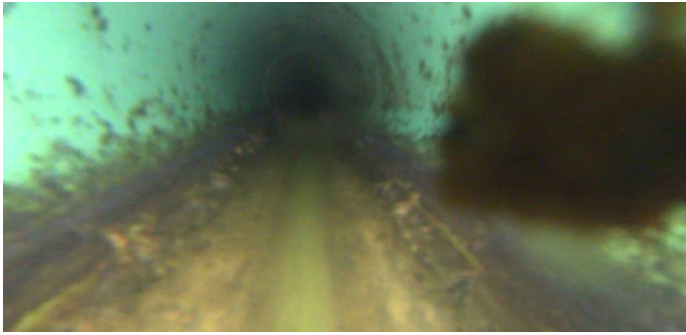
Code: **DAGS**
Description: **Deposits Attached Grease**

Distance (ft): **21.4**
Structural Grade: **0**
O&M Grade: **2**
Clock Start/From: **5**
Clock To: **4**
1st Value:
2nd Value:
Value Percent: **5.000**
Continuous Index: **S01**
Within 8" of Joint: **NO**
Remarks:

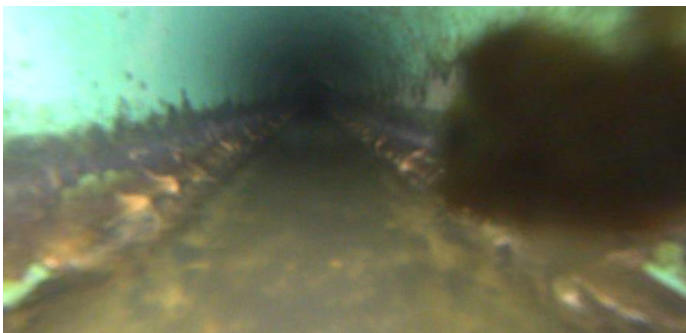
Code: **MSA**
Description: **Abandoned Survey**

Distance (ft): **56.3**
Structural Grade: **0**
O&M Grade: **0**
Clock Start/From:
Clock To:
1st Value:
2nd Value:
Value Percent:
Continuous Index:
Within 8" of Joint: **NO**
Remarks: **DAGS**

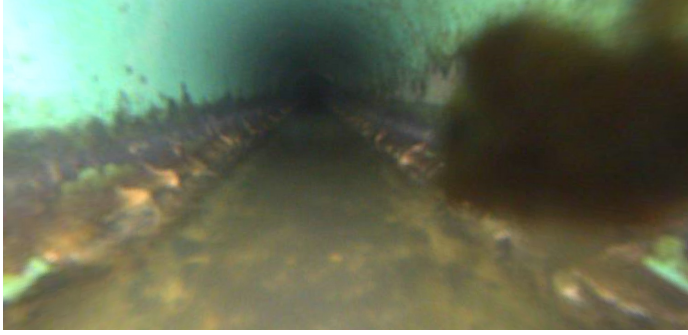
Code:	DAGS
Description:	Deposits Attached Grease
Distance (ft):	56.3
Structural Grade:	0
O&M Grade:	2
Clock Start/From:	5
Clock To:	4
1st Value:	
2nd Value:	
Value Percent:	5.000
Continuous Index:	F01
Within 8" of Joint:	NO
Remarks:
